CHAPTER I

INTRODUCTION

The Mae Moh lignite mine in Lampang, northern Thailand is experiencing such problems. There occurred several wedge and bedding plane failures and some land slides on the pit walls, the first serious failure was recorded back in 1980. However, there is still no particular investigation on slope stability done in detail in this mine. This finding together with the availability of other supporting information plus the economic importance of the mine make it an ideal case for a detailed study, i.e. for the present work.

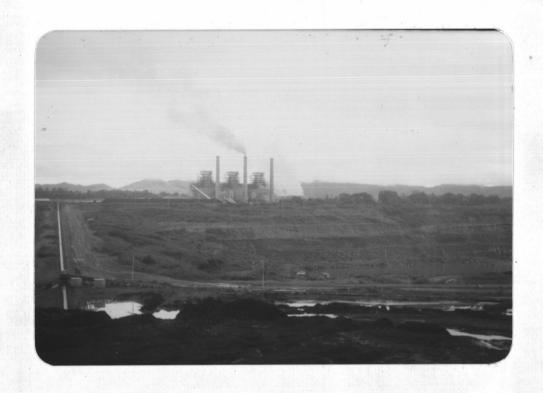
Figure 1. Mae Moh lignite power plant. The northwestern flank slope of the mine is in the foreground.

northwestern slope is 45 to 50 meters high, 1,000 to 1,500 meters long, with the overall slope angle varying from 35° to 45° and has a history of several events of down slope mass-movement. Meanwhile the bedding plane slides on the southeastern slope also threaten the mine operation.

In March, 1980, the first local wedge failure occurred on the northwestern slope (Pramote Pornrattanapitak, 1980, personal communication). The wedge grew larger and the tension cracks formed on the upper part of the slope in July, 1981. Then in August, 1981, a landslide occurred. The sliding mass had a length of 250 meters along the slope face. Concurrently several block failures had been noted on the southeastern slope. The blocks may be as big as 10 x 20 x 2 cubic meters. These blocks slid down the bedding plane into the pit and threatened the equipments and miners' life. These phenomena hence proclaim the necessity of a careful slope-stability study while the authority is taking an immediate solution by remodifying the problematic slopes.
