CHAPTER 5

EVIDENCES AND PARAMETERS AFFECTING DEBRIS FLOW-FLOOD PROCESSES IN NAM KO YAI SUB-CATCHMENT

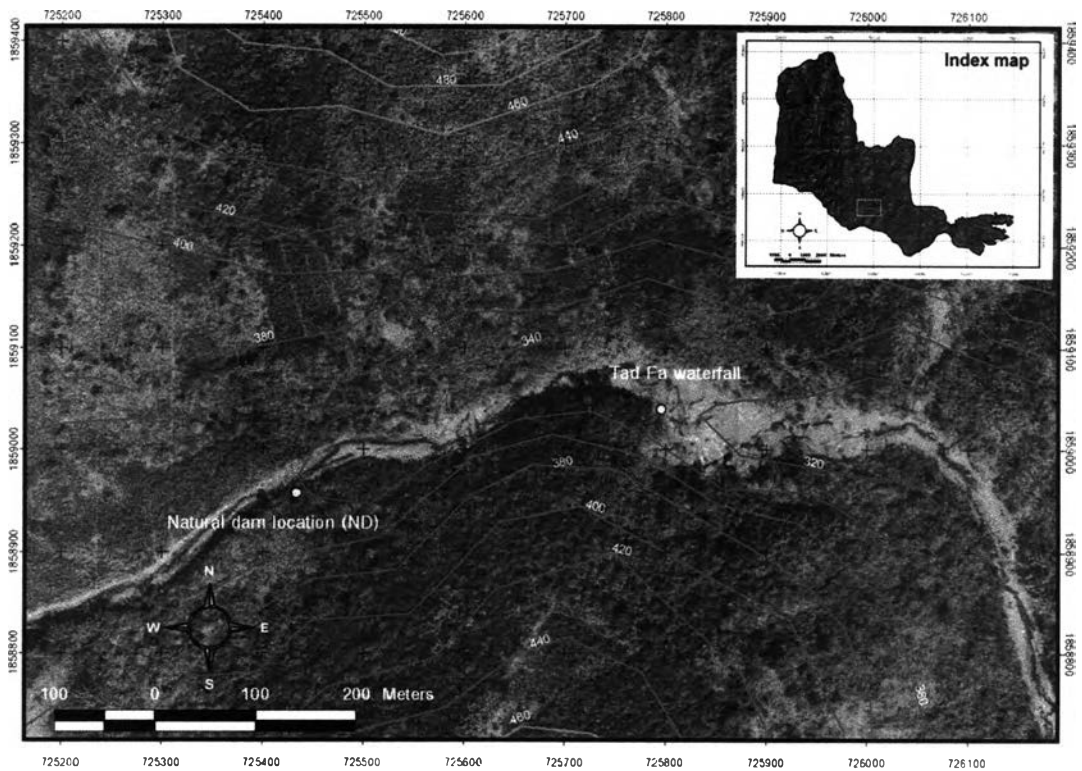
Figure 5-3 Closed-up orthophotograph in Figure 5-2 illustrating the local geography of Nam Ko Yai stream that is suspected to be a natural temporary landslide dam location (ND) in front of the location of Tad Fa waterfall.

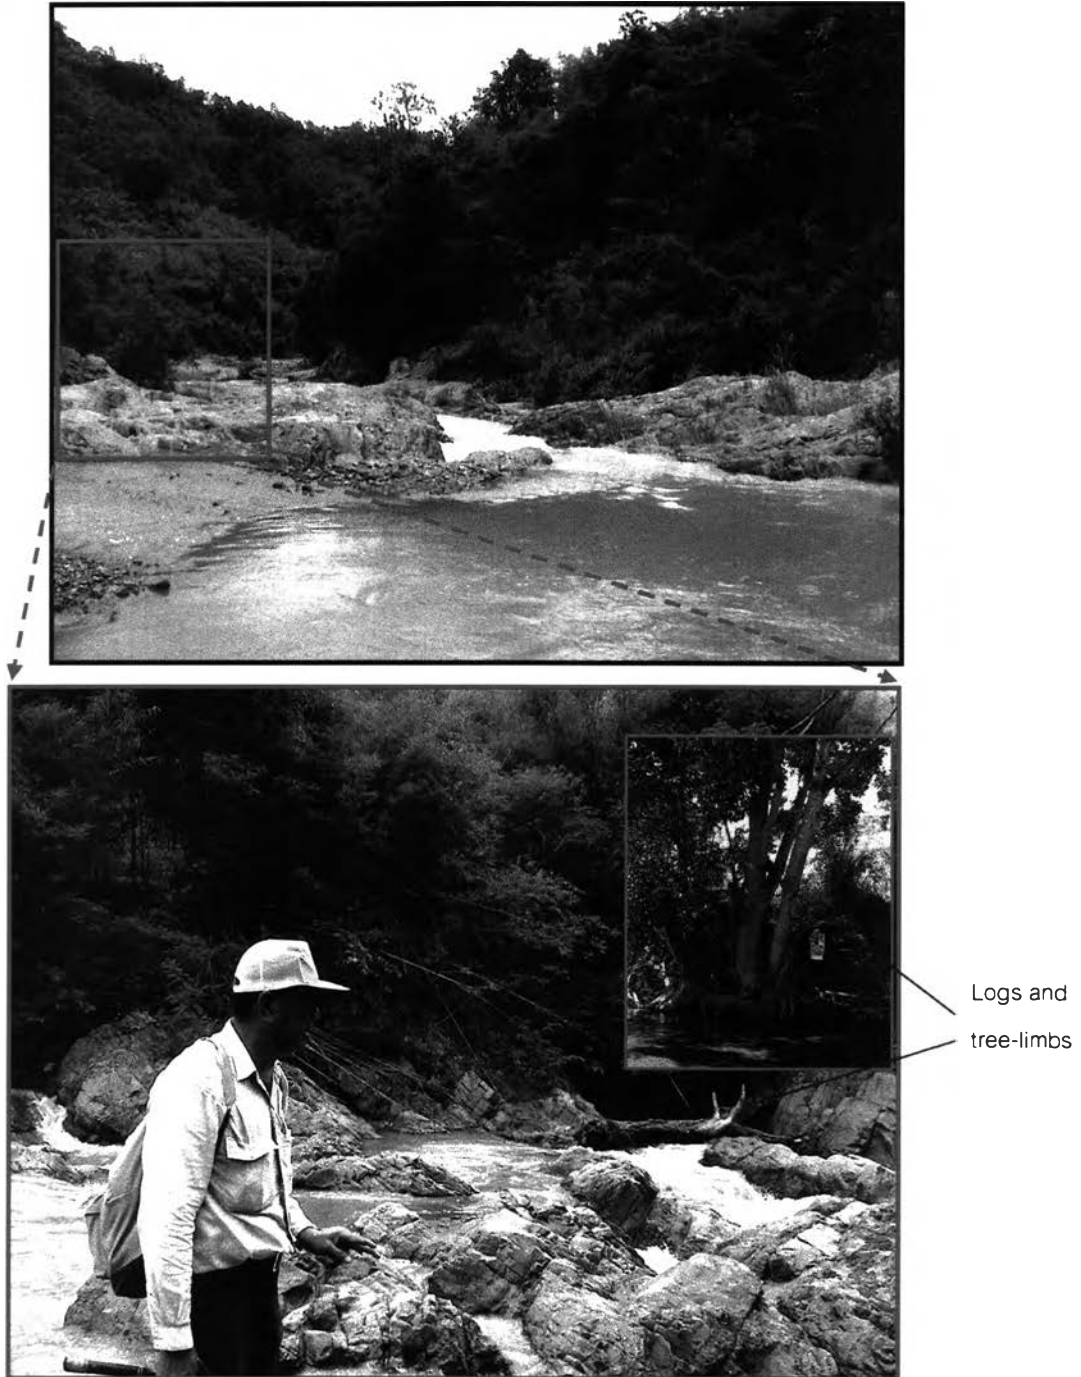
Figure 5-4 Photographs (looking eastward direction) illustrating the configuration of Nam Ko Yai stream channel at location ND (referred to Figure 5-3) that is suitable for accumulated sediments for blockage a torrent stream and formed a natural temporary landslide dam. Note: The evidence of transported timbers was still found not only in the channel as a large one but also left as a smaller one at the higher level of the tree-branches (as shown in the inserted photograph that taken at the upstream of Nam Ko Yai stream, 2.5 km. far away from this point).

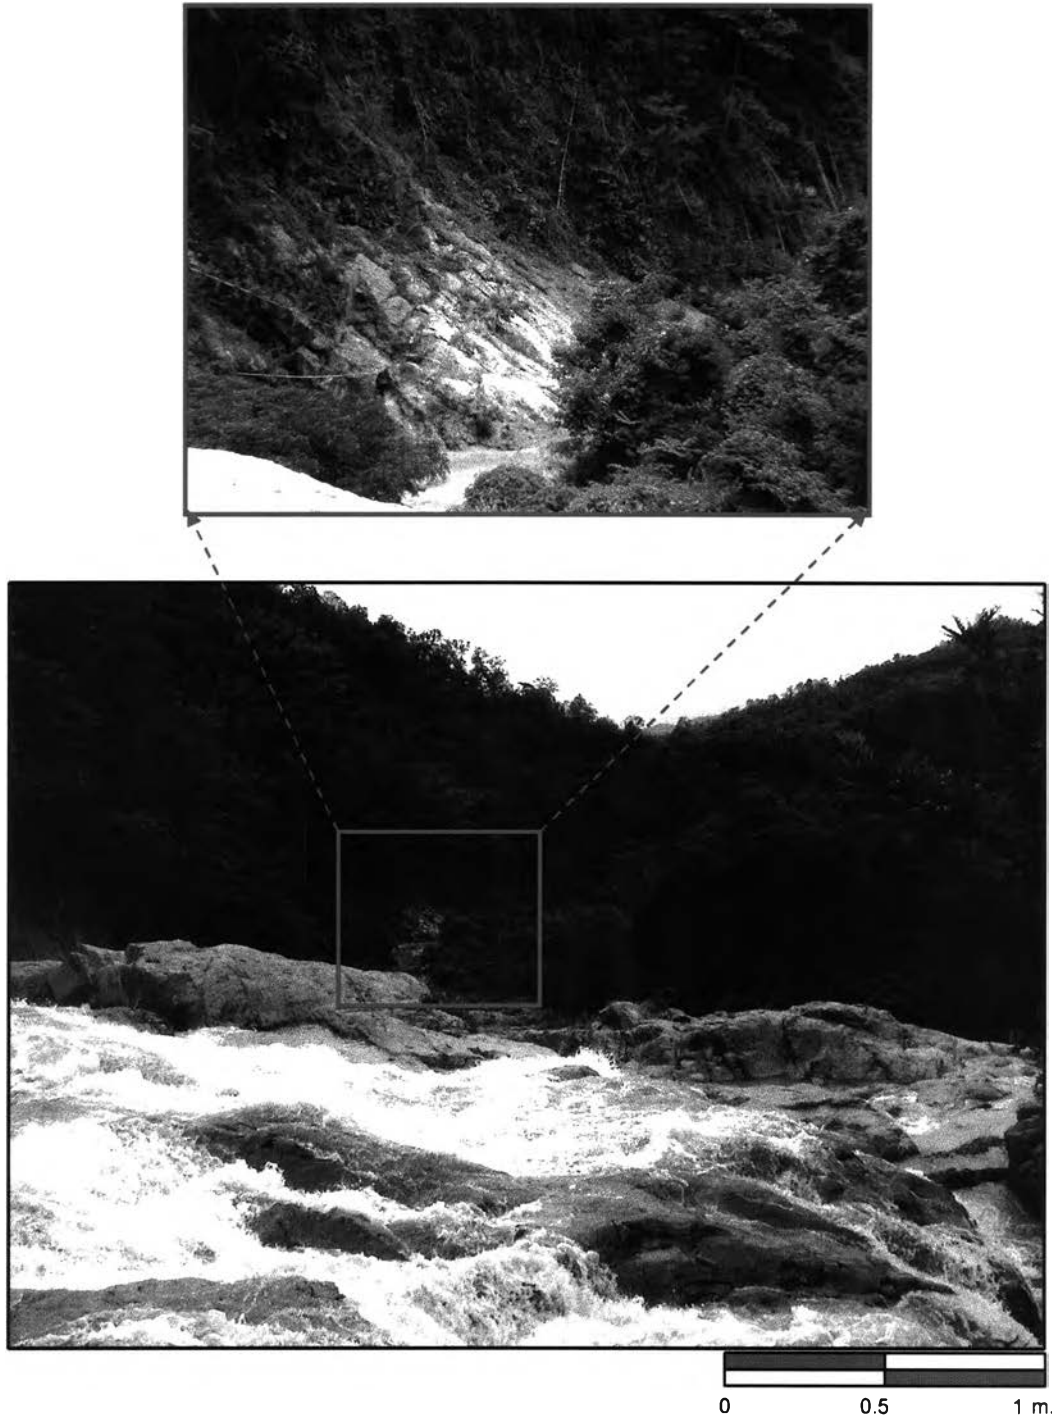
Figure 5-5 Photographs (looking eastward direction) showing the different relief of about 20 m between Tad Fa waterfall (location referred to Figure 5-3) and the downstream V-shape channel that is suitable for increasing water turbulent to form flow-flood occurrence.

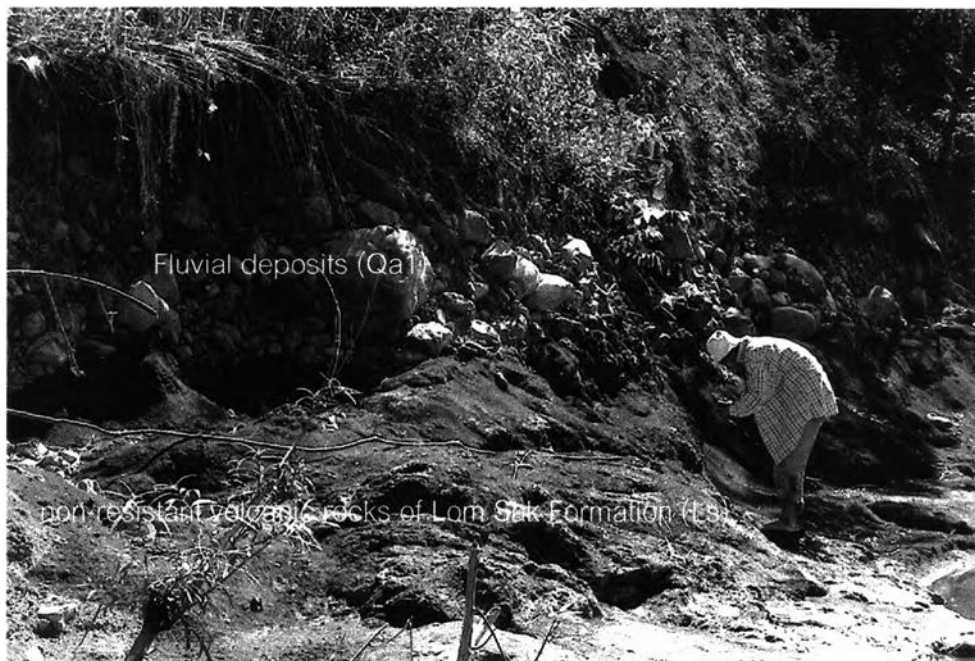
From the base rocks in the upstream from this suspected natural temporary dam location, it is interesting to note that lithology of Lom Sak Formation is mainly composed of non-resistant rocks of volcanic complex as shown in Figure 5-9. So the U-shape upstream of Nam Ko Yai channel is generally controlled by the soft and non-resistant volcanic rocks that are easily eroded as a flat area.

Figure 5-9 Photograph showing the soft and non-resistant volcanic rocks of Lom Sak Formation in the upstream from the suspected natural temporary dam location.

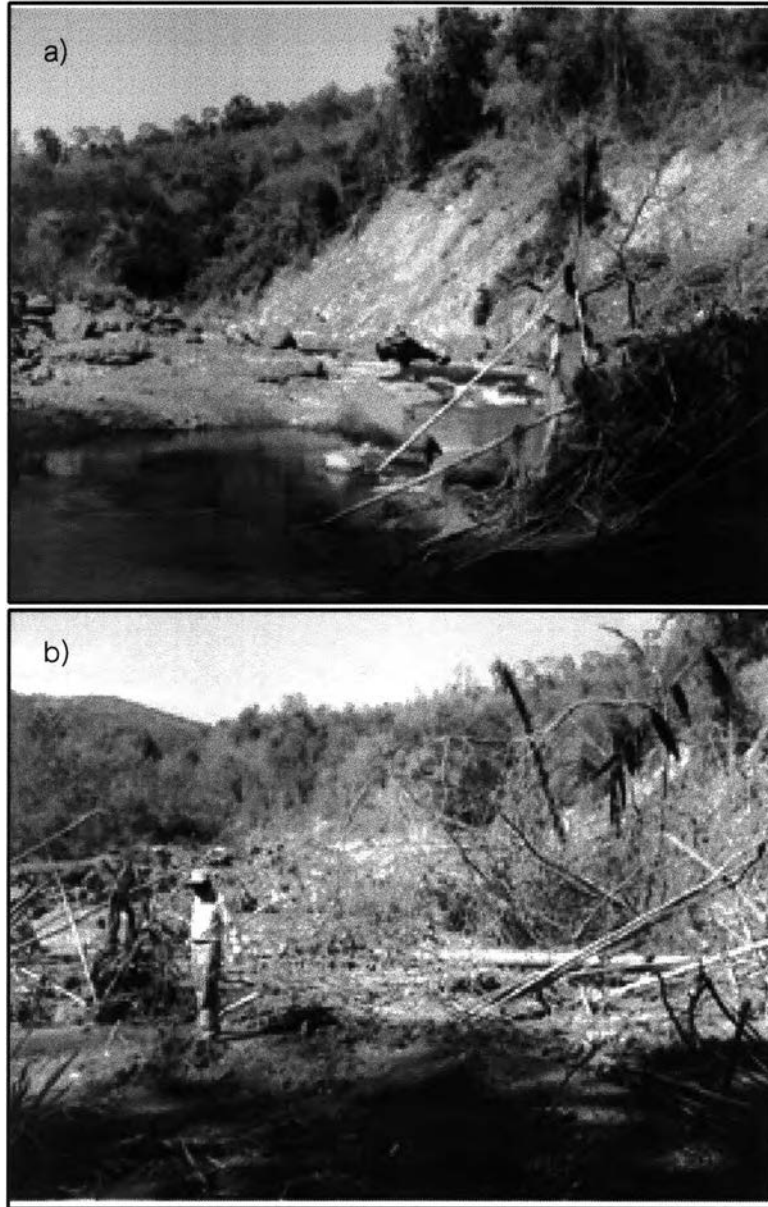
channel, especially in the outer-curvature bank of steep slope and incorporated them into the flow-flood. The evidences of 8/11 event could be observed in the field visit where Nam Ko Yai stream had a steep V-shape cross-section downstream. The traces of the erosional feature in the outer curving-bank were common. Some huge logs or intertwined bamboo clumps were left in the channel or up high on the tree splices as they were not all transported by the torrent stream flows (Figure 5-12).

Figure 5-12 Photographs illustrating a) the traces of erosional feature in the out curving-bank and b) huge logs or intertwined bamboo clumps after the 8/11 flow- flood event in Nam Ko Yai stream channel at location X in Figure 5-11.

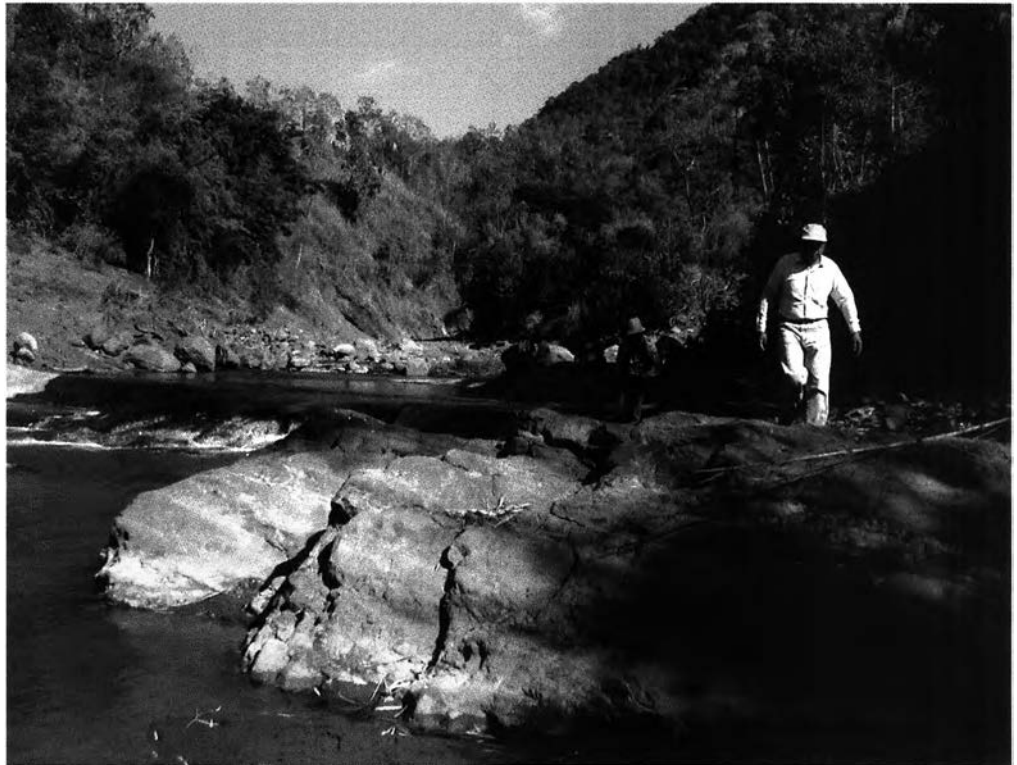
From the base rocks in the downstream from this suspected natural temporary dam location, it is interesting to note that lithology of Lom Sak Formation is mainly composed of high-resistant rocks of volcanic complex as shown in Figure 5-13. So the V-shape downstream with high sinuosity of Nam Ko Yai channel is generally controlled by these high-resistant volcanic rocks with some structural control of fracture lineaments as evidences by mainly channel straight change-directions and the topography.

Figure 5-13 Photograph showing general characteristics of the high-resistant volcanic rocks of Lom Sak Formation (Ls) in the downstream from the suspected natural temporary dam location.

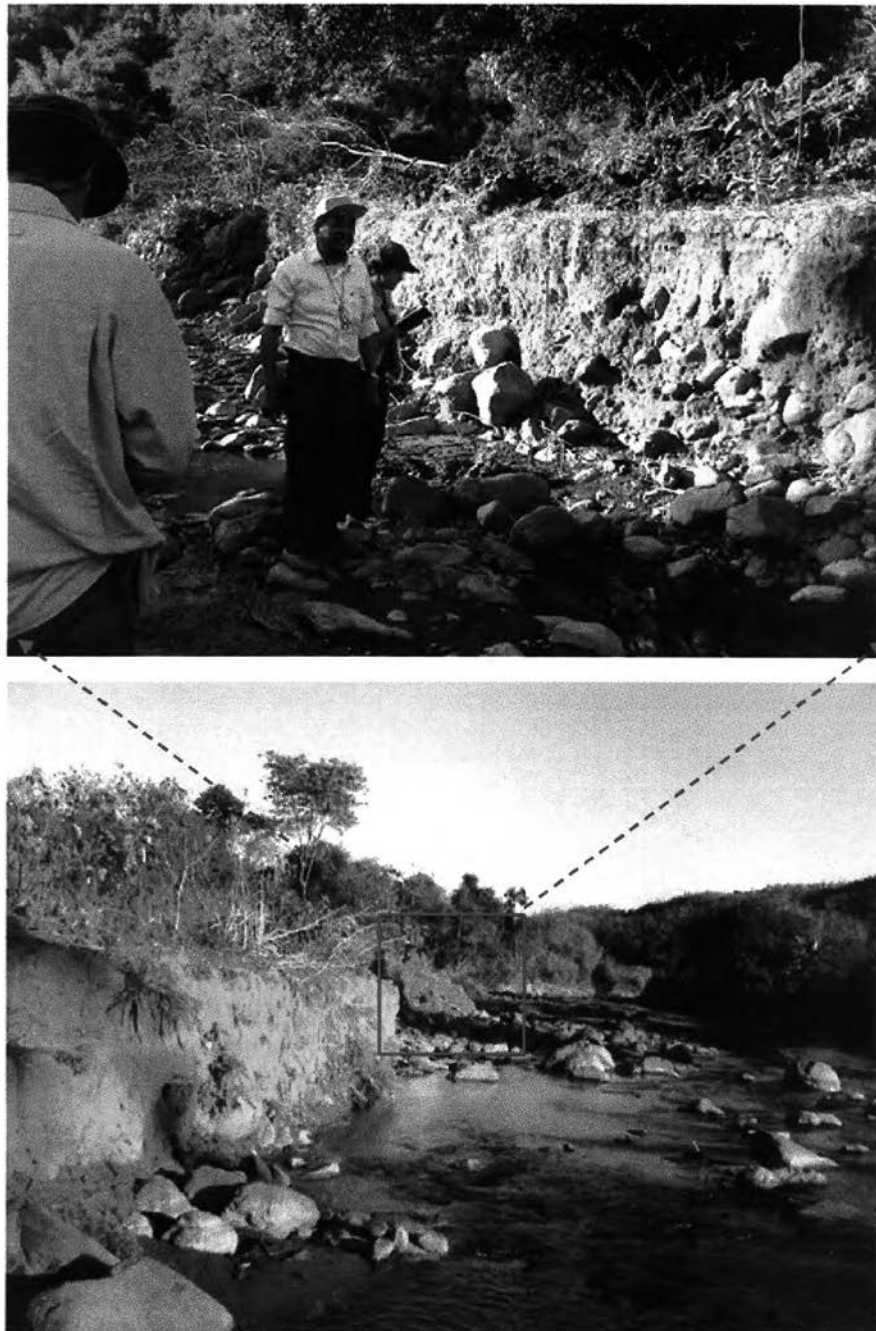
Besides, newly deposited large boulders were found in the channel lying on the green weeds, where the gradient of stream bed changes from steep to flat (Figure 5-14). Eroded soil banks were also common.

Figure 5-14 Photographs of the flat valley area with gentle slope in Nam Ko Yai stream channel at location Y in Figure 5-10 illustrating the rock boulder deposits along the bottom channel, as well as the erosional bank that prevailed the previous debris flow deposits with floating texture, unsorted, and unstratified characteristics of about 1.2 m thick.

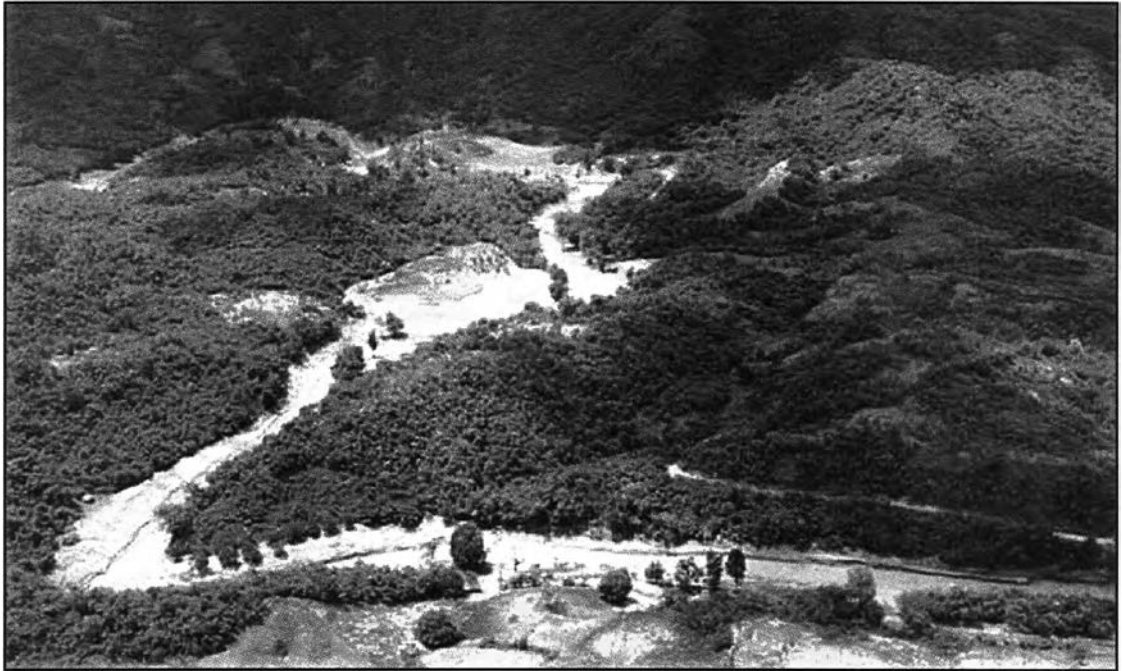
From the field evidences and oblique aerial photograph (Figure 5-15) taken after the 8/11 flow-flood event, mainly the plant debris and soils that had been strongly eroded and transported from the upstream banks of Nam Ko Yai channel with high sinuosity characteristic in flat and hilly valleys were further spread out and deposited in the area of decreased confinement to form an alluvial fan at the toe of mountain front according to their high buoyancy and low viscosity. The descriptions and evidences of previous flow-flood activities in the alluvial fan will be mentioned and discussed in the following chapter.

Figure 5-15 Oblique aerial photographs along Nam Ko Yai stream channel. The photograph, at location Z in Figure 5-11, illustrates the flow-flood track along plant debris and soils had been strongly eroded and transported from its banks before reaching the outlet of the Nam Ko Yai sub-catchment.
