EVALUATING SEABED EROSION BY SIDE-SCAN SONAR SURVEY
IN MUDDY COAST OF CHAO PHRAYA RIVER MOUTH, THAILAND

A Thesis Submitted in Partial Fulfillment of the Requirements
for the Degree of Master of Science Program in Earth Sciences

Department of Geology

Chulalongkorn University

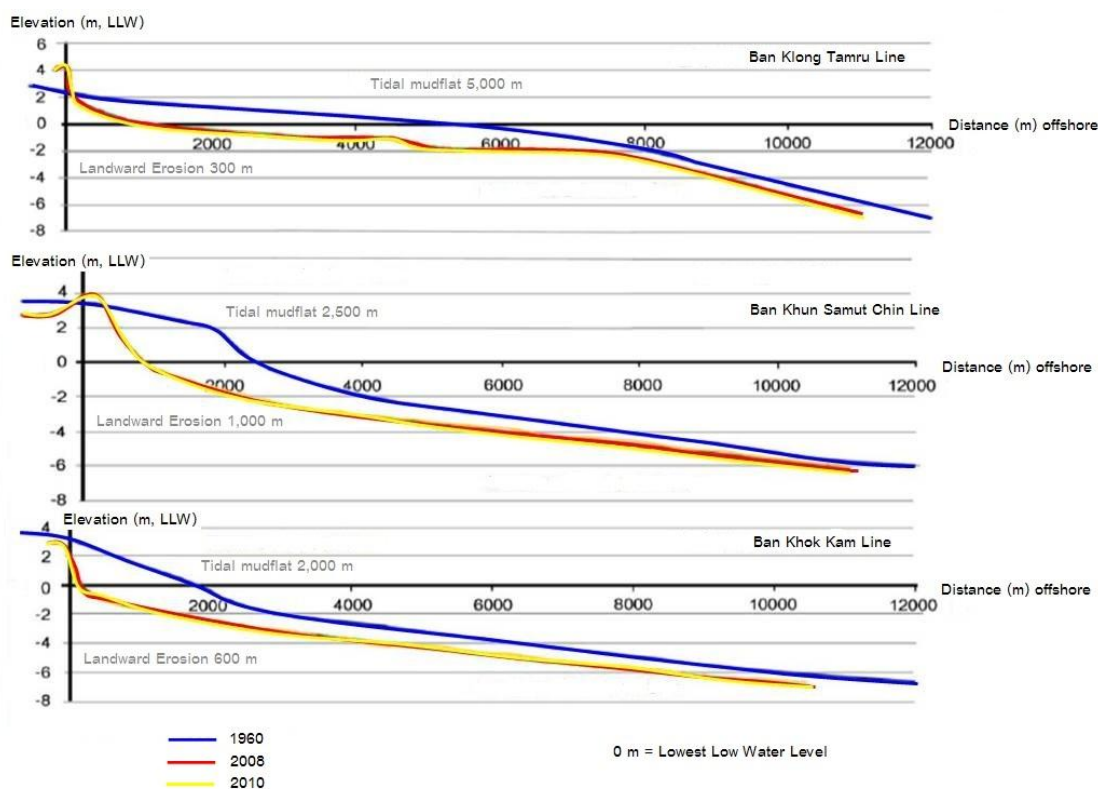
Figure 3 Bathymetric profiles of three survey lines (Jarupongsakul (2010)).

was about 5 km wide while in 2008, it was about 1 km wide. Hence, seafloor erosion causes the muddy coast at Ban Klong Tamru being shortened for about 4 km during these 48 years. At Ban Khun Samut Chin survey line, the seafloor was eroded for about 4 m and the muddy coast was shortened for about 1.5 km during these 48 years, and at Ban Khok Kam survey line, the seafloor was eroded for about 2 m and the muddy coast was shortened for about 1.75 km during the same period. The coastline when the tide was at the lowest was only about 250 m wide (Jarupongsakul (2010)).

Comparative data of the seafloor from the three survey lines between 2008 and 2010 shows only slight change over Ban Klong Tamru line, from 5 to 12 km offshore in Ban Khun Samut Chin line, and from the coast to 1 km offshore in Ban Khok Kam line. According to the survey, the seafloor was gradually shortened, since there was almost no difference between the bathymetric profiles in 2008 and 2010 while the difference between those in 1960 and 2008 was obvious. However, the change might not be normal if there had been an abnormal situation such as storm or flood. These situations might cause the unexpected change on the seafloor. From the profiles of three survey lines between 2008 and 2010, the change of the seafloor was found from the coast to 3 km offshore. Hence, it was believed that pumping the sediments from 3 km offshore or further should not affect the coastal erosion. As a result, filling the sediments in the coastal area by the sediments from 3 km offshore or further could be considered as a measure to handle the problem of coastal erosion (Jarupongsakul (2010)).

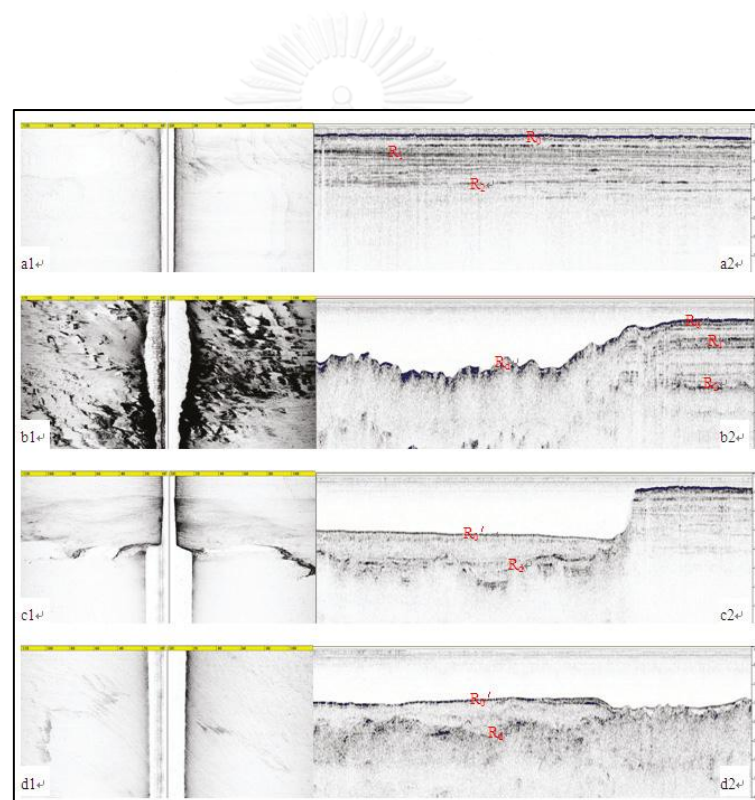
Figure 12 There are four typical seabed geomorphologies and their corresponding sub-bottom profiles in study site. (a) Remaining shoal shows smooth seabed, shallow water depth, and several sets of clear and continuous stratum reflecting interfaces. (b) Rough sand mining pit shows rough seabed, and strong surface reflecting interface, without other stratum displaying. (c) Smooth sand mining pit shows smooth seabed in the pit, and weaker but clear and continuous surface reflecting interface with a blurred underlying reflection interface. (d) Semi-deep terrain, similar to the smooth mining pit, but it has a wide open area and more curved seabed (Tang et al. (2011)).

Tang et al. (2011) analyzed the submarine geomorphic structure of the offshore sand mining area in Pearl River Estuary using SSS and investigated the bathymetry using single-beam echo sounder. Based on results, there were four types of geomorphology, shoal profile which showed several sets of clear and continuous strata reflecting interfaces, rough mining pit profile which showed a strong surface reflecting interfaces without other stratum displaying, smooth mining pit profile which showed weaker but clear and continuous surface reflecting interface with a blurred underlying reflection interface and semi-deep terrain which was similar to the smooth mining pit, but had a wide open area and a more curved seabed (See Figure 12).

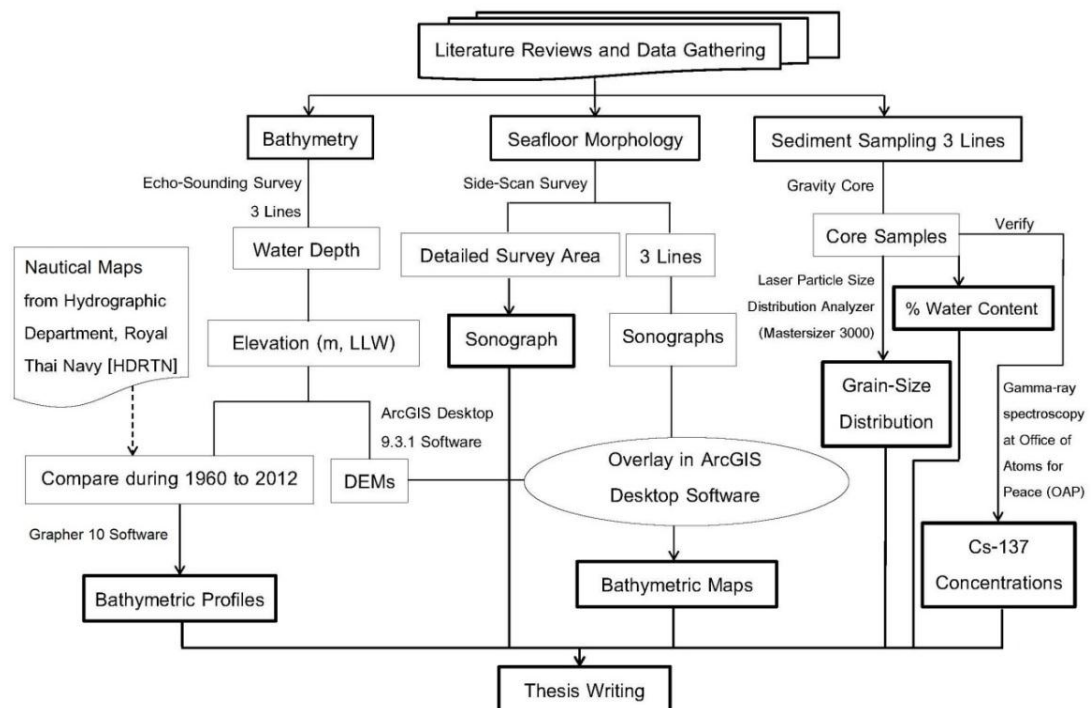
Figure 17 The chart of methodology.

The methodology is started from the literature reviews and data gathering in 3 main topics, bathymetry, seafloor morphology and sediment sampling. The bathymetry was studied by echo-sounding survey for the year 2012 and by the nautical maps from Hydrographic Department Royal Thai Navy (HDRTN) during the year 1960 – 2010, while the seafloor morphology was done by side-scan survey in the year 2012. Both echo-sounding survey and side-scan survey were done in all three lines as shown in Figure 1. In the part of detailed survey area, side-scan survey was also done to study the seafloor morphology. The elevation were taken to process into two ways. The first one is the derivation of digital elevation maps in the year 2012 to study the depth of the sea. The second one is the comparison of the bathymetric profiles during the year 1960 to 2012 to study the seafloor level change. The sonographs from side-scan survey were used to overlay with the DEMs derived from the elevation data in all three survey lines to study the relation between the seafloor morphology and bathymetry. For the part of sediment sampling, core sediments were collected at three survey lines by a gravity core and analyzed in three parts, grain-size distribution, water content, and Cs-137 concentration, to determine the relationship between the bathymetric profile and seafloor erosion in the study area. The chart of methodology is shown in Figure 17.

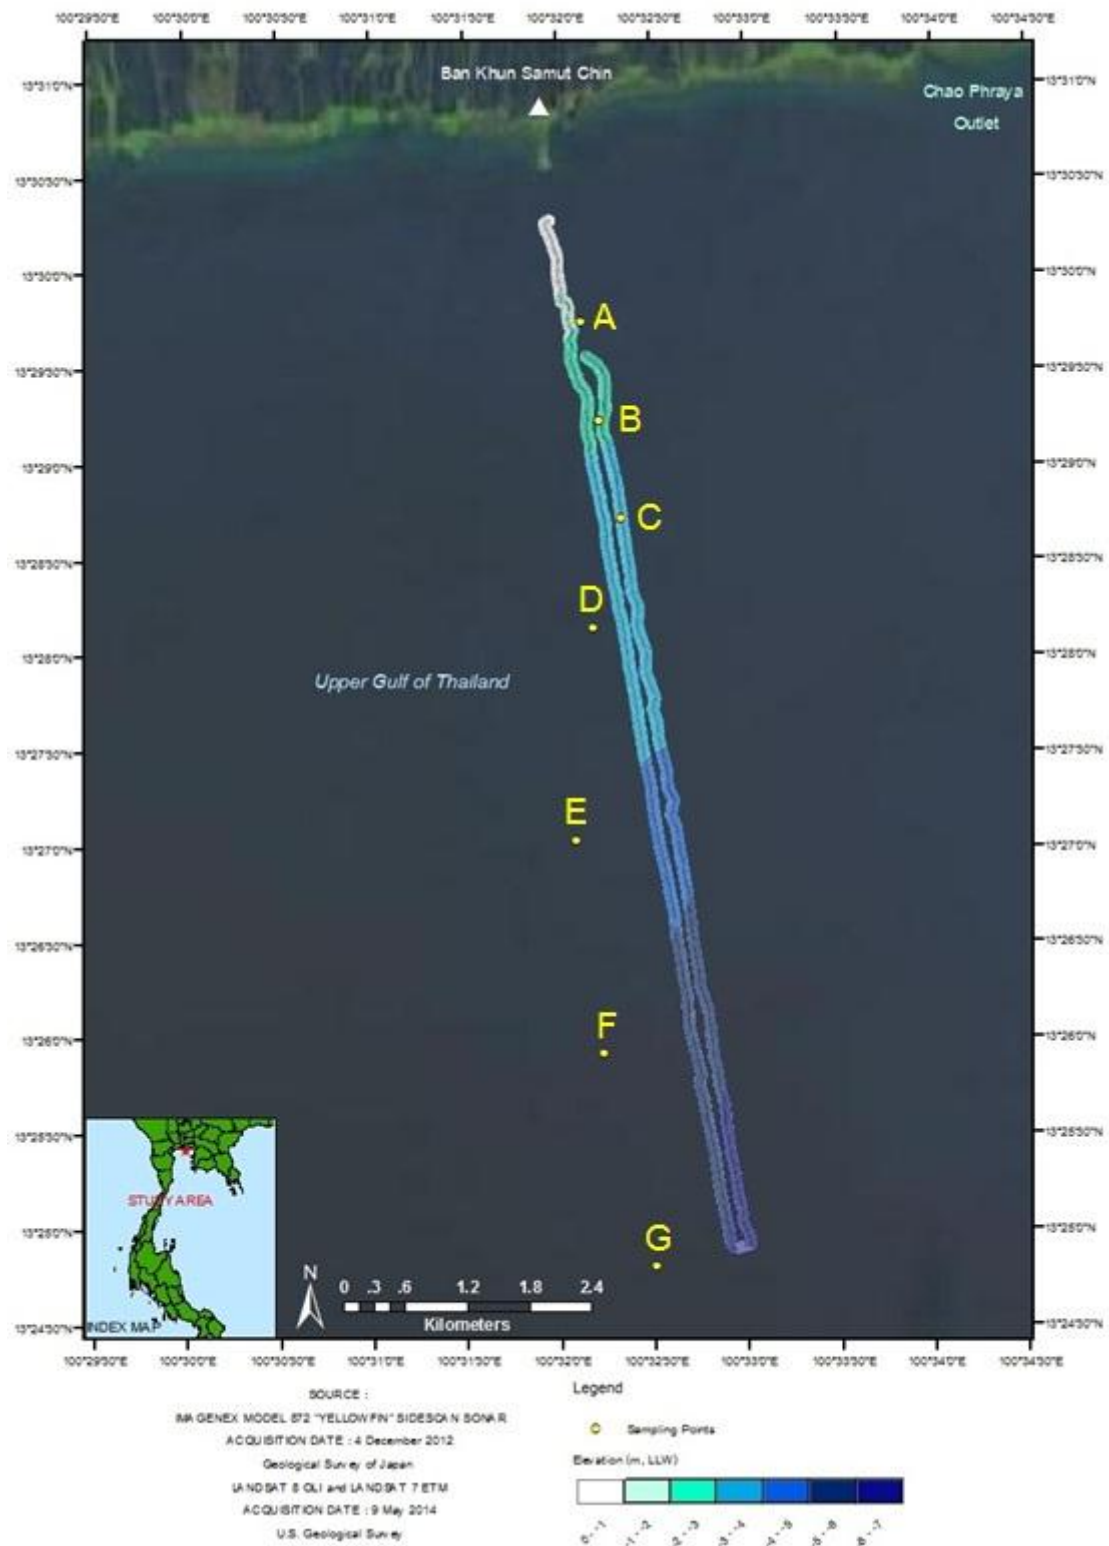
Figure 20 Sediment sampling points at Ban Khun Samut Chin survey line. Sonograph data is derived from Geological Survey of Japan (2012).

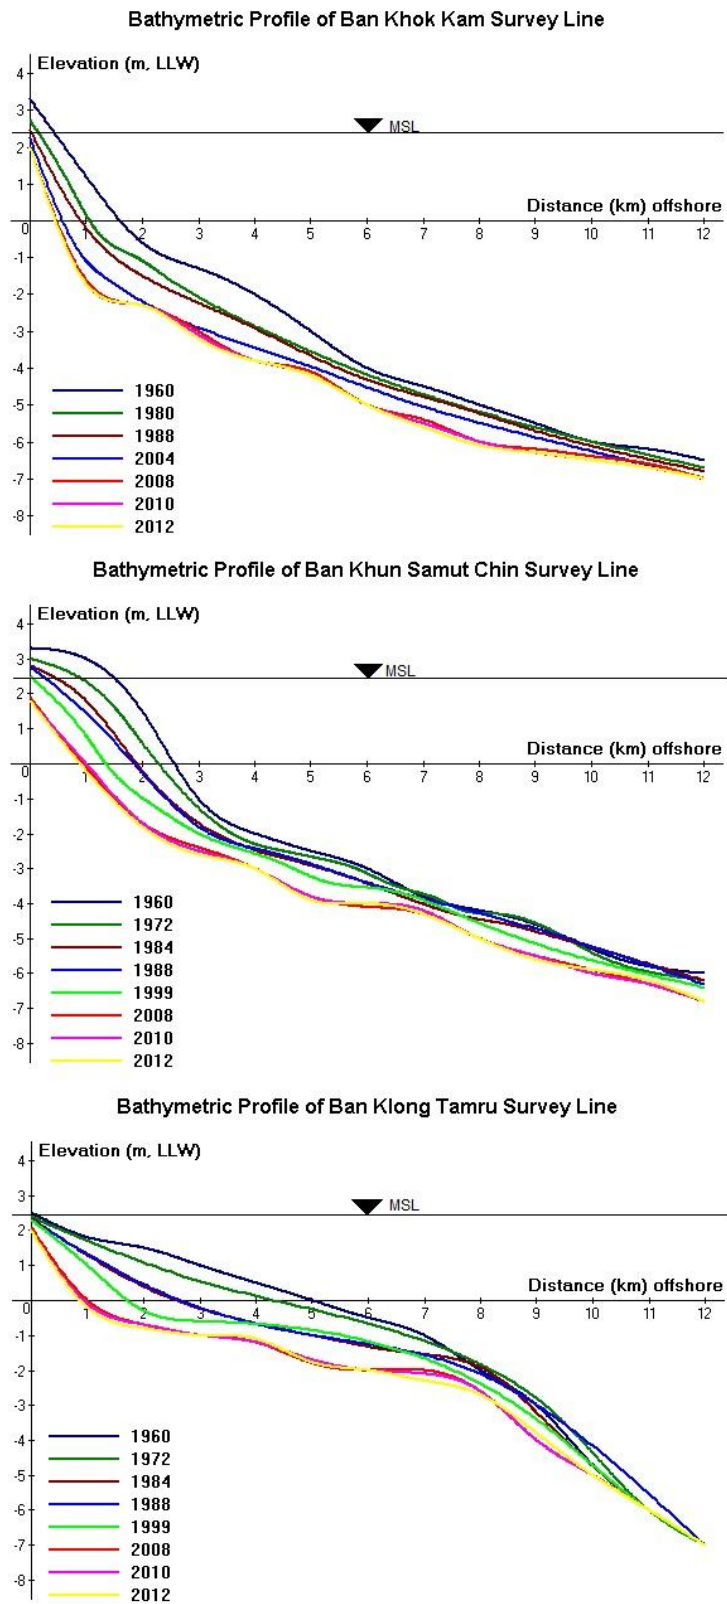
Figure 23 Bathymetric profiles from shorelines to 12 km offshore during 1960 to 2012 at three survey lines (Suthisanonth et al. (2015)).

gradually shortened since these profiles reveal the change of the coast in the long period. However, the change can hardly be seen the short period. Hence, it can be concluded that, there has been the erosion in the study area, but it is hard to observe in the short time scale.

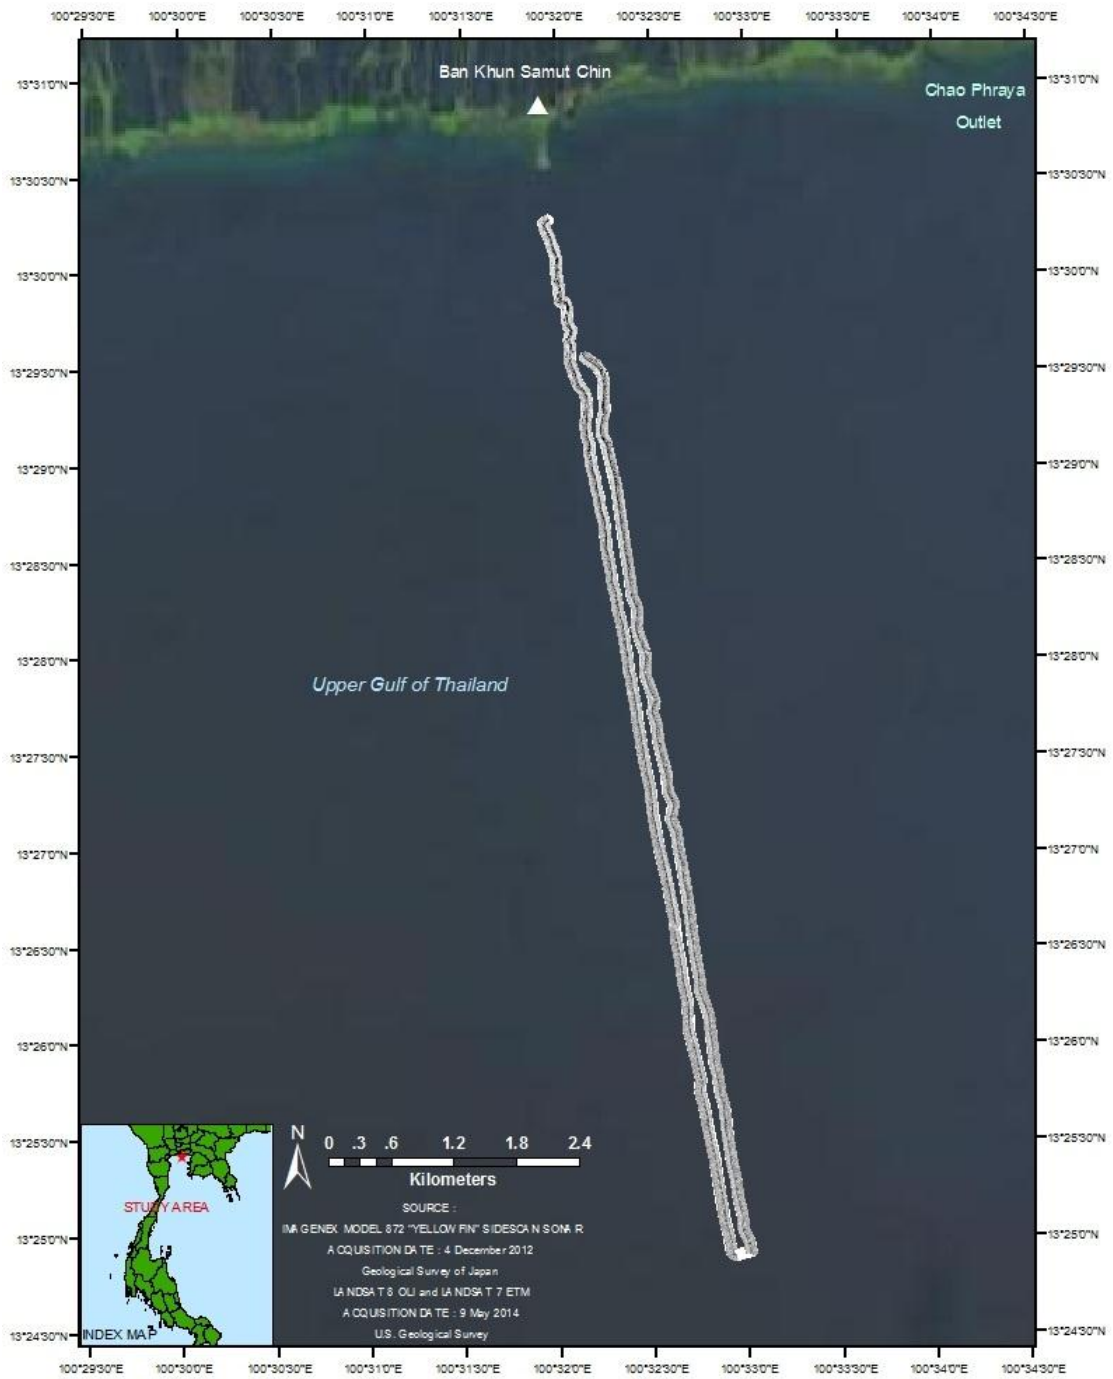
Figure 24 Sonograph of Ban Khun Samut Chin survey line. Sonograph data is derived from Geological Survey of Japan (2012).

The result of detailed survey area represented as the sonograph which shows the obvious seafloor morphology of the middle of Ban Khun Samut Chin survey line. Both sonograph and collected samples from all 3 survey lines reveal that the sediments on the seafloor are soft materials. In some part around 2 - 4 km offshore, the sonograph reveals the darker areas which are presented of the scratched features on the seafloor. These scratches are caused by mussel farming. During the survey, it is found that this area was full of the bamboo sticks in the sea which is from mussel farming. In addition, sometimes, these features can be found at the further offshore. They are caused by offshore fisheries (See Figure 27).

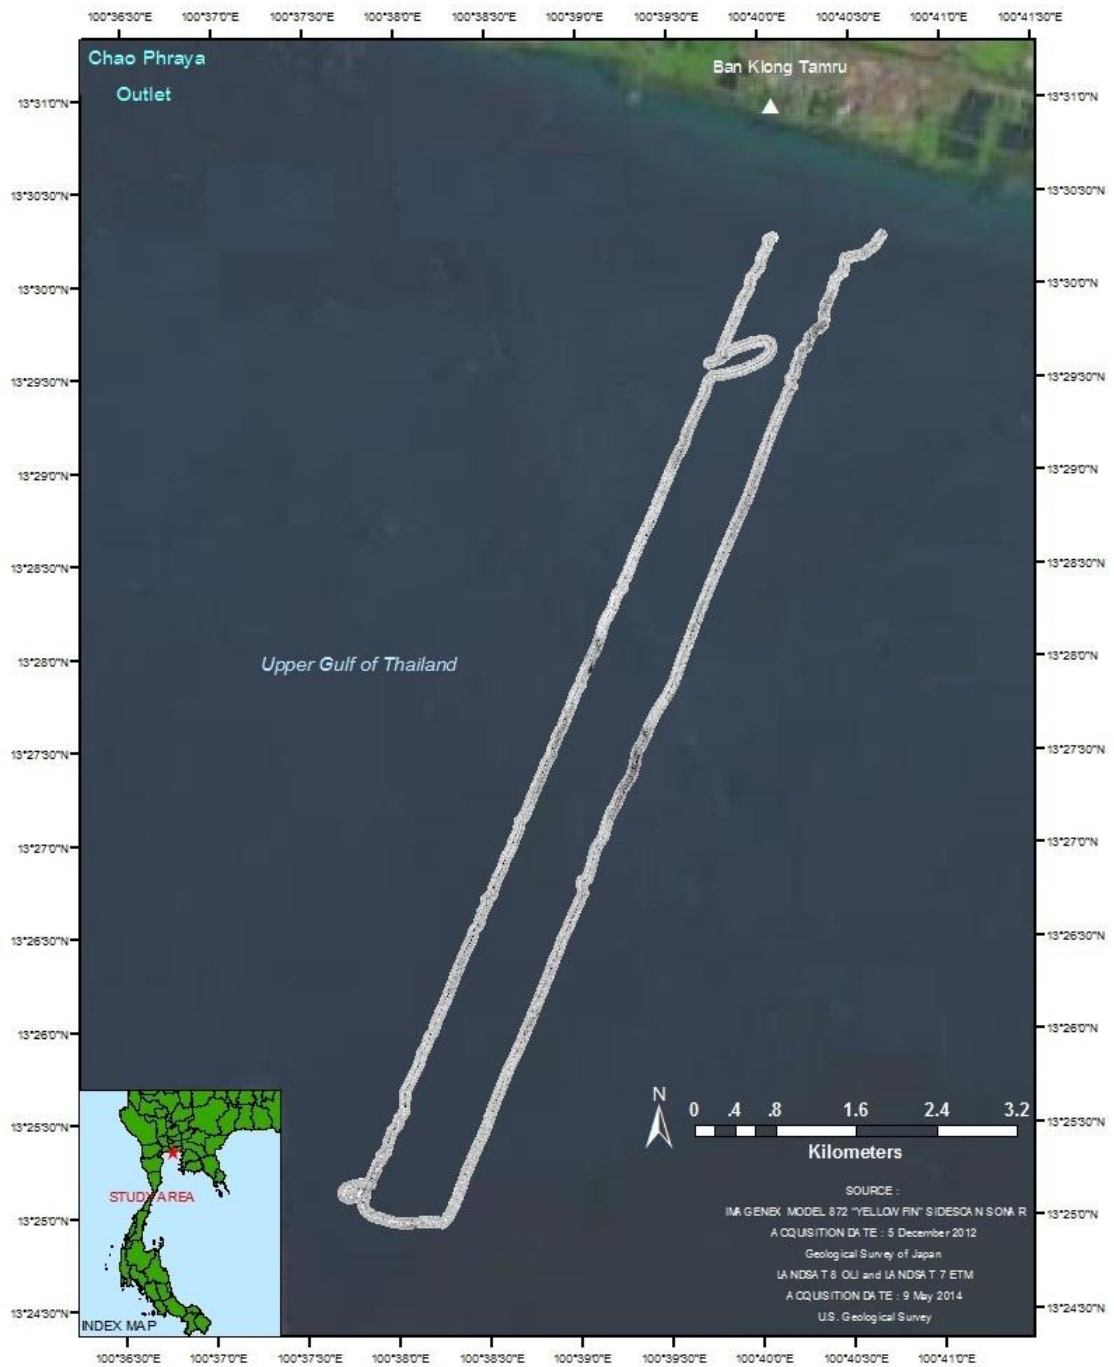
Figure 25 Sonograph of Ban Klong Tamru survey line. Sonograph data is derived from Geological Survey of Japan (2012).

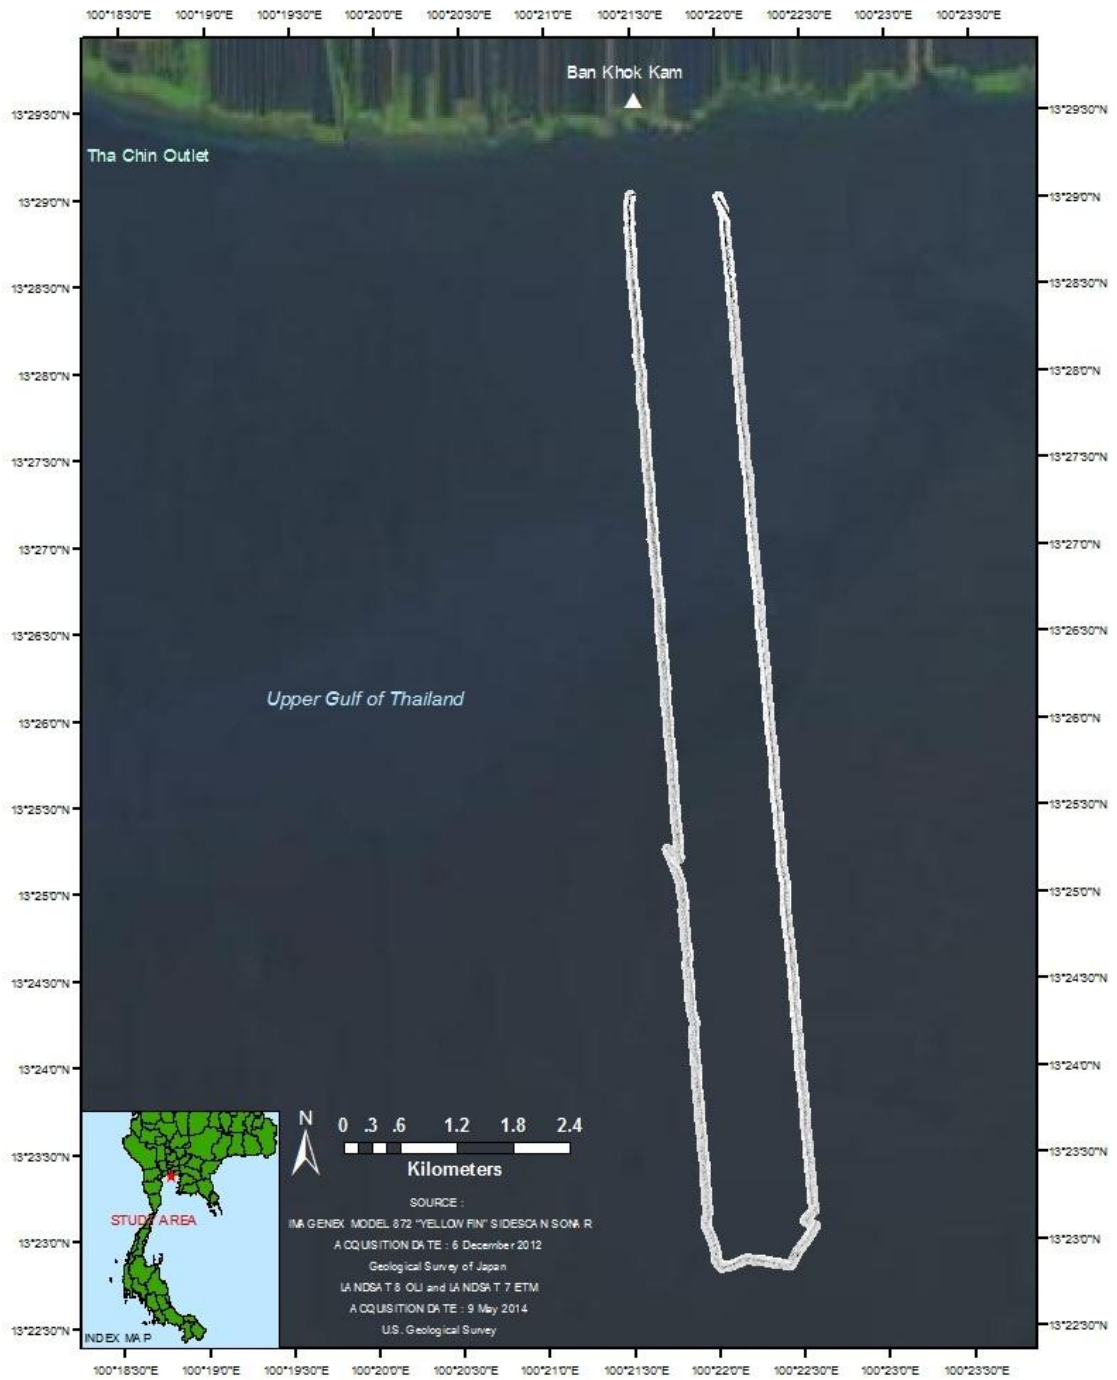
Figure 26 Sonograph of Ban Khok Kam survey line. Sonograph data is derived from Geological Survey of Japan (2012).

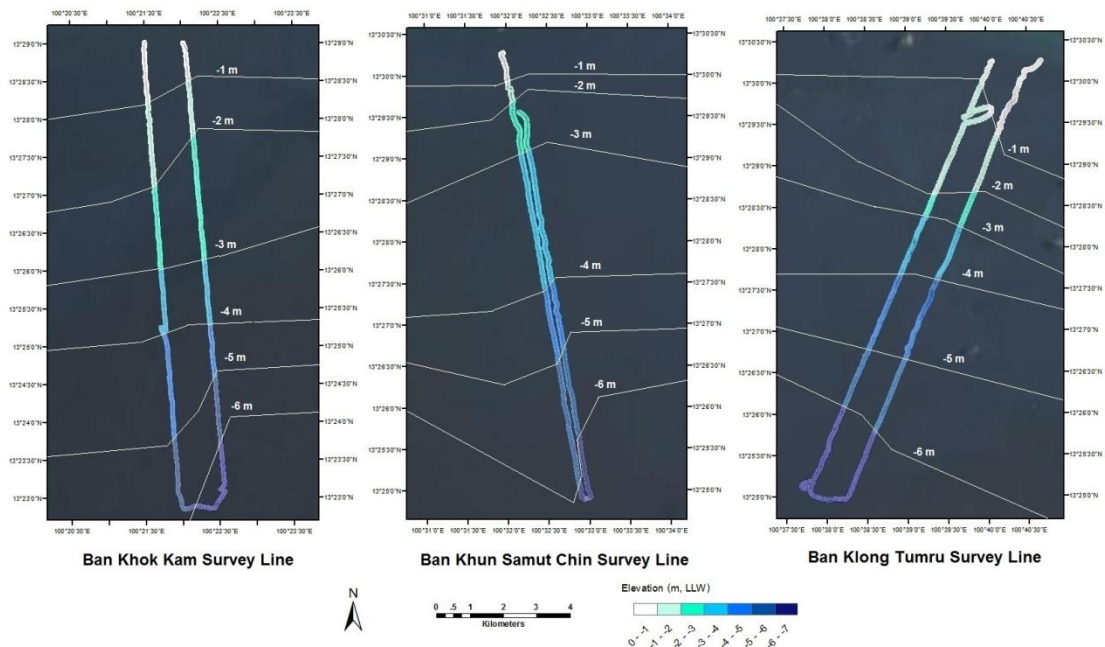
Figure 28 Bathymetric maps of three survey lines (Suthisanonth et al. (2015)). Sonographs data are derived from Geological Survey of Japan (2012).

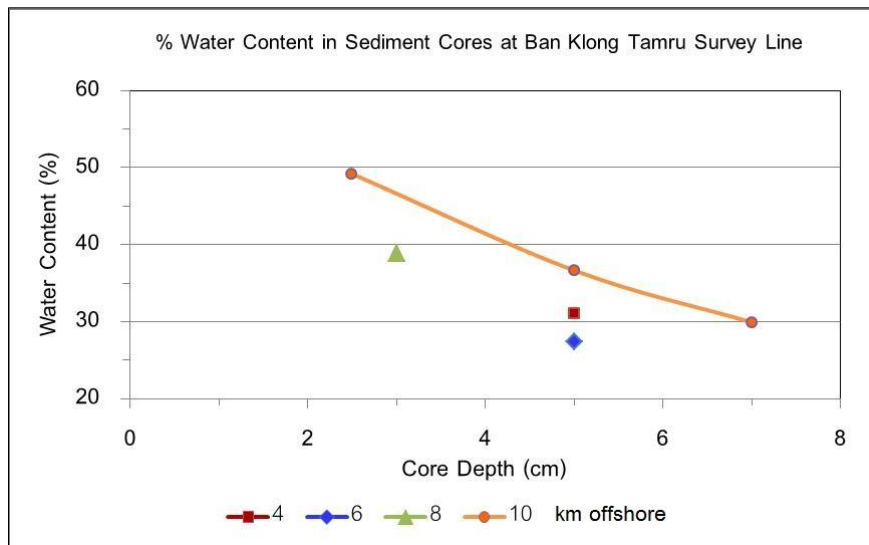
Figure 30 Water content in sediment cores at Ban Klong Tamru survey line.

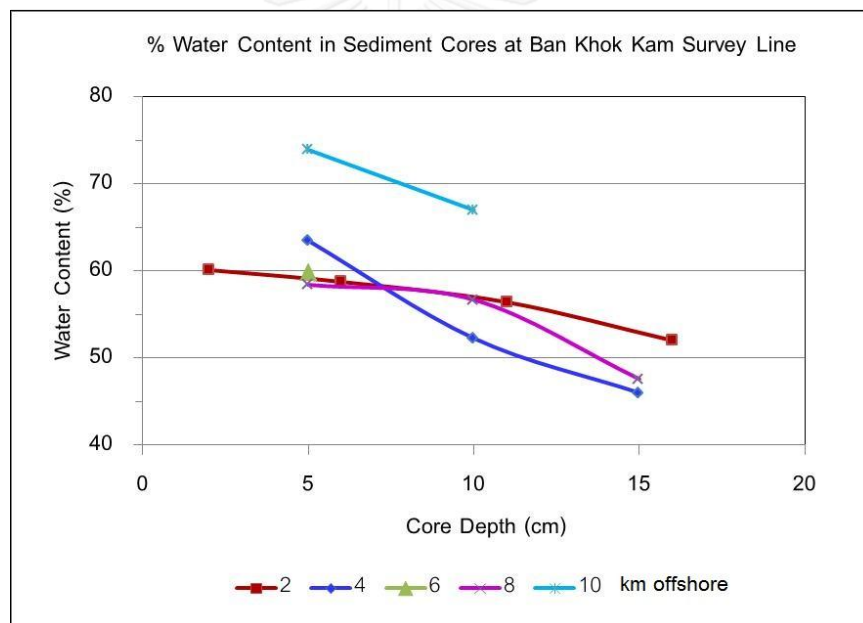
Figure 31 Water content in sediment cores at Ban Khok Kam survey line.

At Ban Khok Kam survey line (see Figure 31), the result shows that the water content is lower in the deep strata layers of the sediment but higher in the farther offshore area as well. At the distance of 2 - 8 km offshore, all samples have low percent of water content. The result suggests that the sediments in these areas are stiff muds (Saito et al. (2013)). However, at 10 km offshore, the water content is high and it is suggested that the sediments in these areas are soft muds (Saito et al. (2013)).

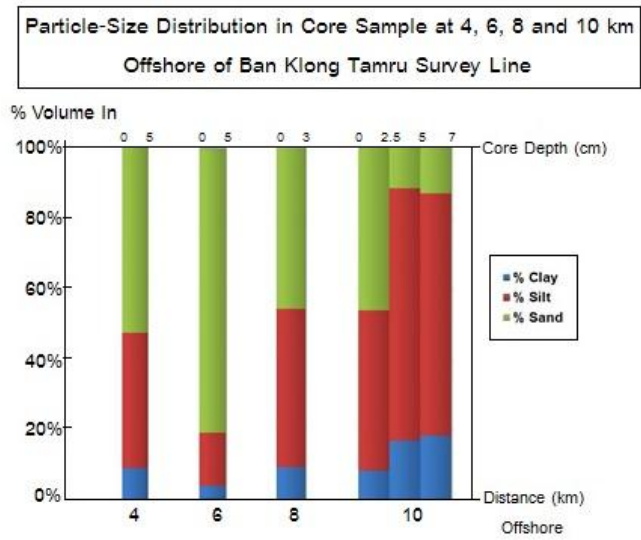
Figure 33 Particle-size distributions in core samples at 4, 6, 8, and 10 km offshore of Ban Klong Tamru survey line.

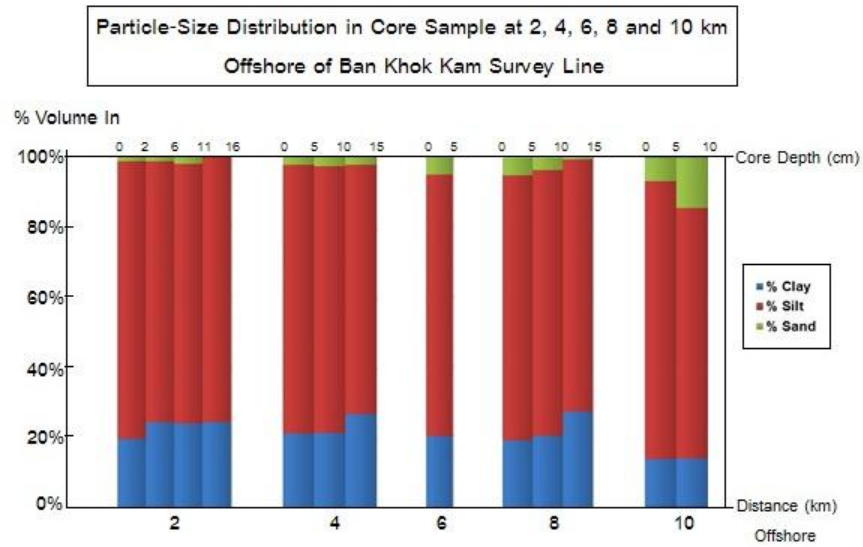
Figure 34 Particle-size distributions in core samples at 2, 4, 6, 8, and 10 km offshore of Ban Khok Kam survey line.

At Ban Khok Kam survey line, most of the samples are silt loam, except at 10 - 15 cm depth of 4 km offshore and 10 - 15 cm depth of 8 km offshore where sediments are silty clay loam (see Appendix D). The particle-size distribution in core samples at Ban Khok Kam survey line is shown in Figure 34. The results show that most of the sediments are silt loam in all layers. At the deeper layer, 10 - 15 cm depth, sediments are finer and can be classified as silty clay loam.

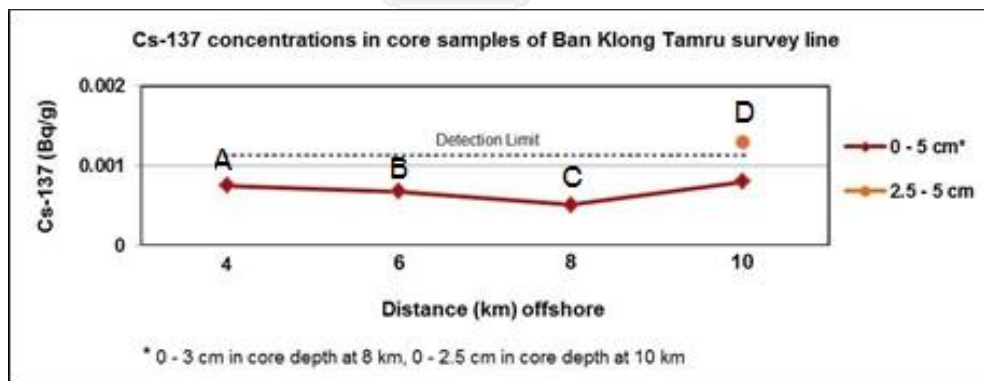
Figure 36 Cs-137 concentrations in core samples of Ban Klong Tamru survey line.

At Ban Klong Tamru survey line, the collected samples are too few clearly to determine the points of erosion and deposition. The Cs-137 concentration is lower than the detection limit in most samples. The exception is the lower layer of the core sample at 10 km offshore. In that layer, the Cs-137 concentration is slightly higher than the detection limit. However, it is not clear enough to indicate the point of erosion in these areas because the collected sediments in this survey line are mainly consisted of sand which causes the difficulty for observing Cs-137 in the sediments (Exeter (2013)). The result of Cs-137 concentrations at Ban Klong Tamru survey line is shown in Figure 36.

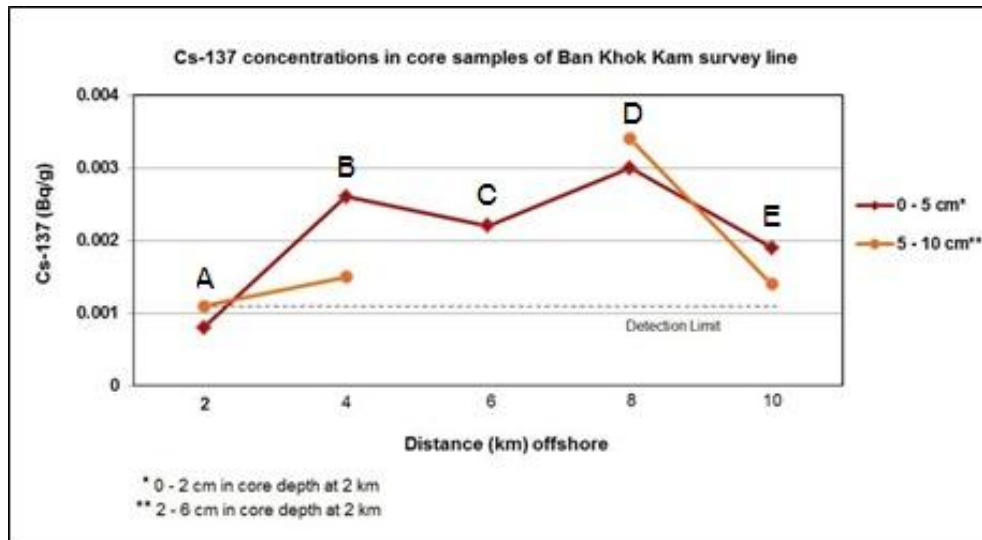
Figure 37 Cs-137 concentrations in core samples of Ban Khok Kam survey line.

values of Cs-137 concentration than the detection limit. The exception is at 2 km offshore where the value is low. Therefore, it is suspected that the areas from 3 km offshore are redeposited while the areas at around 0 - 2 km offshore are eroded. The result of Cs-137 concentrations at Ban Khok Kam survey line is shown in Figure 37.

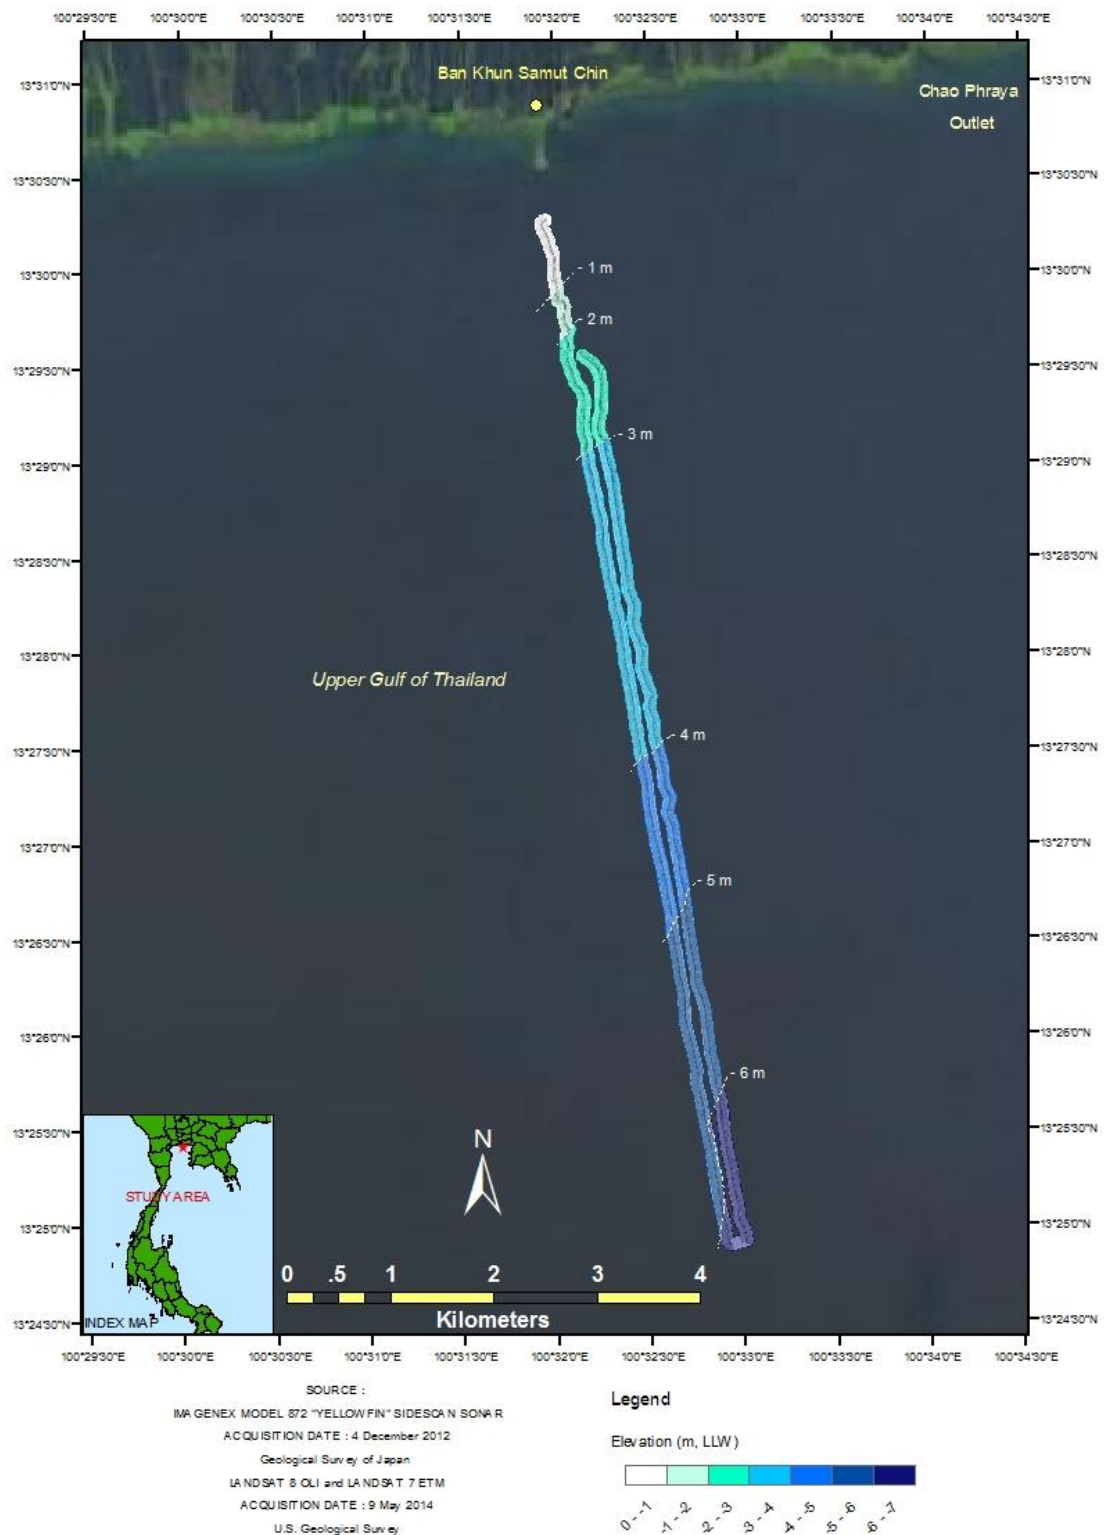
Figure 38 Bathymetric map of Ban Khun Samut Chin line (Suthisanonth et al. (2015)). Sonograph data is derived from Geological Survey of Japan (2012).
