CRACK DETECTION ON ASPHALTIC CONCRETE ROAD SURFACE IMAGES  
USING MODIFIED GRID CELL ANALYSIS

A Thesis Submitted in Partial Fulfillment of the Requirements  
for the Degree of Master of Engineering Program in Computer Engineering  
Department of Computer Engineering

Faculty of Engineering  
Chulalongkorn University  
Academic Year 2007

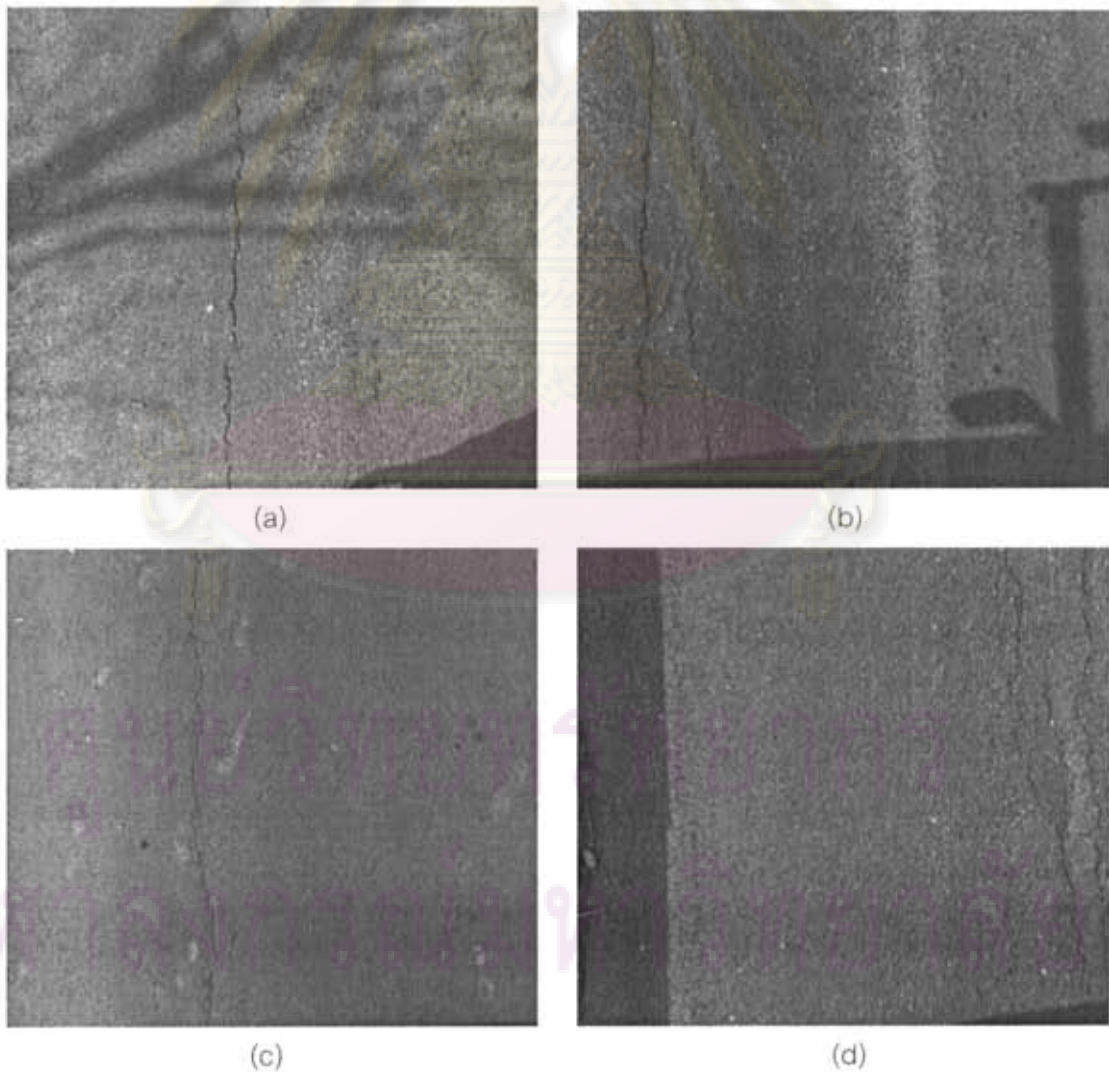
There are two major difficulties in crack detection process. The first difficulty is due to the surveying with an area scan camera in an open environment where light condition is a considerable problem. There is a lot of unavoidable shadow and shading

Figure 1.1 Example Images with Illumination and Texture Problems

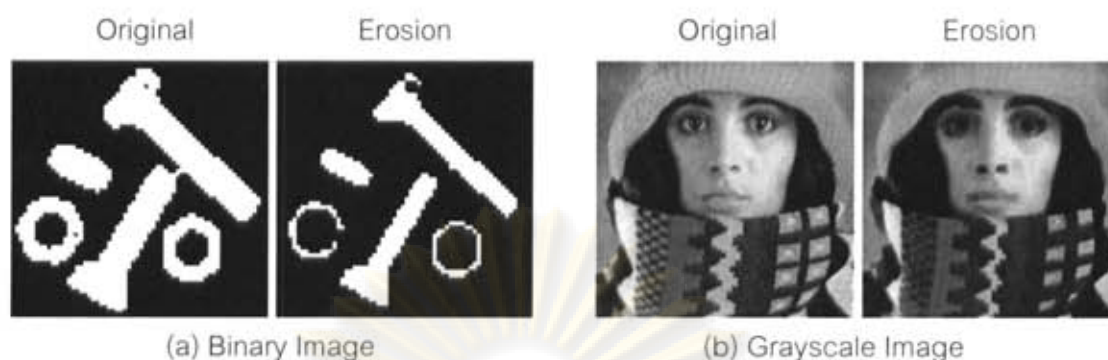
Figure 2.2 Examples of Erosion Operation [10]

Where  $D_f$  and  $D_b$  are the domain of  $f$  and  $b$ , respectively. Erosion generally decreases the sizes of objects and removes small objects by subtracting objects with a radius smaller than the structuring element. With grayscale images, erosion reduces the brightness and size of bright objects on a dark background by taking the neighborhood minimum when passing the structuring element over the image. The examples of erosion with 3x3 rectangle shape structuring element were shown in Figure 2.2.

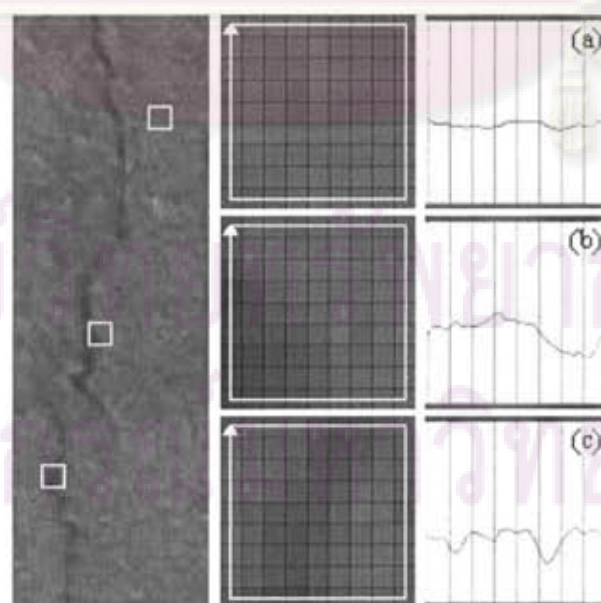
A crack cell is identified by comparing its features from crack information to preset thresholds. Crack information includes the length, the width, and the contrast of a dark object. It also includes mean brightness, minimum brightness, and the presence of a dark strip within the cell, which is the valley in the border brightness profile. When a cell does not contain a crack, its border profile shows no apparent valley as shown in Figure 2.4(a). In Figure 2.4(c), the border profile shows two sharp valleys, indicating the crossing points of a crack on the border. Figure 2.4(b) shows only one significant valley in the border grayscale, the cell may have edge crack. The result of grid cell analysis is a seed point which is the darkest spot in the cell.

Figure 2.4 Grid Cell Attribute in Pavement Image

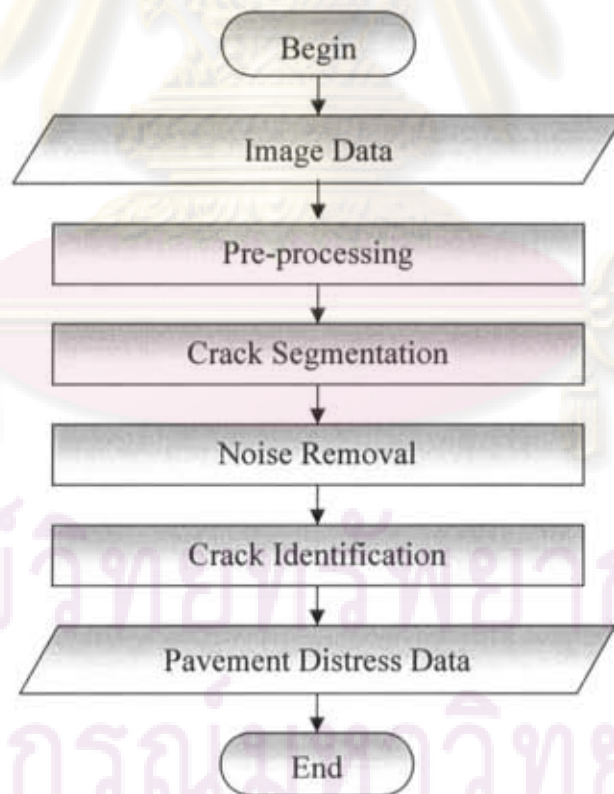
In this chapter, the process of crack detection is described. The approach can be viewed as four phases. The first phase is the pre-processing phase which is for improving original images. The second phase is the crack segmentation which extracts crack objects from the original images. The next phase is the noise removal phase which is used for increasing the accuracy of the crack identification algorithm. The last phase is the crack identification phase which is used for classifying crack type. After this phase, the output distress data can then be used in highway management system. The flow chart of this approach is shown in Figure 3.1.

Figure 3.1 Proposed Approach Flow Chart

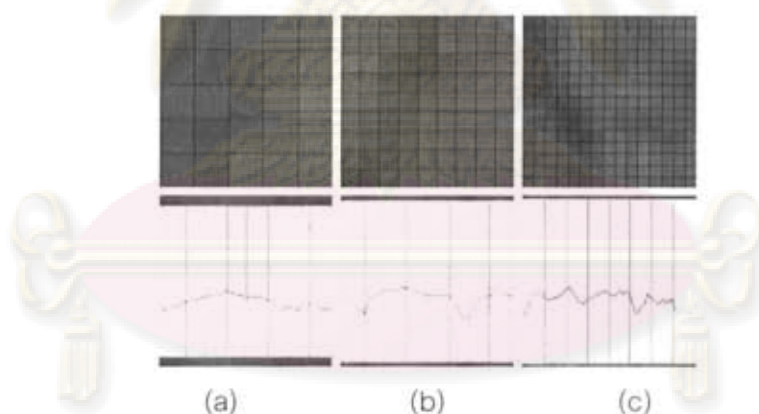
The grid cell size is also related to the crack width or the width of the dark strip. The proper grid cell size should give distinct crack in an image. For the dataset on hand, the grid cell size should be approximately three times the crack width which is nine pixels in width and height. In this research, a grid cell size of 9x9 was used.

Figure 3.2 Difference Grid Cell Size with its Border Brightness Profile

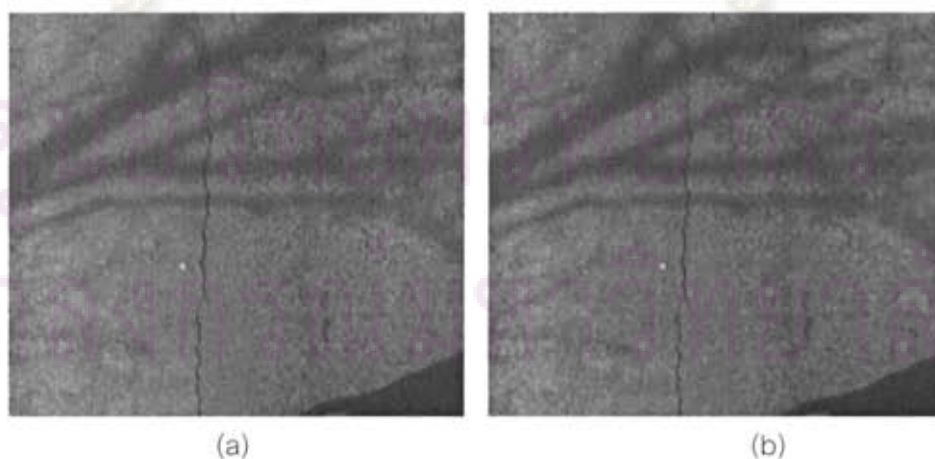
The second step of the pre-processing phase is closing technique. Although the opening technique gives an obvious crack line, black noise spots are also darker. Closing technique is used to remove the small dark spots which are smaller than structure element.

Figure 3.4 Pre-processing Phase

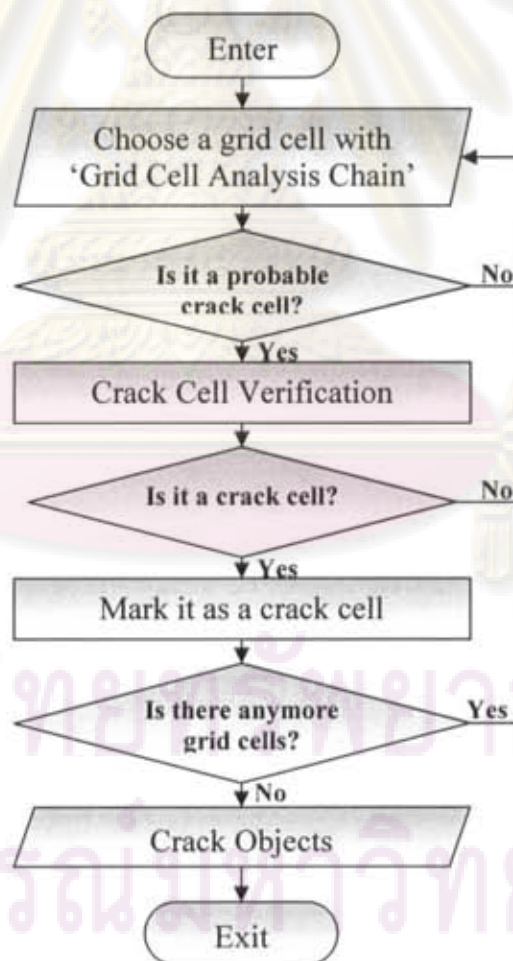
Figure 3.5 Crack Segmentation Flow Chart

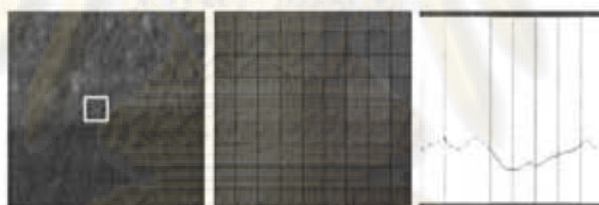
From the GCA, a pavement image is divided into grid cells which are classified as crack or non-crack cells. In contrast to GCA method which needs preset thresholds, this approach uses the border brightness profile with hill climbing technique to find the valleys in order to cope with the non-uniform illumination problem.

Figure 3.6 Grid Cell Attribute above Edge of Shadow Area

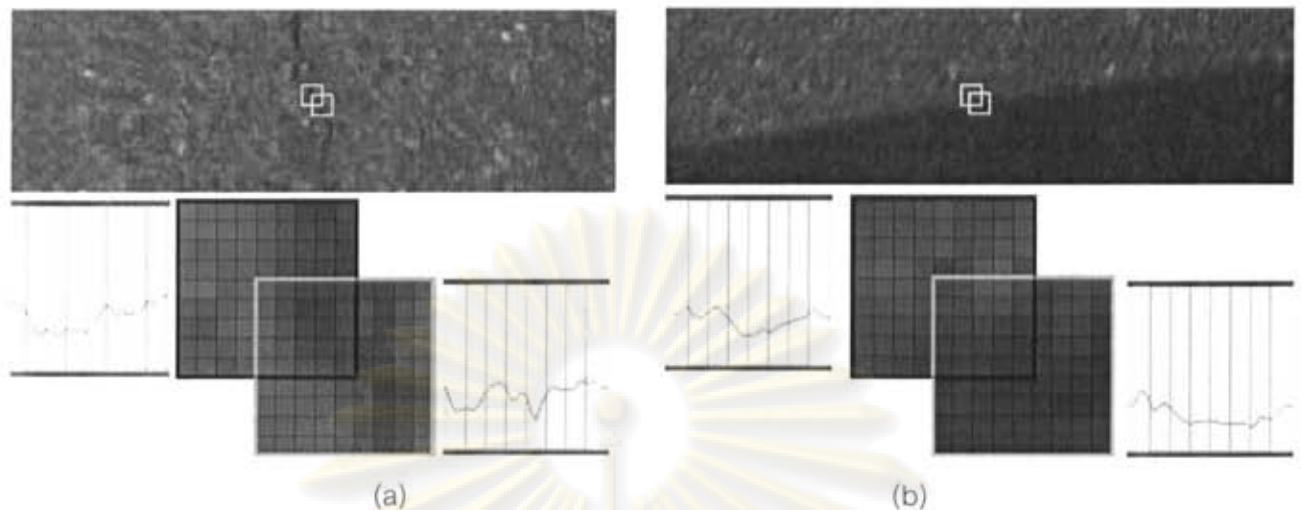
However, the above method would eliminate the cells that have edge crack. As a result, double checking on images is necessarily applied. After divided into grid cells, the original image is divided again in overlapping area as given in Figure 3.7. This method can extract the crack area and keep away from the edge of shadow.

Figure 3.7 Grid Cell Attributes with Overlapping Area

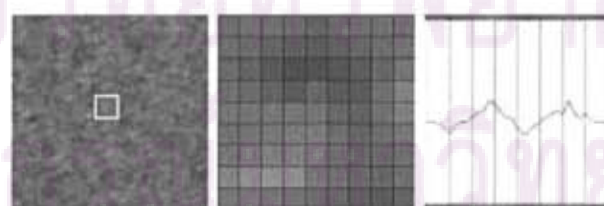
Strong texture is another problem that reduces the accuracy of crack detection algorithm. Figure 3.8 shows a non-crack cell which has a profile similar to a crack profile.

Figure 3.8 Grid Cell Attribute with Strong Texture

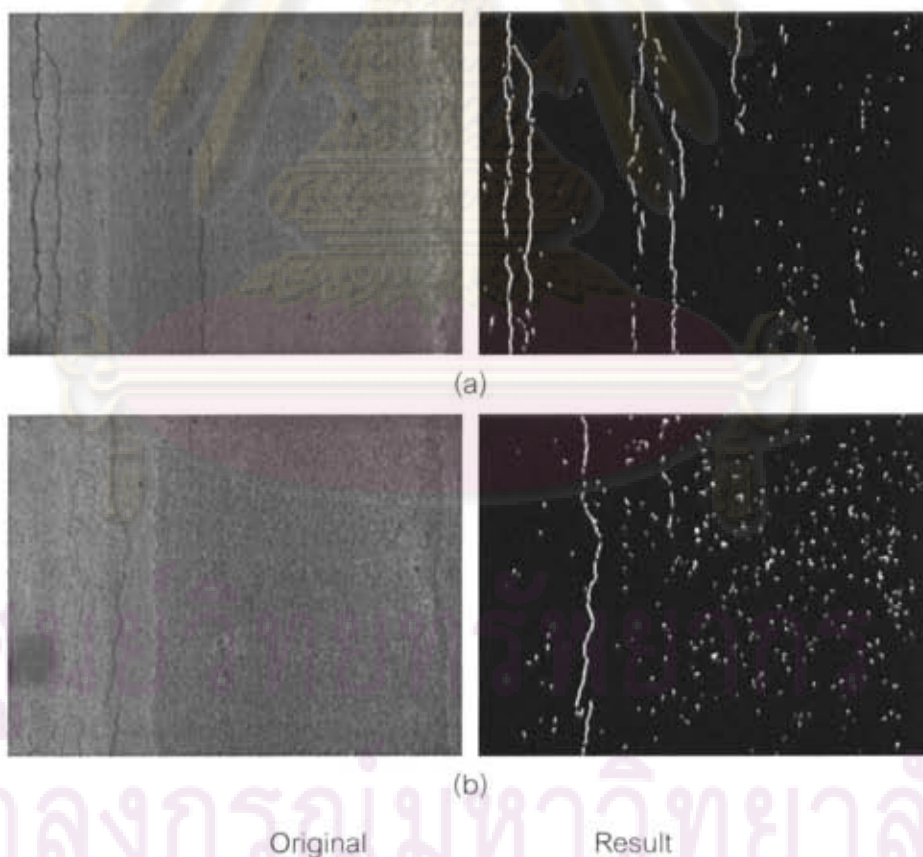
Figure 3.10 shows the resulting images from the segmentation phase with noise objects. The noise came from dark spots on the original image as shown in Figure 3.10(a). Other types of pavement distress may also give noise. For example, Figure 3.10(b) shows an original image with patching which gives the resulting image too much noise.

Figure 3.10 Examples of Noise in Resulting Images of Segmentation Phase

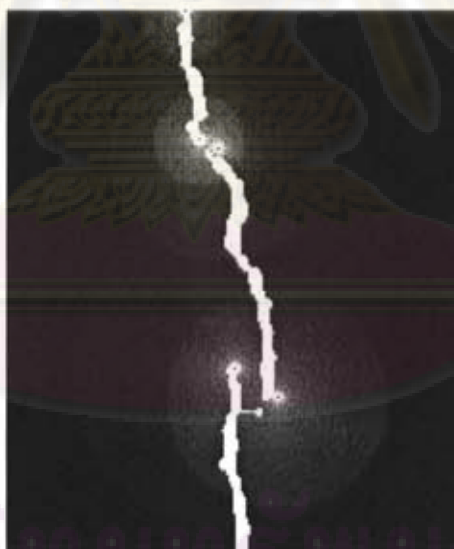
Since the gravitational force is directly proportional to the pixel area of both interacting objects, more large objects will attract each other with a greater gravitational force. In contrast to the area, the force is inversely proportional to the shortest distance between the tips of the two objects. Farther distance will result in weaker gravitational forces.

Figure 3.12 Crack Gravitation

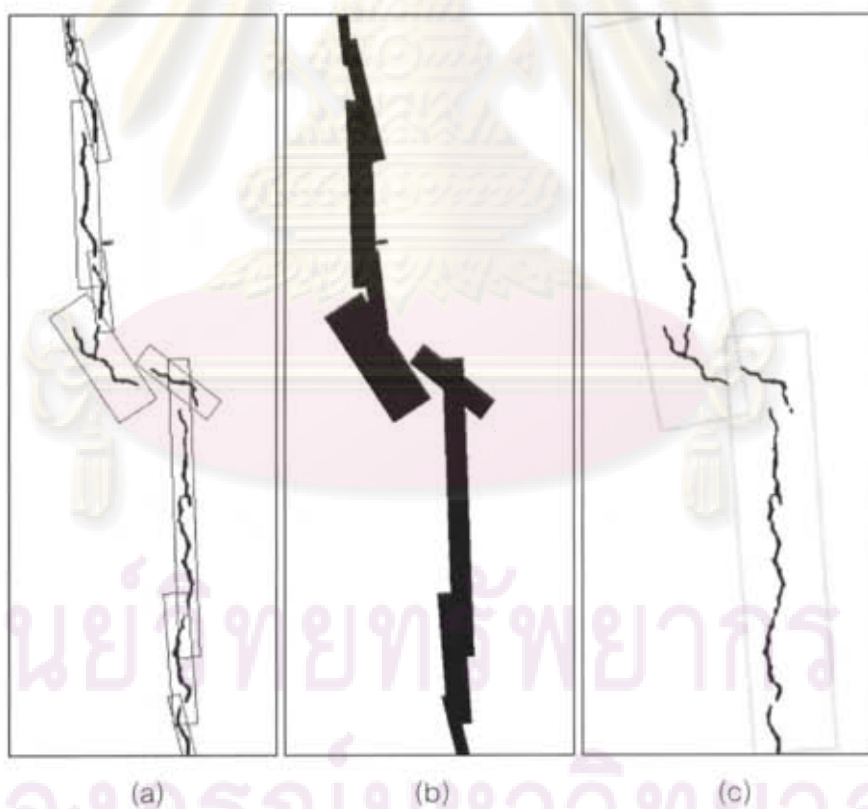
After expanding the heights, each rectangle is filled, as shown in Figure 3.16(b), and convex hulls technique is then applied to fine the rectangle with minimum circumference rectangle again. Figure 3.16(c) shows the result of merging method. The result object gives enough crack distress information to identify crack.

Figure 3.16 Merging Method

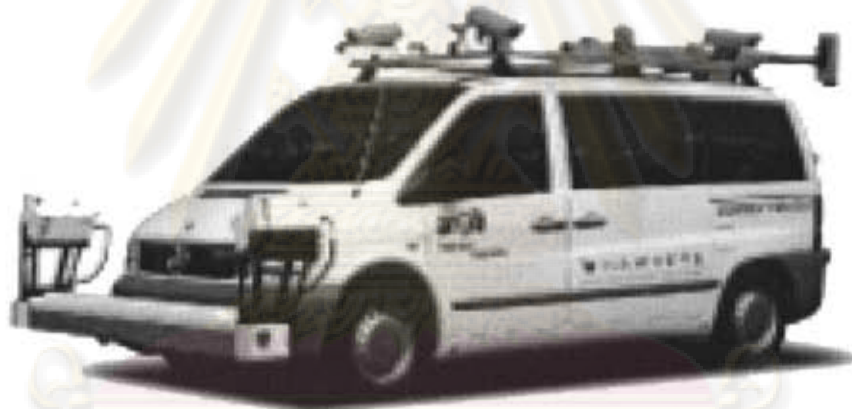
Figure 4.1 Survey Vehicle [14]

The images used in this research were from road survey database [14]. The survey of road pavement distress was done in the north part of Thailand by Department of Highway, Ministry of Transport, and CERT, Chulalongkorn University. The system used in the survey was installed in a van, as shown in Figure 4.1. The survey vehicle contained computers and survey equipment, such as laser profilometer, a GPS receiver, a gyroscope, asset view cameras and pavement view cameras.

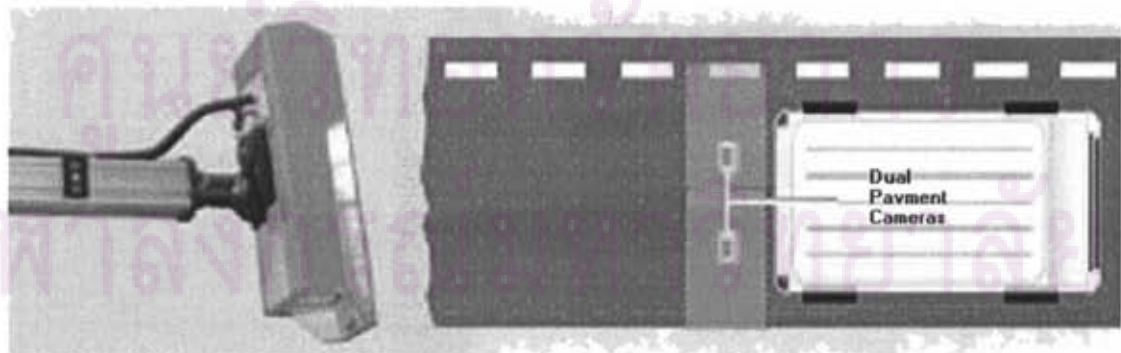
Figure 4.2 Pavement View Cameras [14]

However, there were some areas in the image, as shown in Figure 4.2, that were not completely separated. In order to eliminate the overlapped area, instead of blending, the input images from both cameras needed to be cropped.

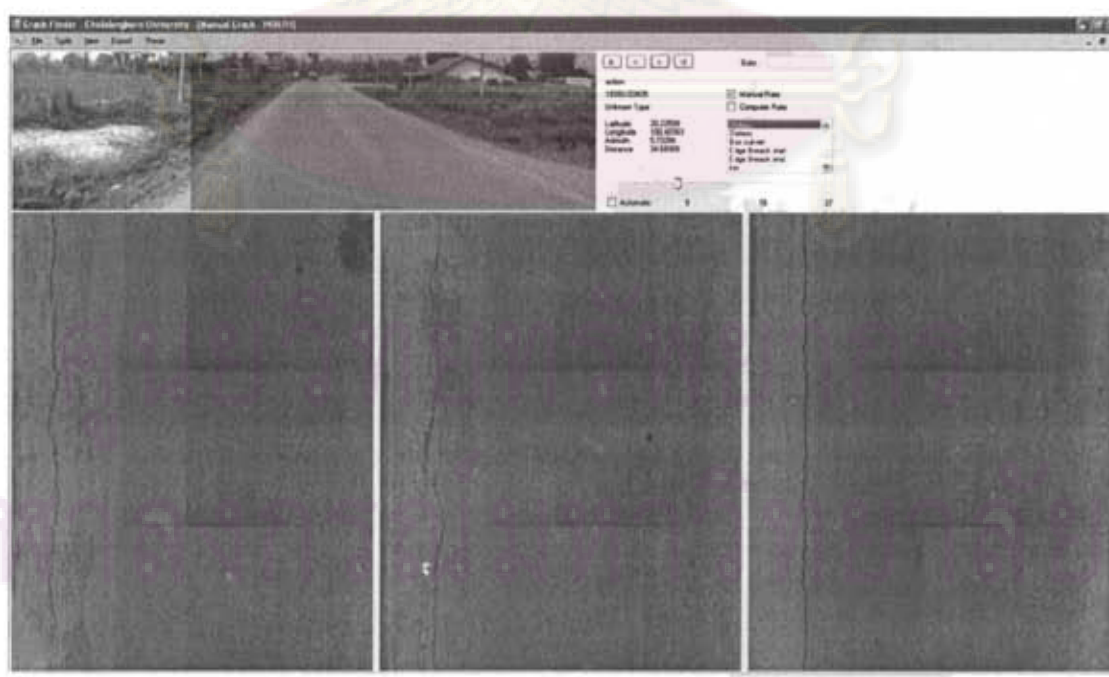
Figure 4.4 Manual Distress Rating Part of CU Crack Finder Program

In manual distress rating, pavement images were carefully monitored by professional inspectors. Because this part was designed according to inspectors' requirements, the user interface of this part was easy to use, so crack bounded area was approximately estimated. The user interface consisted of asset view images from three cameras (installed on the front roof top of the survey vehicle), GPS information and pavement view images (which were assembled as a continued road image). The interface is shown in Figure 4.4.

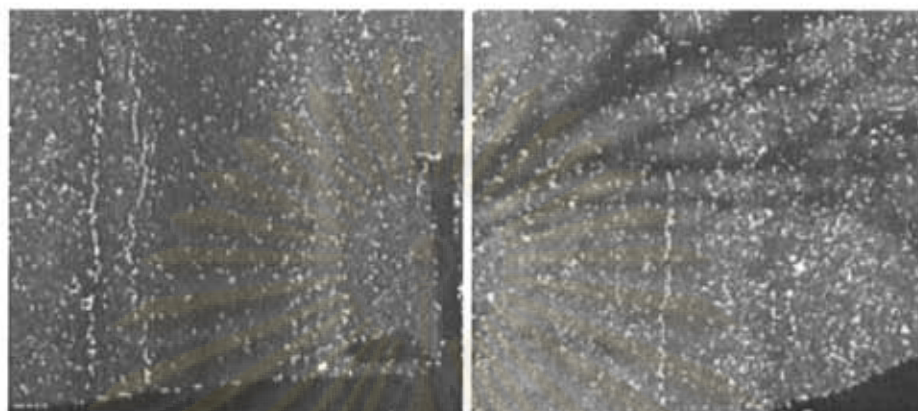
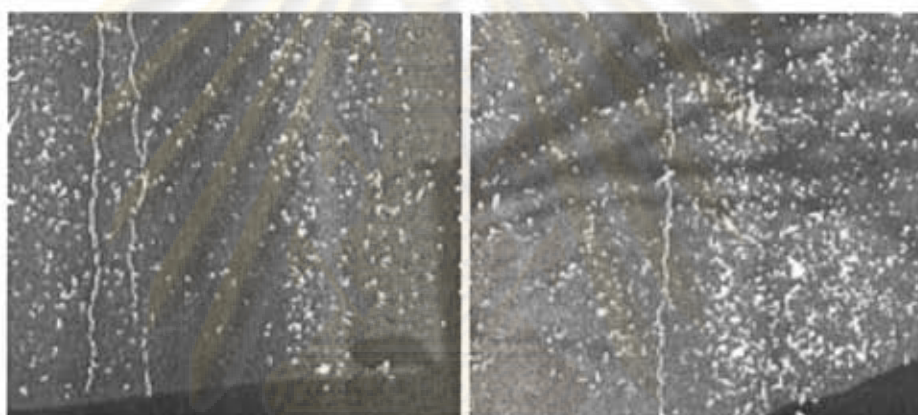
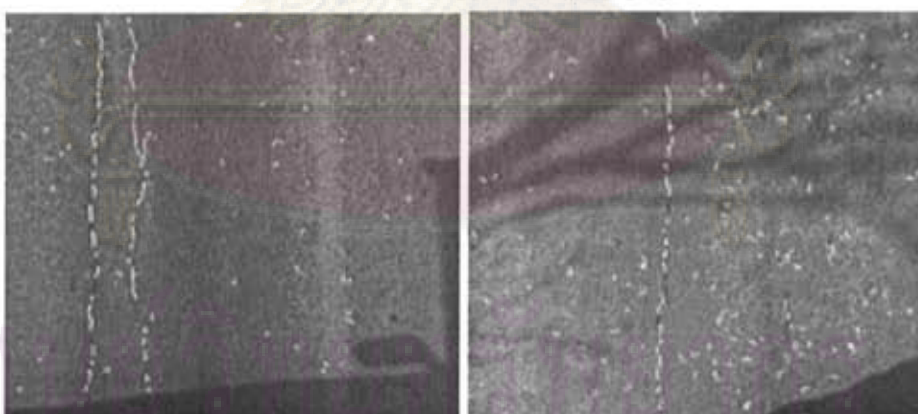
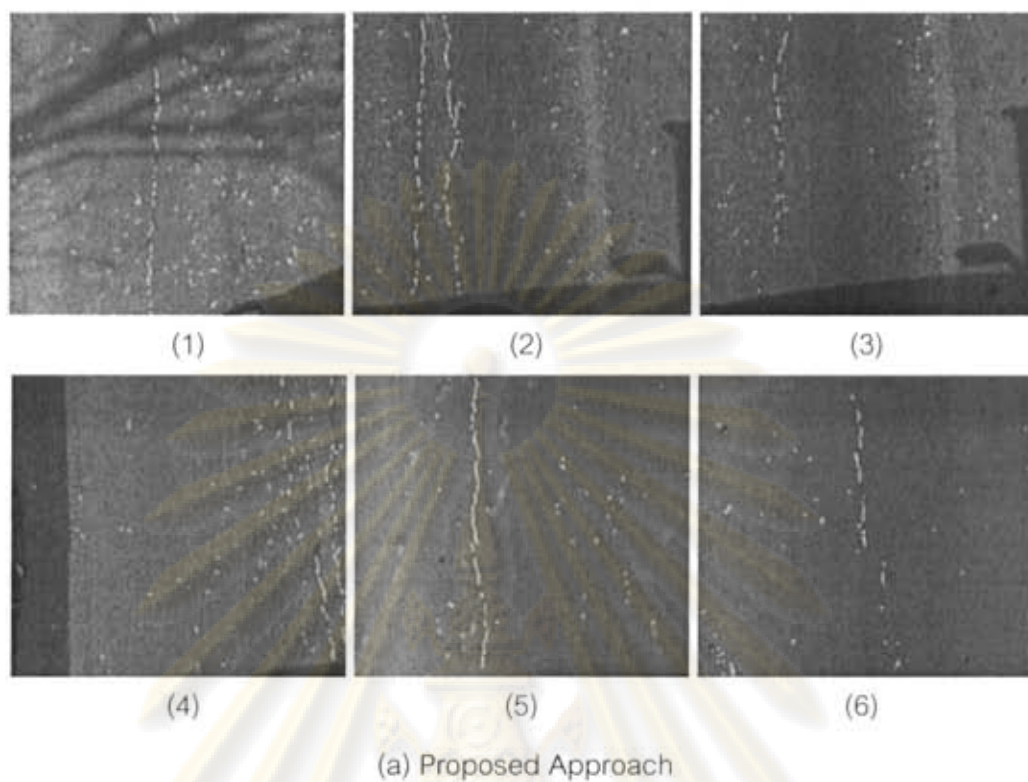
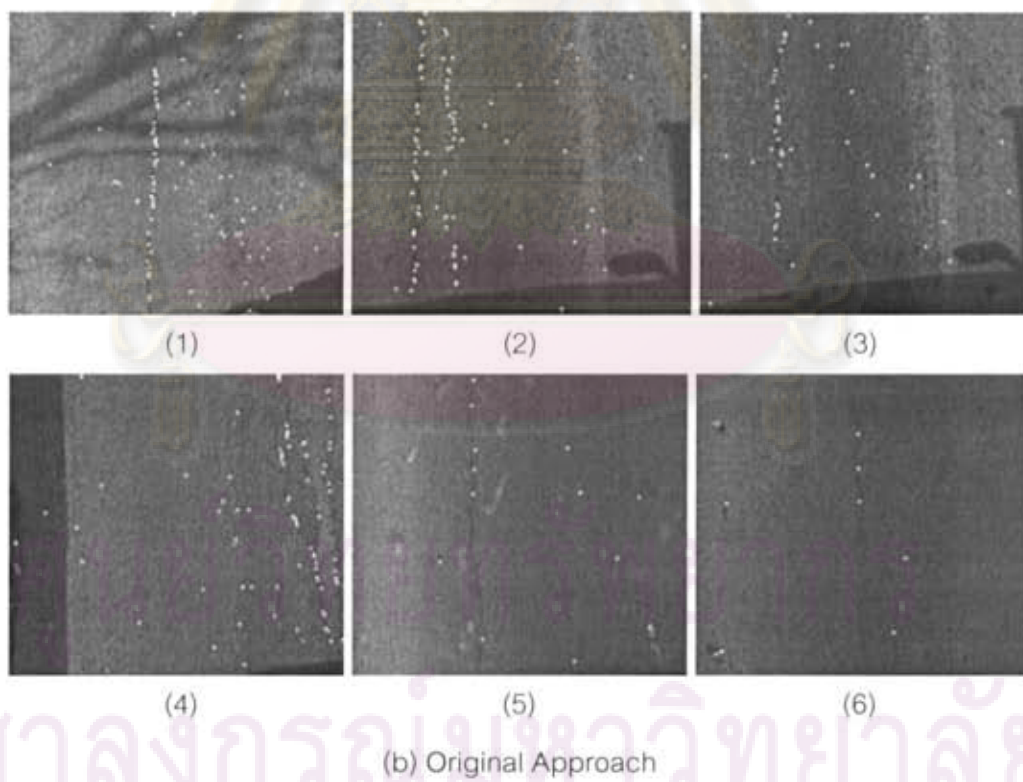
Compared to the original algorithm, the proposed approach, using enhanced features, is less sensitive to light condition. Figure 4.7(a) shows the result images implemented with this approach. Figure 4.7(b) shows the result images implemented with the original algorithm. Both algorithms were applied to the same set of images with the same parameters, i.e. threshold values for original algorithm and window size for the proposed algorithm, for every single image. The results got from the proposed algorithm were satisfactory, while another gives best result only in the first image of Figure 4.7(b1).

(a) GCA without Approached Techniques

(b) Applied Grid Cell Analysis Chain

(c) Applied Grid Cell Analysis Chain and Crack Cell Verification

Figure 4.7 Experimental Result Images

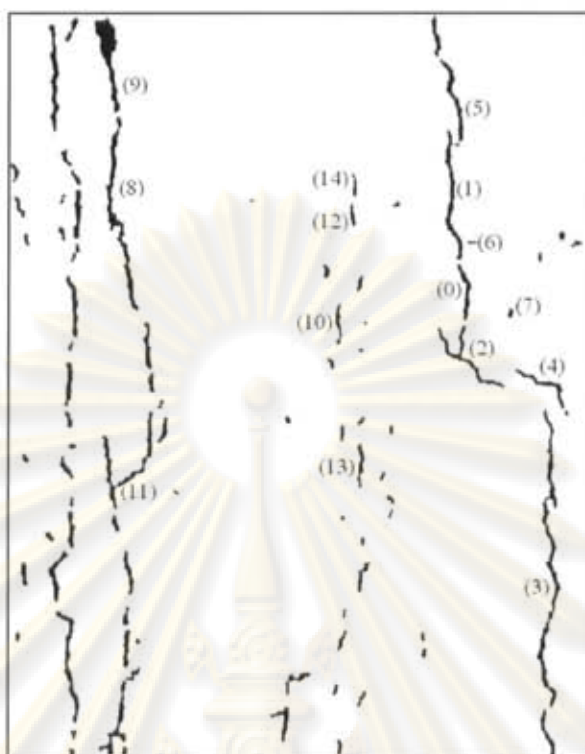
Figure 4.8 Considered Object (0) on a Crack Line

Figure 4.9 shows the object where the considered object (0) is noise object with an area of 61 pixels. Significant object information is shown in Table 4.2. Since the considered object (0) is small, the biggest object gives small feature value, 4.46, compared to feature value of the object (1), 1,207.54, in Figure 4.8.

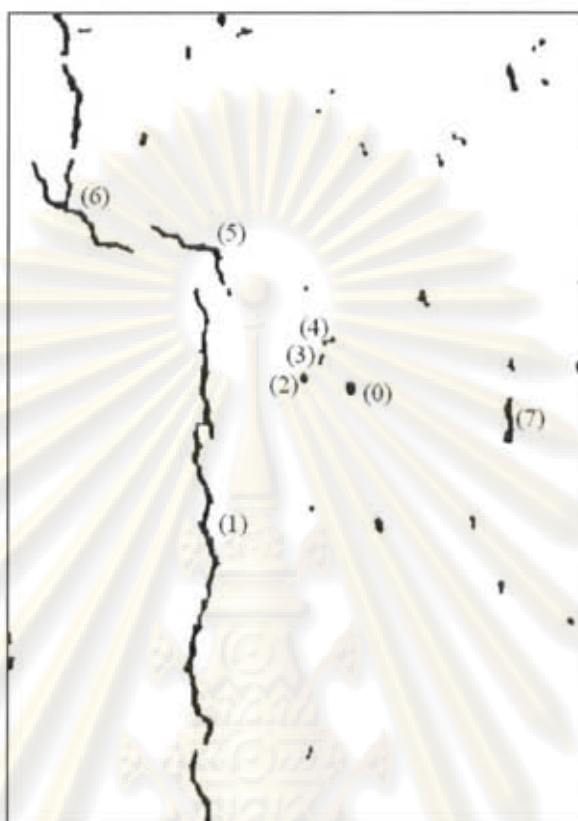
Figure 4.9 Considered Noise Object (0)

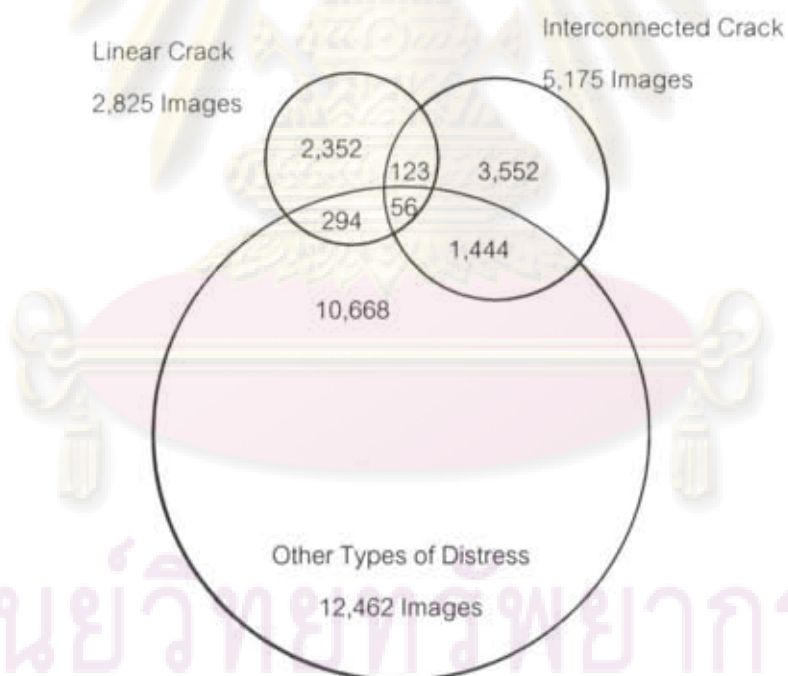
Figure 4.14 Venn Diagram of Distress Image Frames

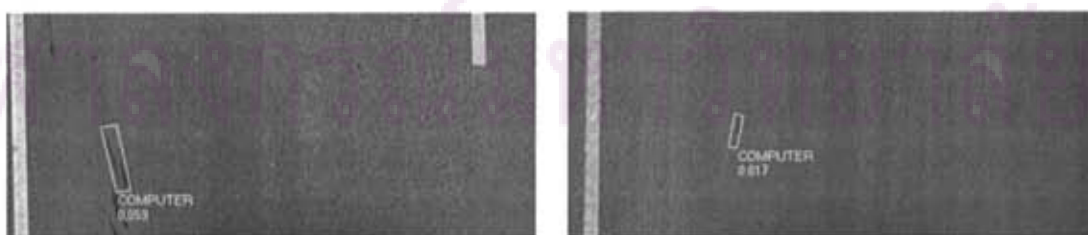
False positive might be caused by several reasons. Oil spots on pavement road were an example. The round shape oil spot was easy to distinguish from crack lines, whereas the oil stains of line shape also had same characteristics as crack lines. Consequently, the proposed approach could handle the oil spots in round shape, but give the false positive on images with oil stains of line shape, as shown in Figure 4.16.

Figure 4.16 False Positive on the Images with Oil Lines

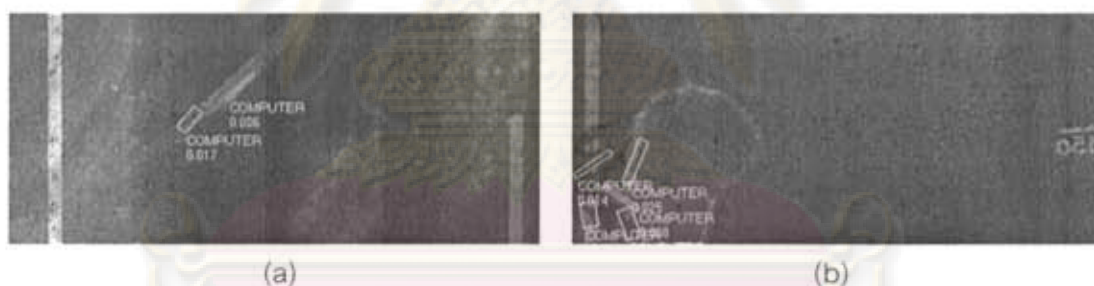
Because road shoulders might appear in the input images, objects that were not part of the road, e.g. grass, hay or tree branches could show up in the images. Figure 4.17(b) shows an image with hay on the shoulder area which was judged to be crack area.

Figure 4.17 False Positive on the images with objects

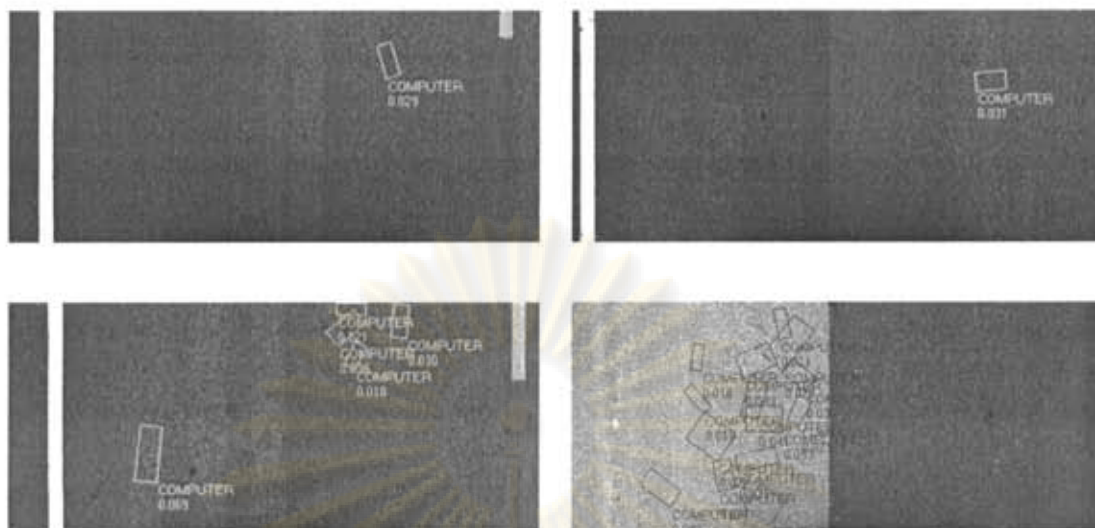
The proposed algorithm was designed to cope with illumination and strong texture problems. The algorithm tended to give a good result with non-uniform illumination image but it still gave false positive area in some strong texture images. Figure 4.18 shows example images of this case.

Figure 4.18 False Positive on the Images with Strong Texture and Illumination Problems

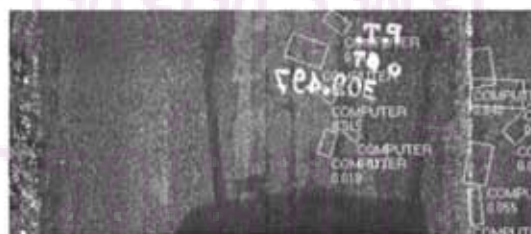
Figure 4.20 False Positive on Noisy Image

Because of long distance of the survey, it was difficult to select the input images according to the research scope. Wet surfaces were one of the uncontrolled factors, as shown in Figure 4.19, which might give false positive. However, not only wet surfaces, noisy images also gave the false positive error. Figure 4.20 shows an example of noisy image with false positive error.

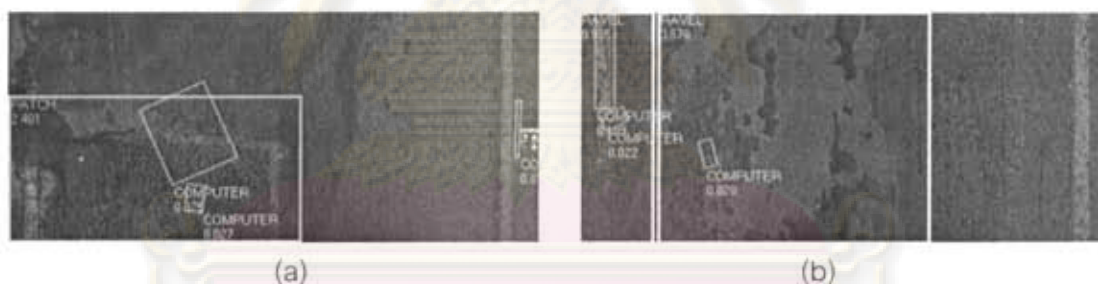
Similarly, Figure 4.21 (b) shows a crack on an area that was judged by the rater to be a raveling area. After applying the algorithm to the image, the crack line was marked. The correctness was measured by comparing crack positions that were defined by human vision to those defined by the algorithm. Such situation caused false positive error even if the algorithm could indicate the cracks.

Figure 4.21 False Positive on Crack and Other Types of Distresses

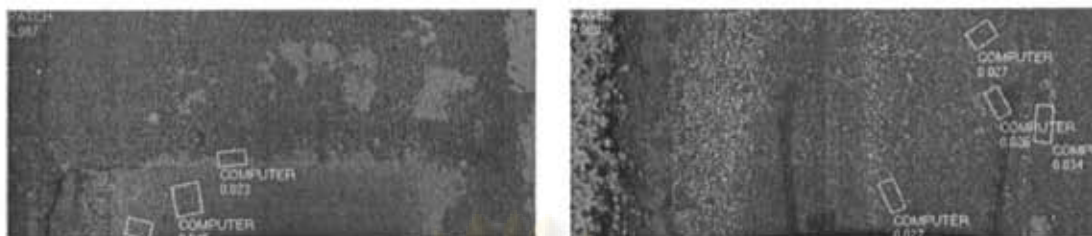
In some cases, false positive occurred when there were other types of distress or patching in the input images. Examples of these cases are shown in Figure 4.22. These patching or raveling areas had different characteristics from clean pavement. The algorithm, sometime, found them as crack areas which were judged as false positive error. The majority of these false positive cases was raveling distress as shown in Table 4.7 and Figure 4.23.

Figure 4.22 False Positive on Distressed Images.

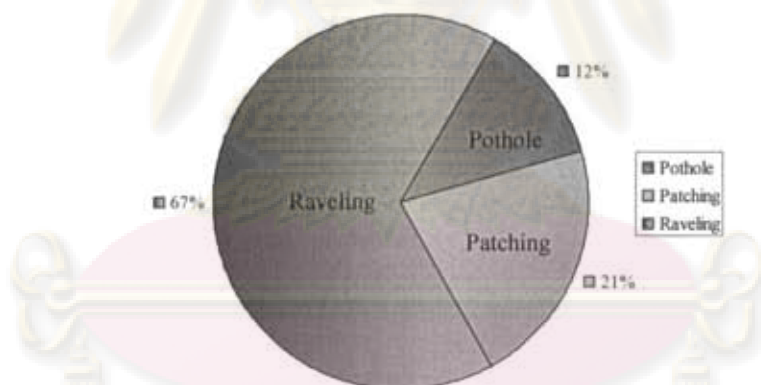
Distress Type	Crack Distressed Images Judged by the Algorithm	
	Images	Percentage
Pothole	1,084	12.26%
Patching	1,897	21.45%
Raveling	5,862	66.29%

Figure 4.23 Total Number of Distressed Image with False Positive Error

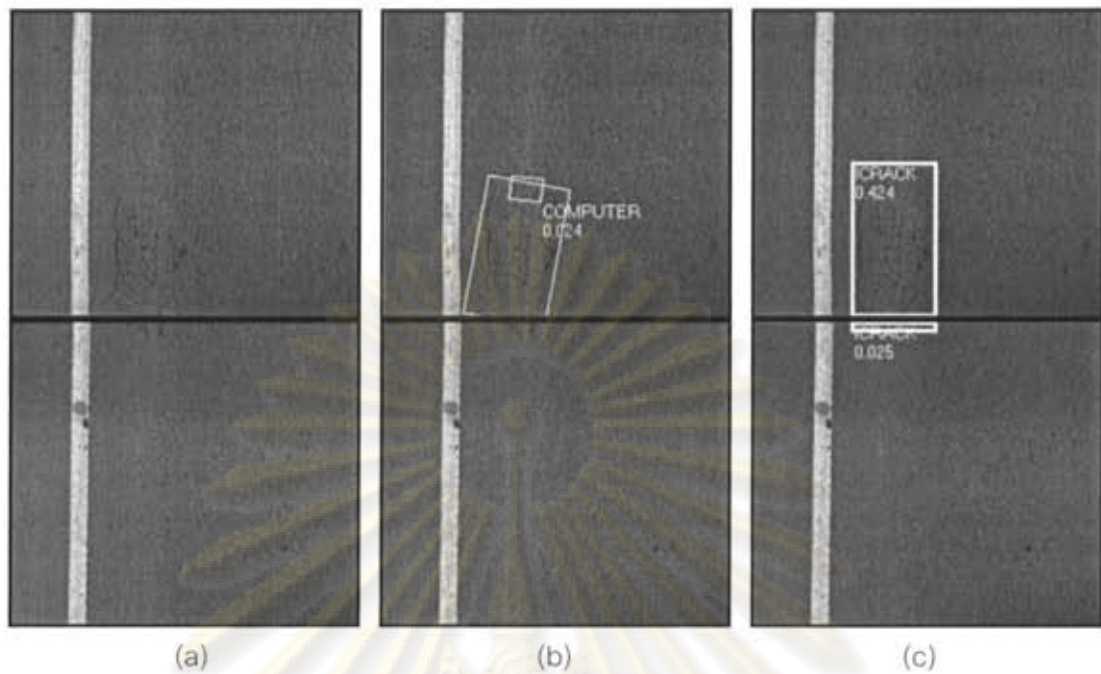
In some interconnected crack distressed images, as shown in Figure 4.26, the rater also estimated distressed area which over occupies two images. Figure 4.26(a)

Figure 4.26 Interconnected Crack Rating
