ENGINEERING AND PHYSICAL PROPERTIES OF RESIDUAL SOIL FROM LANDSLIDE
HAZARD AREA IN AMPHOE CHIANG KLANG, CHANGWAT NAN, THAILAND

A Thesis Submitted in Partial Fulfillment of the Requirements
for the Degree of Master of Science Program in Earth Science

Department of Geology

Chulalongkorn University

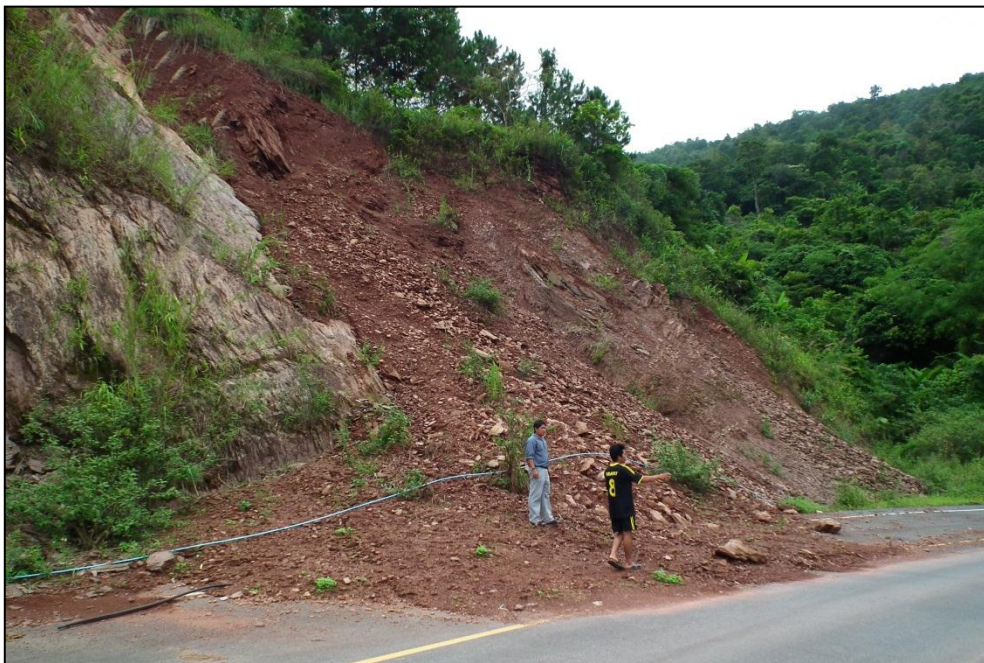
Figure 1.3. Landslide occurrence (cut slope failure) in the Ban Nong Pla area.

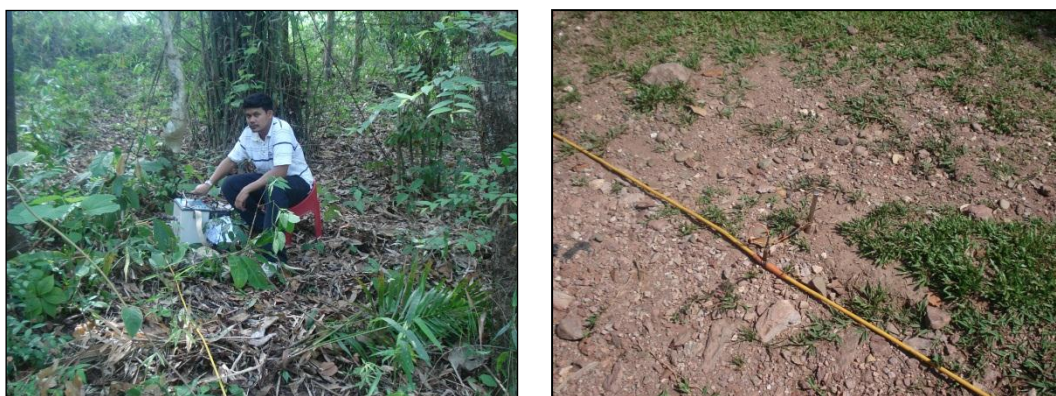
Figure 3.6. 2-D resistivity survey in study area using 48 electrodes (SYSCAL switch multi- electrode equipment)

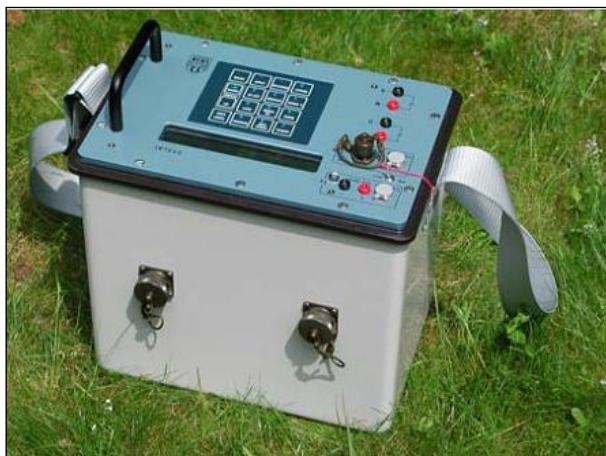
Figure 3.9. SYSCAL R1 Plus Switch 24 - 48 or 72 electrodes spacing between electrodes (std) : 5m (using to 2-D resistivity survey in study area)

For instance, for a 48 electrode 5 m spacing Pole Dipole array, a required quality of 1% in a standard noise, a 100 ohm.m average resistivity and a 2.5 kohm ground resistance, the duration of acquisition of 500 readings is 25 minutes with a 600 V output voltage one channel unit (SYSCAL R1 Plus Switch 48 shown in figure 3.9.), while it

decreases down to only 2 minutes with a 800V output voltage ten channel unit (SYSCAL Pro Switch 48).

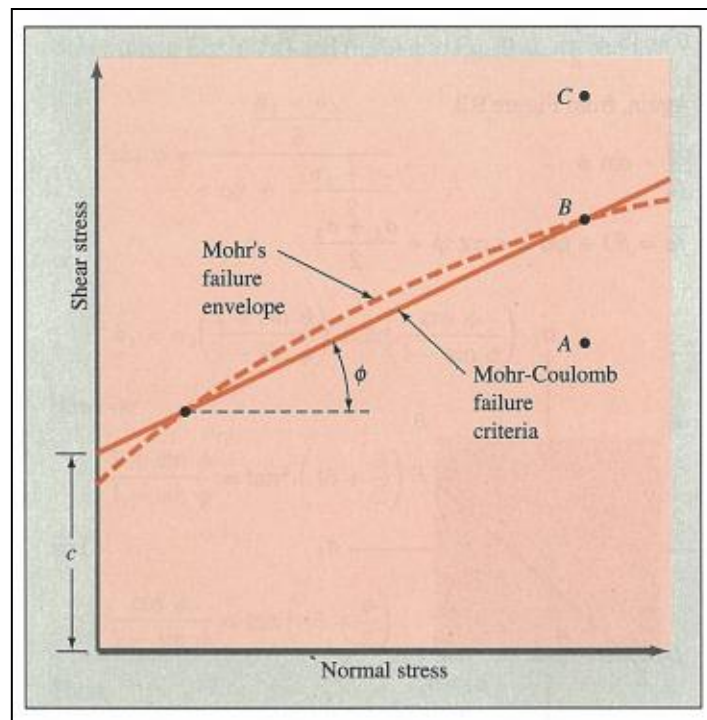
Figure 3.21. Mohr's failure envelope and Mohr- Coulomb failure criteria (Das ,1994).

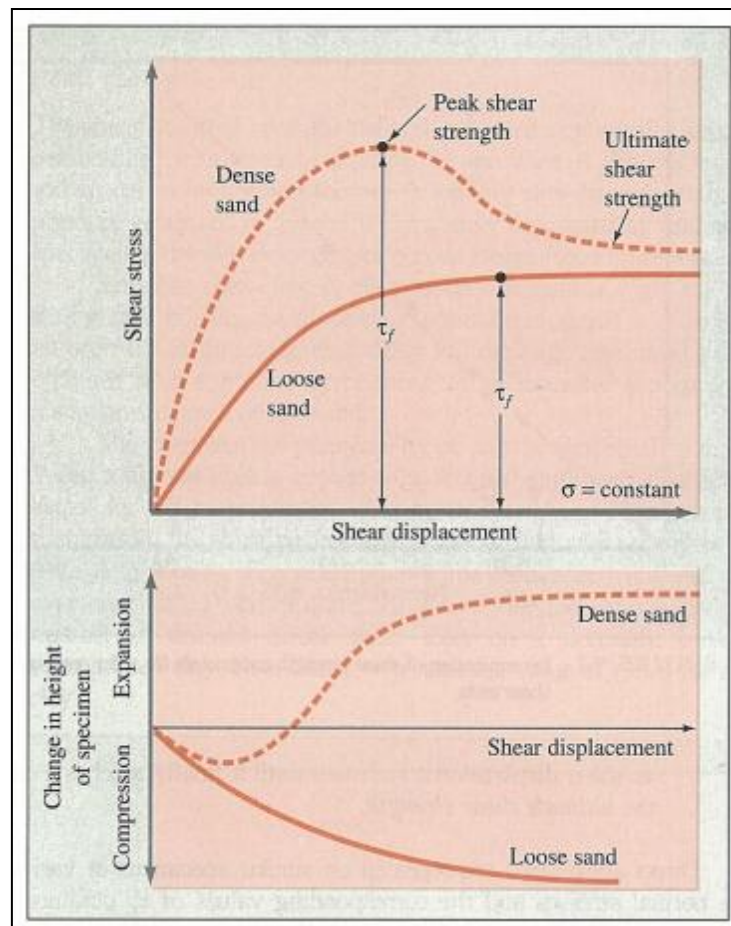
Figure 3.23. Plot of shear stress and change in height of specimen against shear displacement for loose and dense dry sand : direct shear test (Das ,1994)

$$\tau = \text{Shear stress} = \frac{\text{resisting shear force}}{\text{Area of cross-section of the specimen}}$$

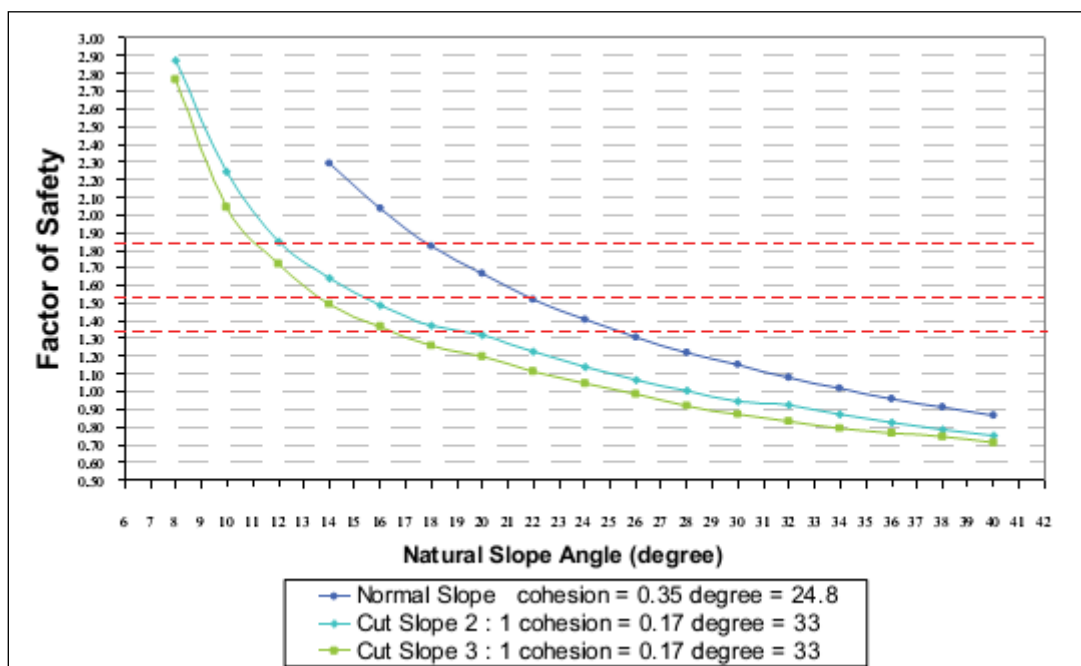
Figure 5.15. Factor of safety of cut slope and natural slope studied by Soralump et al (2010).

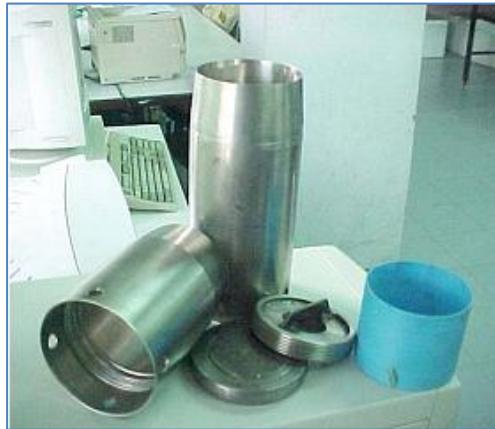
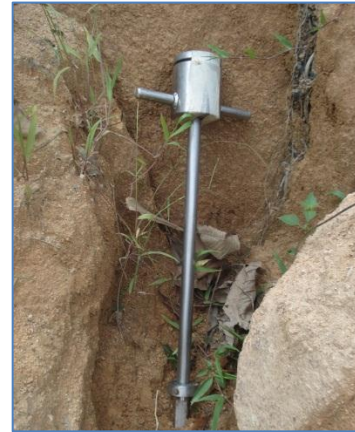
Appendix figure A1 The equipment for collecting sample in the field

- Contain the PVC cylinder that has diameter pass in 2.5 inches , thick 2 inches as shown in Appendix figure A1

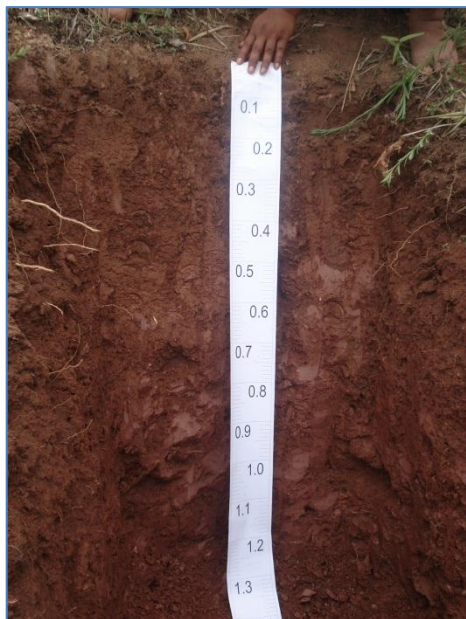
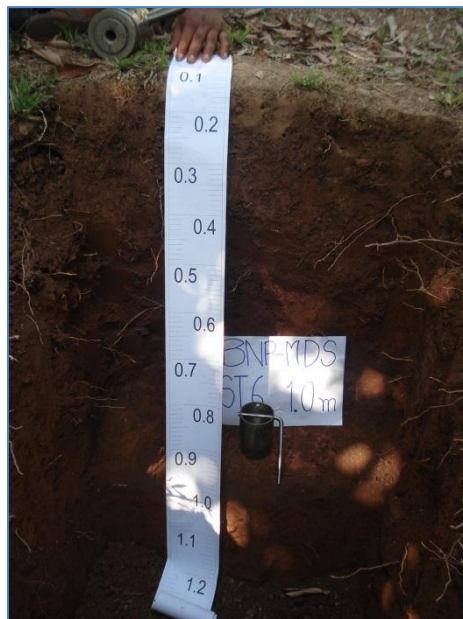
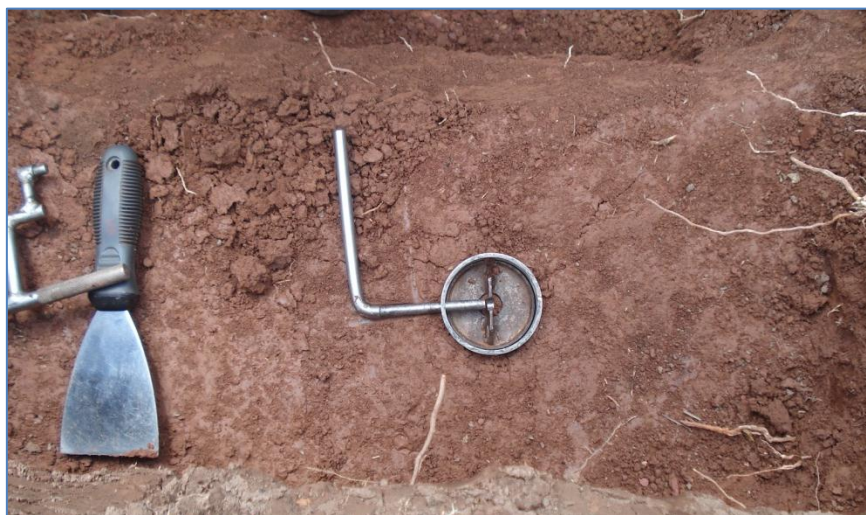
Appendix figure A3 Step the collecting soil sample(continue)

1. Preparation the area for collect sample by dig to the require level for collect sample.
2. Preparation a cylinder for collect sample and PVC cylinder by applying vaseline, Measure the size and weighed the PVC cylinder Install number at PVC cylinder.
3. Put position preferred collect sample using a trowel slice off a soil top provided smooth regularly.
4. Put a Styrofoam beads into cylinder for reinvigorate the samples don't provided push up faster until losing quality.

5. Strike sample cylinder by divide about 3 section for take a styrofoam beads leave collect sample cylinder.
6. When strike sample cylinder to the required level for collect sample. Lead a steel (shape L) for bowl a collect sample cylinder in order that a soil at muzzle the sample cylinder absence out.
7. Pull a collect sample cylinder.
8. Put a PVC cylinder that has a soil sample to trim. Then led to weighed for find the density of soil value.
9. Scrape a soil at muzzle the PVC cylinder about 0.5 cm both two sides.
10. Drip a liquid paraffin both two sides order to prevent extinction moisture content of sample.
11. Wrapping a transparent plastic and plastic cushioning.
12. Contain a sample into foam box.

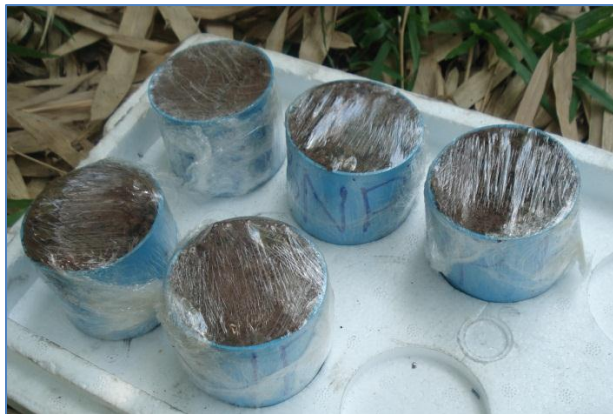
Appendix figure A3 Step the collecting soil sample (continue)

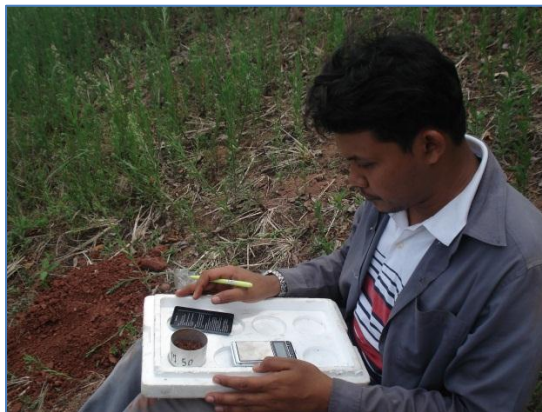
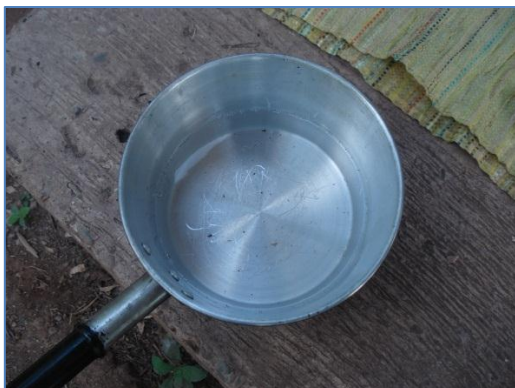
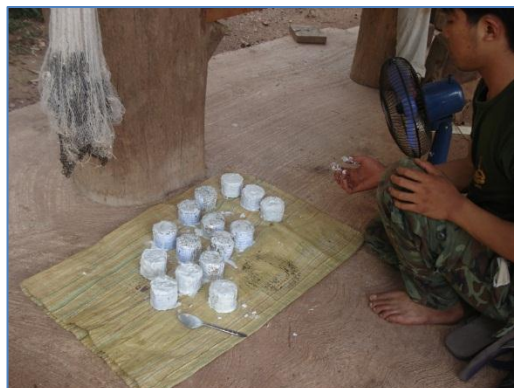
Appendix figure A3 led to weighed and Drip a liquid paraffin
