## CHAPTER IV

### RESULTS AND DISCUSSIONS

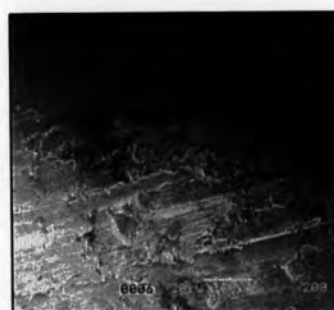
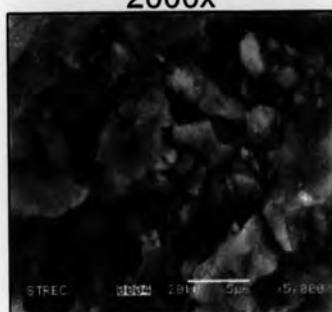
**Figure 4-1** Surface morphology of a blank sample

Figure 4-1 shows that the surface morphology of the blank coupon is irregular and heterogeneous. The closer examination under higher resolutions found surface pits and crevices which act as potential adsorption sites for elemental Hg.

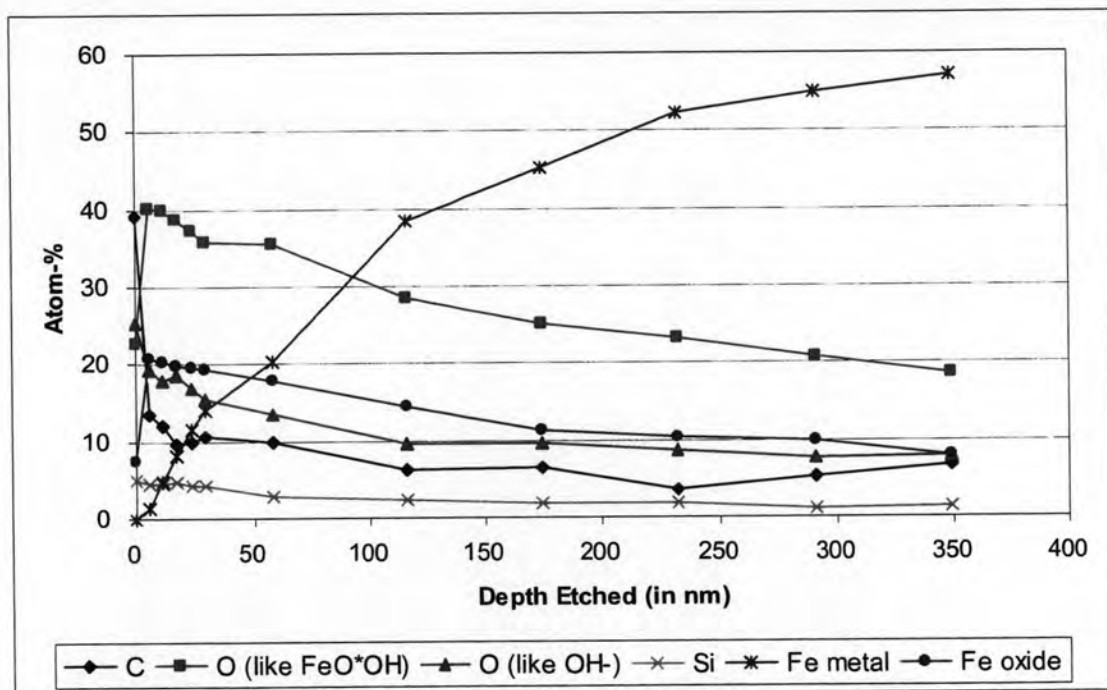
**Figure 4-2** Chemical depth profile of a blank sample

- Fe-metal gradually increases from the surface through the course of the depth profile analyzed prior to becoming more predominant and persistent at the depth of about 350 nm;
- O (like OH-) gradually declines from the surface and becomes persistent at the depth of approximately 120 nm. The OH-like O detected may be an intermediate in Fe corrosion process;

- Si slowly declines and become persistent at the depth after 50 nm approximately;
- C decreases rapidly to the depth of approximately 30 nm prior to being more persistent at the depth after 100 nm which continues throughout the depth profile analyzed;

- Similar patterns of depth profile between Fe-oxide and O (like FeO\*OH) are observed to increase rapidly at the top surface (about 5-10 nm) before they gradually decrease throughout the course of the depth profile. Both of Fe-oxide and FeO\*OH are considered to be products of iron corrosion indicating that the top surface of the blank coupons was oxidized; and

- The depth profile of O (like FeO\*OH) found in the experiment is very similar to that reported by Zalavutdinov (2001). He also found that O on the surface of F82H steel analyzed using Ion Mass Spectrometry (SIM) analysis showed rapid increase at the topmost surface prior to its gradual decrease through the course of the depth profile until to a total depth about 450 nm.

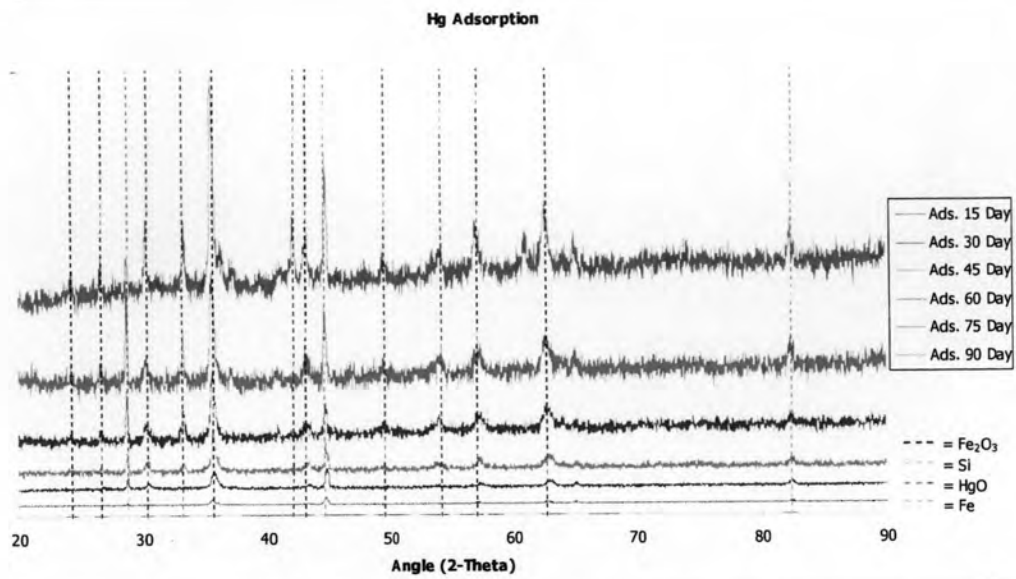
**Figure 4-8** XRD profile of 15 - 60 day Hg adsorption sample

Figure 4-8 shows the presence of crystalline substances that were detected on the Hg adsorbed coupon surface the surface including Fe-metal, Fe<sub>2</sub>O<sub>3</sub>, Si and HgO on all Hg treatment coupons of 15 – 90 day. The results show that other Hg form of HgO was detected after no later than a week of the analysis.

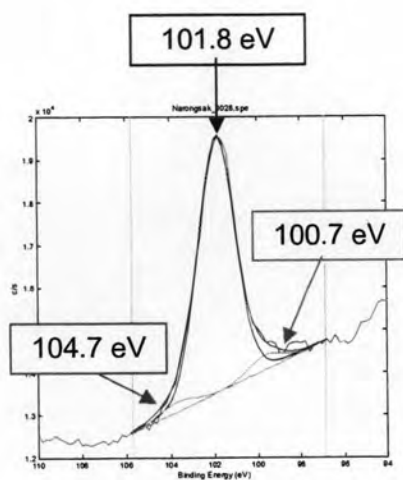
**Figure 4-9** XPS Profile of Hg species on the topmost surface of Hg adsorption samples

The results of XPS analysis show that XPS spectra of Hg4f7/2 were observed with binding energy of 100.7 eV. Matching of the detected to the published binding energies revealed that it matched to those of the oxide state of Hg4f7/2 (100.5-101.0 eV). This shows that with the XPS analysis after no later than two weeks, HgO is the only speciation that found on the surface of Hg adsorbed coupons. The published binding energies are presented in Table 4-3 below:

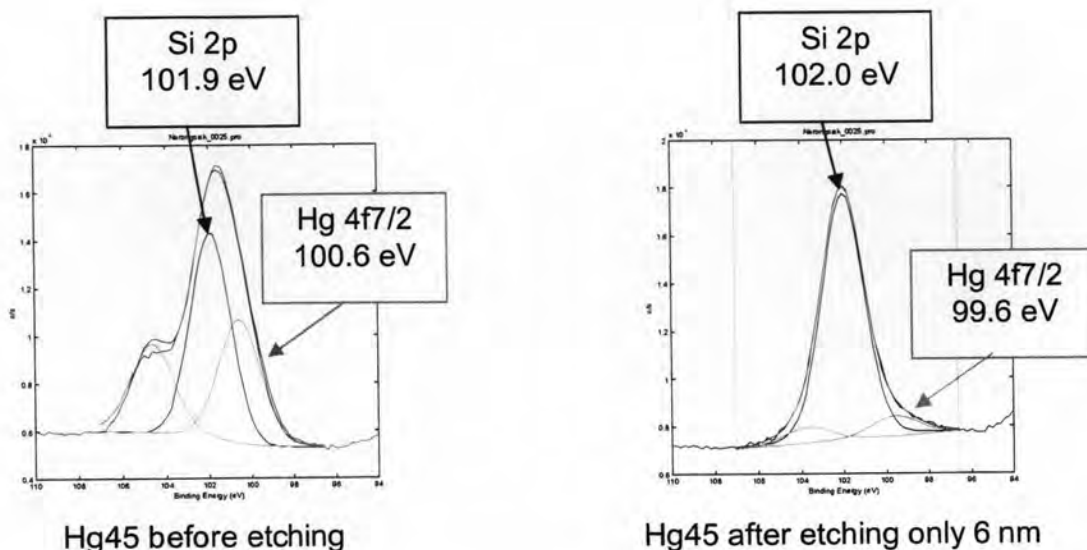
**Figure 4-12** Depth profile of Hg at the surface and after etching only 6 nm of Hg 45 day adsorption sample

Figure 4-12 shows that Hg found on the surface of Hg adsorbed coupons is in oxidized state of Hg(II) with the binding energy of 100.6 eV of Hg4f7/2 as discussed earlier. However, after a brief etching for only 6 nm from the topmost surface, Hg was found in zero valence state of elemental form with the binding energy of 99.6 eV for Hg4f7/2 as compared to the published binding energies of elemental Hg presented in Table 4-3.

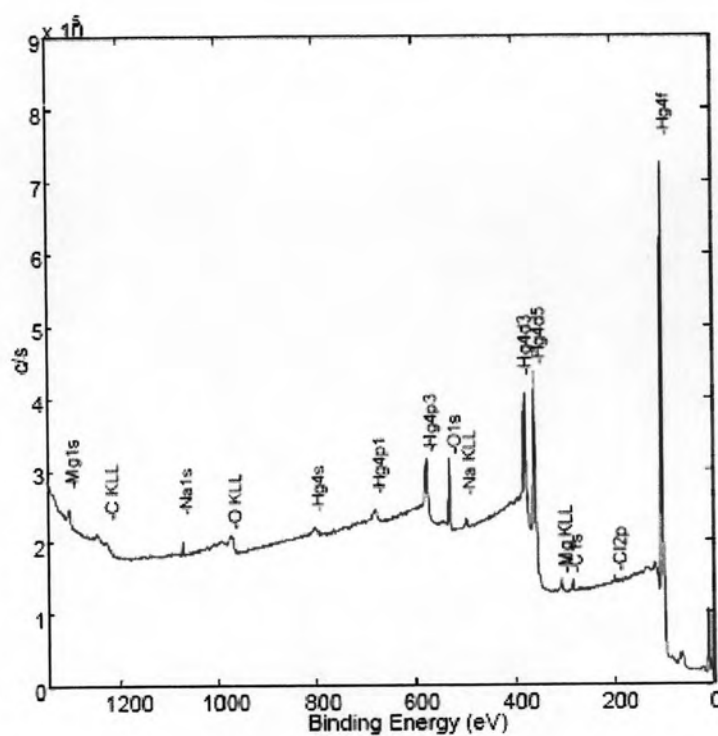
**Figure 4-13** XPS profiles of HgO

Figure 4-13 shows that HgO has only small concentrations of impurities observable. Of these, C is present at the largest concentration, which is about 20 % atom, to be consistent with expected adventitious carbon.

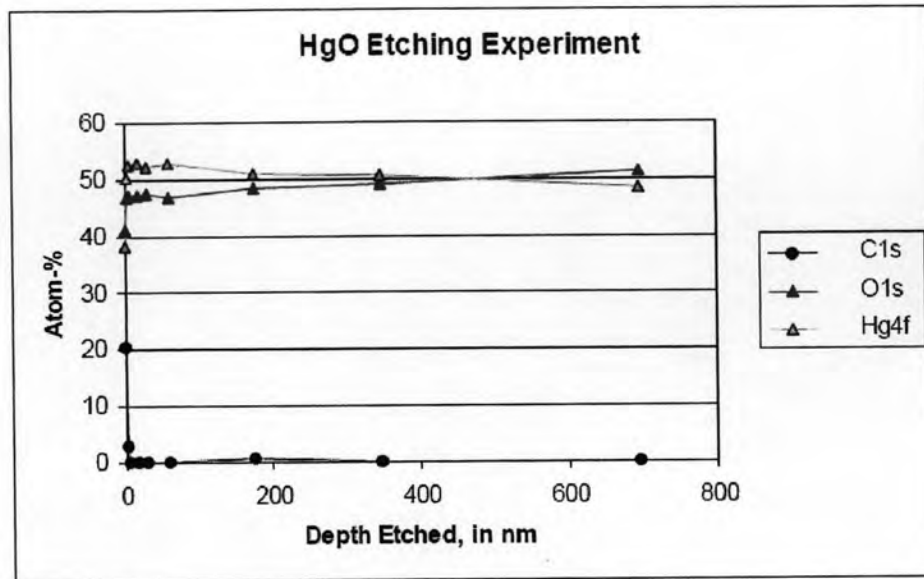
**Figure 4-14** Depth profile of HgO showing C, O and Hg

Based on the Figure above, there is no evidence to suggest decreasing of O content with etching of HgO. Only the superficial adventitious C concentration decreases substantially with depth. The calculation of Hg/O atomic ratio was therefore undertaken throughout the course of the depth profile of which the result is presented in Figure 4-15 below:

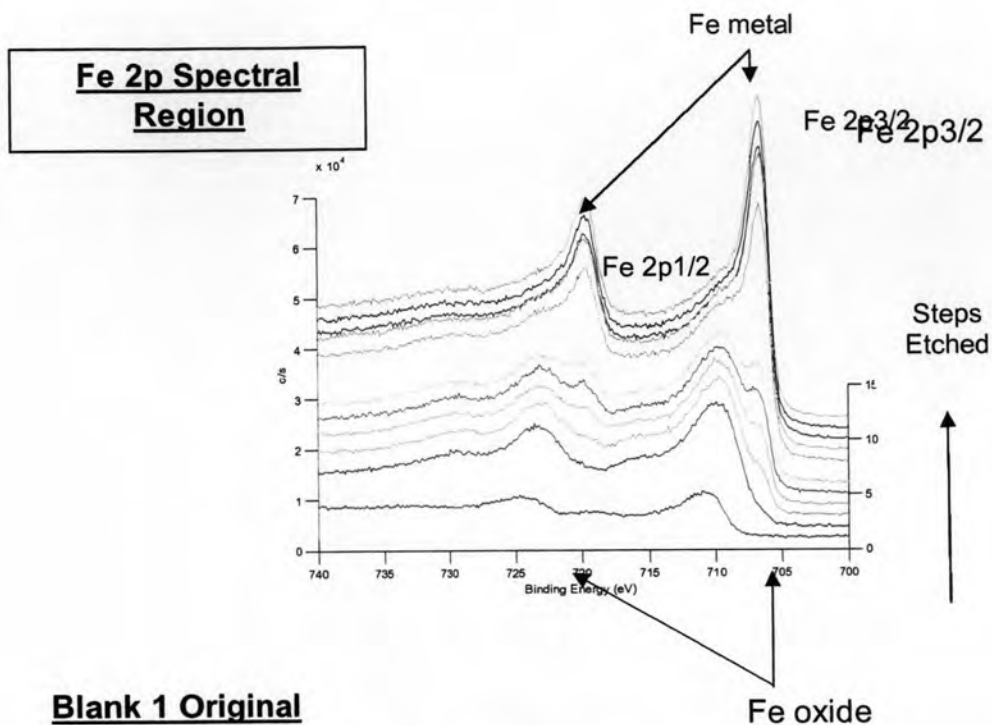
Figure 4-16 Depth profile by XPS – Oxide layers on a blank sample

Figure 4-17 Depth Profile by XPS – Oxide Layers on the Surface of a 30 day Hg Adsorption Steel Coupon

**Figure 4-18** Depth profile by XPS – Oxide layers on the surface of a 60 day Hg adsorption steel coupon

In the blank sample, Fe<sub>2O3</sub> is mostly present on the steel surface whereas Fe (metal) gradually increases and becomes more predominant through the course of the depth profile. However, for 30 and 90 day Hg treatment, much thicker layers Fe<sub>2O3</sub> were observed on the surface which also develops further into the depth profile in comparison to those of the blank coupon. This shows potential growing of Fe<sub>2O3</sub> layers on the surface of the steel coupon that may be contributed by effects of elemental Hg.

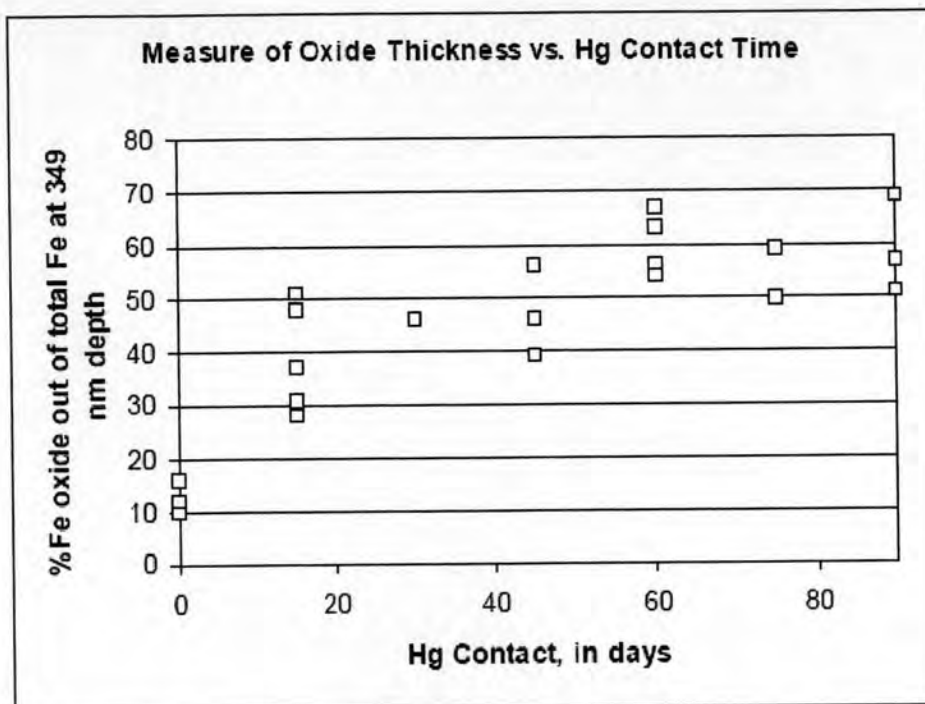
**Figure 4-19** Measurement of oxide thickness on the surface of Hg adsorption coupon surface with different Hg treatment periods.

Figure 4-19 above shows that the longer the Hg contact time, the thicker the oxide layer is observed. It is therefore indicative that Hg may cause ferrous steel corrosion.
