COASTAL EROSION AT THE PAK PHANANG RIVER BASIN,  
CHANGWAT NAKORN SI THAMMARAT

จุฬาลงกรณ์มหาวิทยาลัย  
A Thesis Submitted in Partial Fulfillment of the Requirements  
for the Degree of Master of Science Program in Geology

Thesis Title            Coastal Erosion at Pak Phanang River Basin, Changwat Nakorn Si  
 Thammarat  
 By                         Mr. Apichart Suphawajruksakul  
 Field of Study         Geology  
 Thesis Advisor        Associate Professor Thanawat Jarupongsakul, Ph.D.

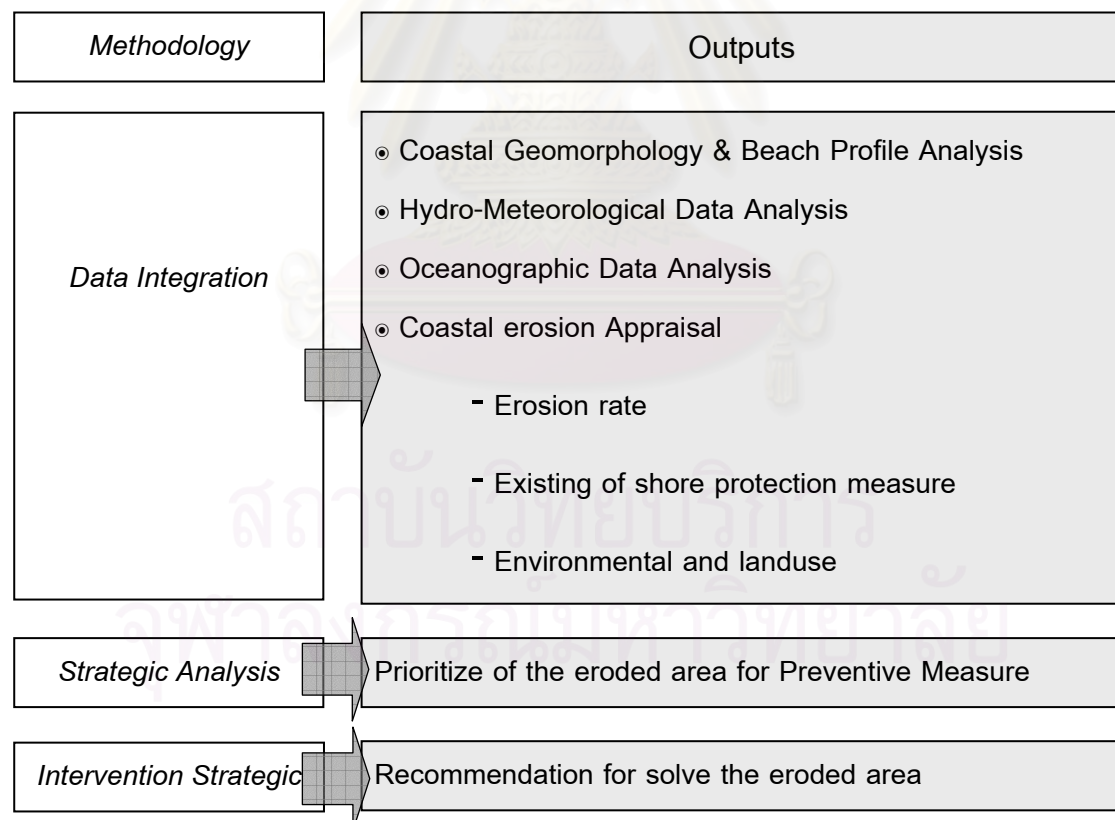
Figure 1.1 Illustrates the methodology used and outputs in this study

This study used integral knowledge of geology, hydrology, oceanology, economy, coastal engineering, GIS, and remote sensing technique. The methodology of this study is divided into three steps. Firstly, the basic data acquisition of previous works and literature studies were collected. Then the field investigation was carried during November 2004 to January 2005. The data analysis is composed of coastal geomorphology, hydro-meteorological data, oceanographic data and coastal erosion appraisal data. Afterward data were prepared and analyzed by the GIS technique (Figure 1.2). Secondary, the prioritizations of eroded areas were done and preventive measures in the eroded areas were proposed and then illustrated in maps. Finally includes integration of all the results to recommend for solve the eroded area of the study. The methods of study are shown on the schematic chart in Figure 1.1.

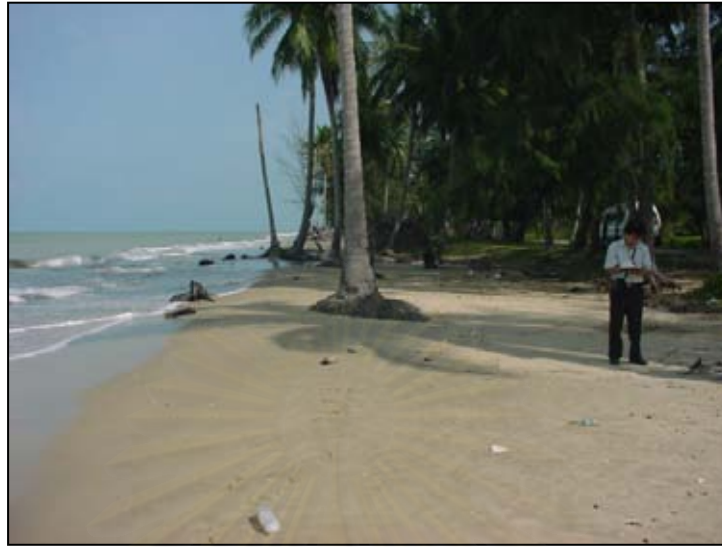
Figure 2.6 Recent sandy beach at Lam Talum Puk UTM 628114E/940360N

The characteristic of coastal geomorphic units of the study area is barrier beaches, in front of the sea, and sand spits in the north part of Talumpuk area. The recent sandy beaches are high approximately 60 kilometers length, 5 to 15 meters weight, and 0.5 to 1 meters height. Small runnels are coral and shell, are found between the beaches (Figure 2.6).

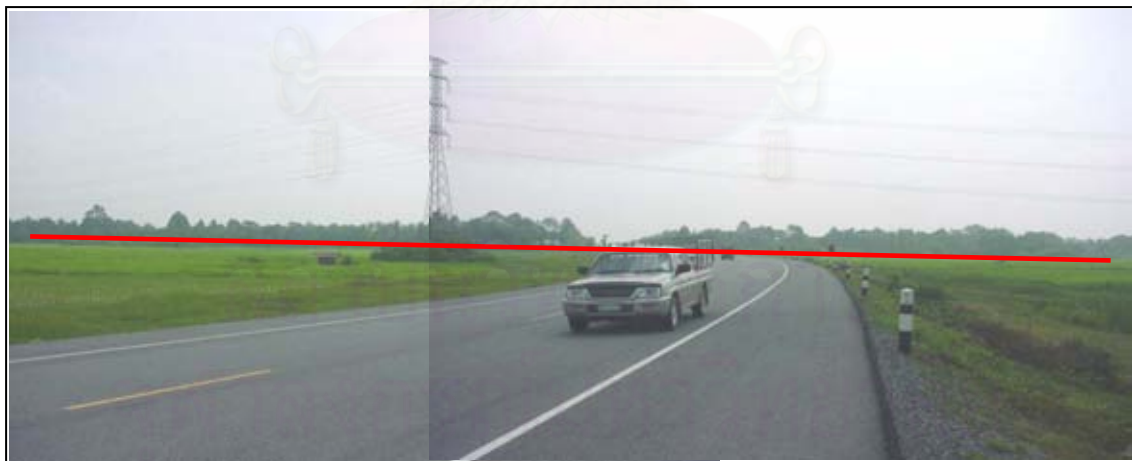
Figure 2.7 Old sandy beaches near the train tracks (red line) UTM 603734E/920200N

north to the south in the center of the study area and it has lagoon between two old sandy beaches. The characteristic of these old sandy beach are 2 to 5 meters high, 1 to 5 kilometers wide and has a longest distance from shoreline about 40 kilometers at the Cha-Uoad district. These old sandy beach are village and living area (Figure 2.7).

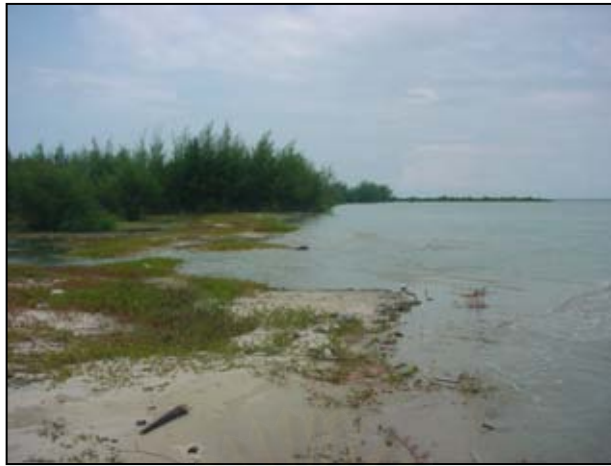
Figure 2.8 Subtidal flat in the north of Lam Talum Puk

Subtidal flat is the outside area that meets with shoreline and intertidal flat. It is a flat area that is under the lowest tide in the subtidal flat. It is found in the northern area in the Pak Phanang Gulf covering approximately 75-80 square kilometers. The characteristic of sedimentary deposition is clayey sand with plants cover (Figure 2.10).

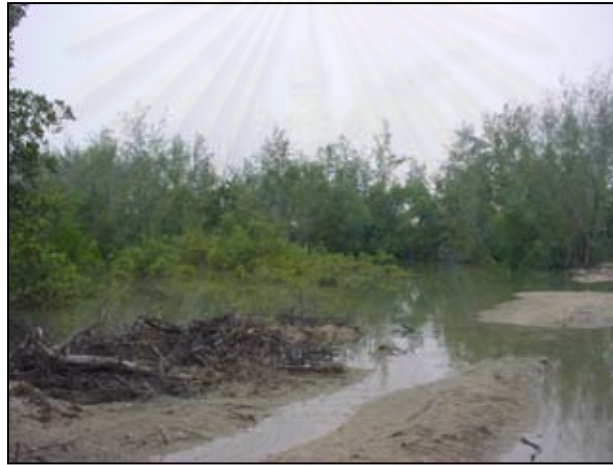
Figure 2.9 Intertidal flat in the study area UTM 622901E/941467N direction W

Intertidal flat is a flat area that is affected by high tides and low tides. It is found from the north of Pak Nakorn river mouth in Pak Phanang River to Talum-Puk area, expanding totally 120 square kilometers. This area lies between old tidal flat and subtidal flat that is once a mangrove area (Figure 2.9).

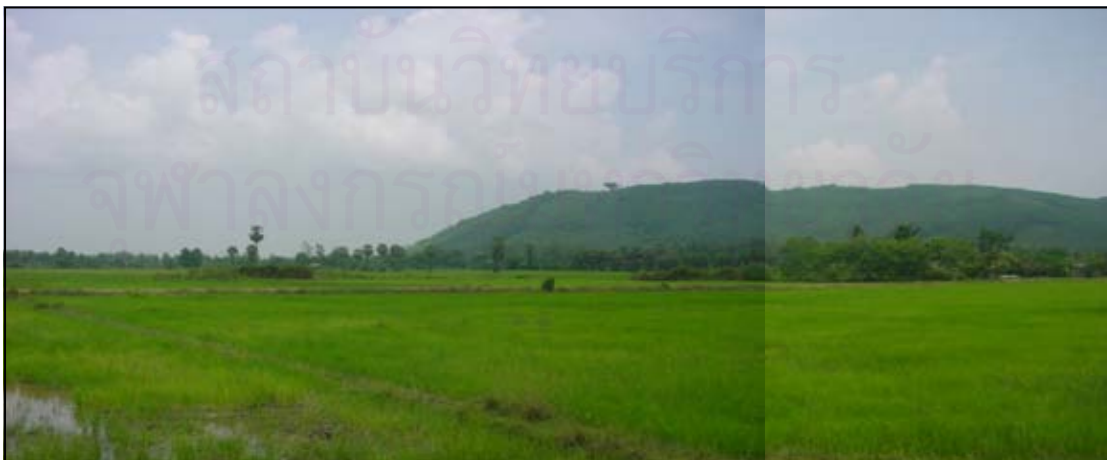
Figure 2.10 Old tidal flat in the study area UTM 602953E/920351N direction NE

Old tidal flat is flat area covering about 1,800 square kilometers, about one-third of the study area in the eastern part (Figure 2.8). It lies between an old sandy beach and a recent sandy beach with height topography of 0.5 to 2 meters. Sediment has been deposited from the maximum transgression to the regression of sea water about 5,000 years ago. It consists of greenish gray marine clay, which is used as rice field, shrimps farm and housing area.

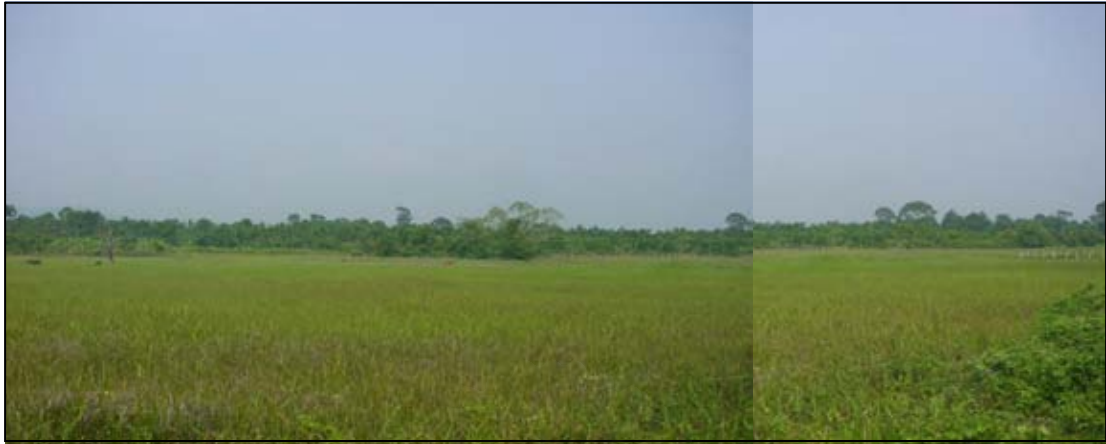
Figure 2.11 Old lagoons in the study area UTM 600110E/916308N direction NE.

Old lagoon is a low-lying area which formed during maximum transgression, 6,000 years ago. After that, old river mouth in the southern of the study area was closed. It is between old sandy beaches from the north to the south in the middle part of the study area. Old lagoon in this area is narrow in the northern part and wide in the southern part. It is an extensive area about 400 square kilometers and comprises fine grained sand, silt interbedded with mud, clay and some organic matter. This area is suitable for paddy fields and rubber plantation (Figure 2.11).

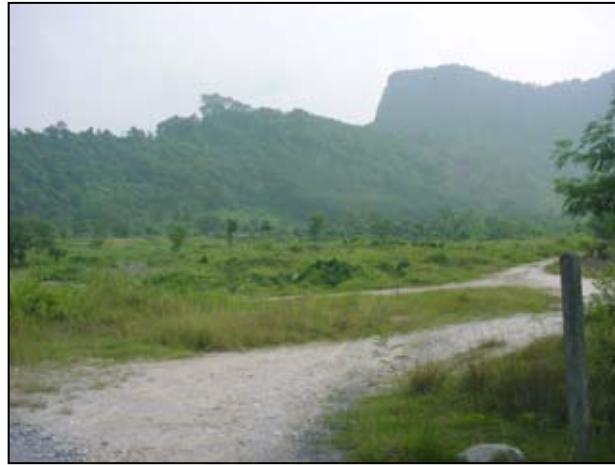
Figure 2.14 Colluvial and old alluvial fan in the study area UTM 593157E/908427N direction NE

Colluvial deposit is composed of sediments and loose blocks that have been deposited near the foot of the hill. The colluvial deposit can be found in the west of the study area between mountains and flat plains. This area is used for agricultures such as para rubber, palm and areca palm (Figure 2.14).

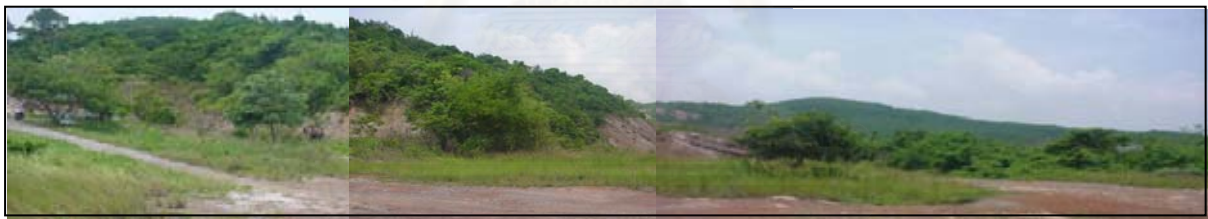
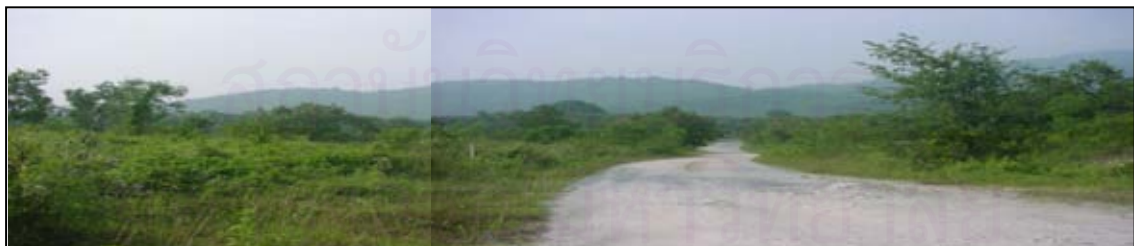
Figure 2.15 Sandstone mountain (Khorat group) UTM 630956E/892181N direction N (upper picture) and granite mountain UTM 593154E/908415N (lower picture)

The high area in the study area is in the west with smaller areas in the east and the center of the plain. The elevation of the mountain and hills are more than 20 meters above the mean sea level. They consist of limestone, granite, sedimentary and metamorphic rocks that are locally been mined for construction (Figure 2.15).

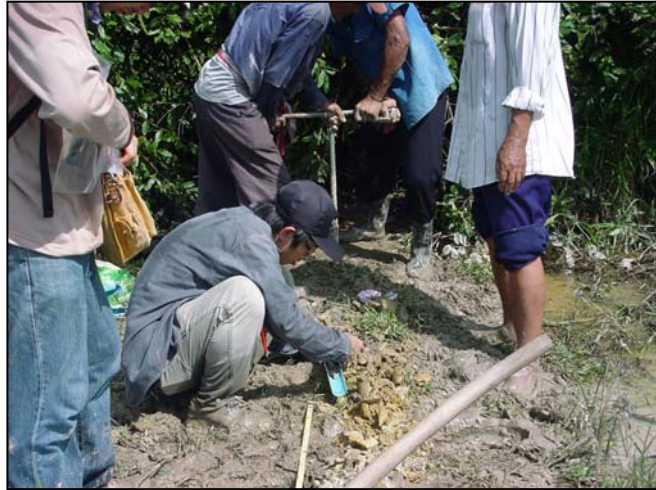
Figure 2.17 Hand auger is the application tool used in the field

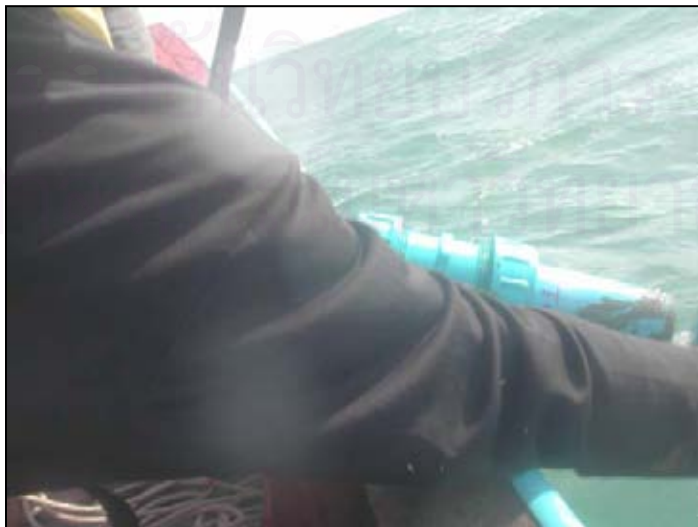
Figure 2.26 Collected samples by the hand corer method

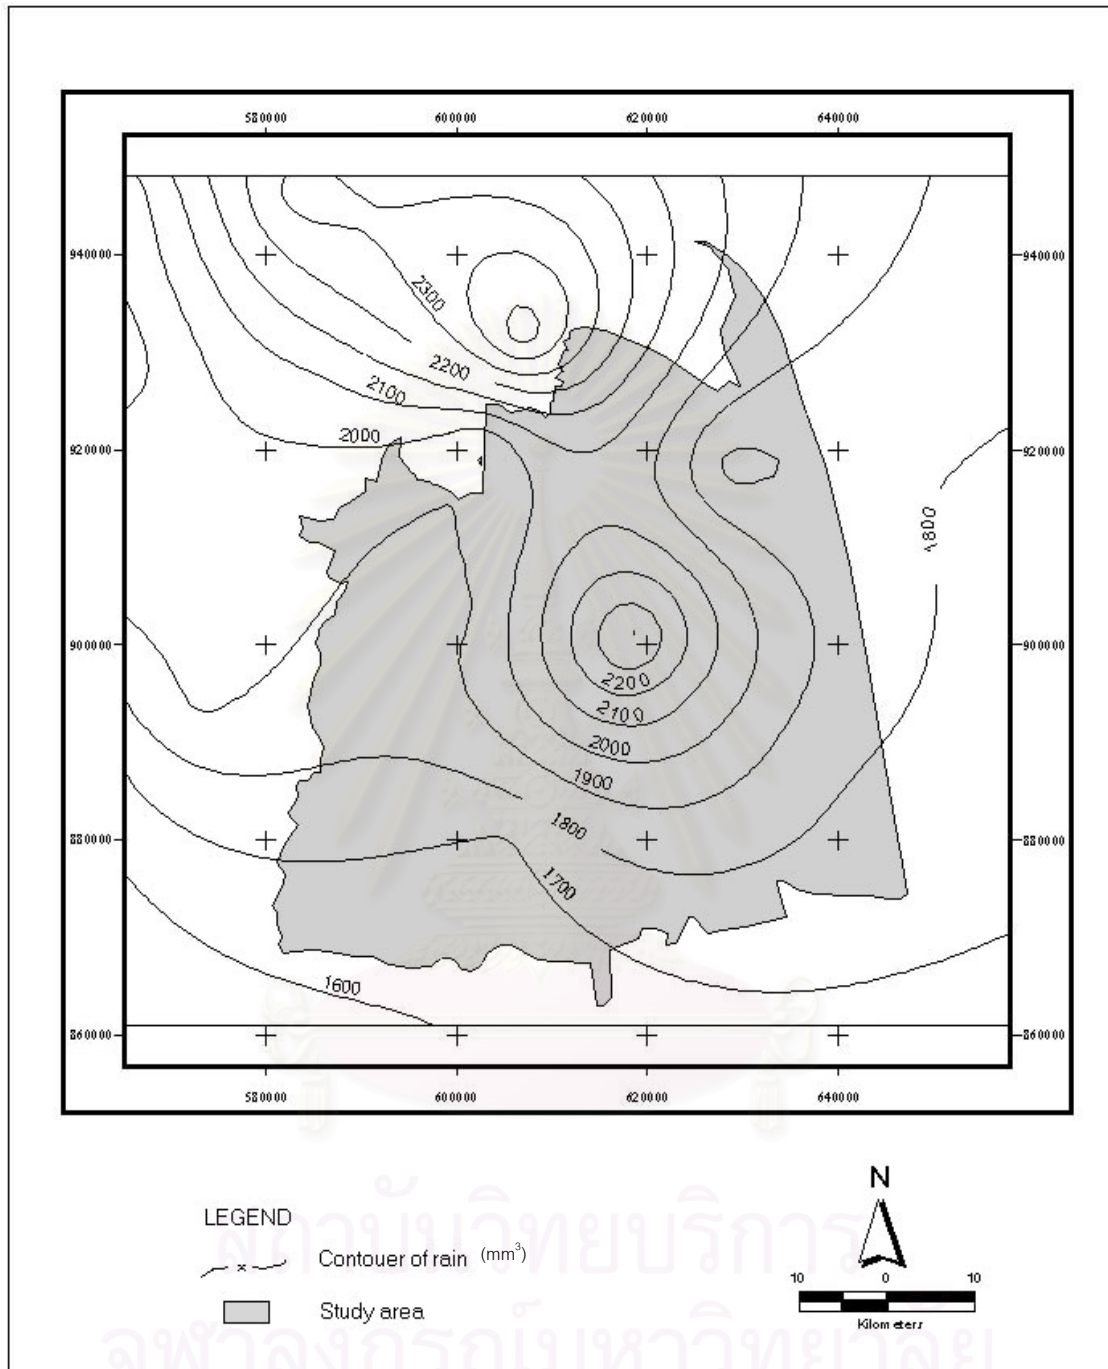
Figure 3.2 Annual rainfall charts (in years 1975-2000) at Pak Phanang area

The Meteorological data from Nakorn Si Thammarat station for 30 years (1971-2000) revealed that the average temperature was about 27 Celsius with the lowest temperature of about 17 Celsius in December and highest temperature of about 38 Celsius in April. This area has 81 percentages of humidity and 2,396.1 millimeter of rain annually. The north of Pak Phanang basin experiences more rainfall than that in southern basin. The rainfall is approximately 1,766.8 millimeter per year in the Pak Phanang district. The details are shown in the Table 3.1 and Figure 3.2

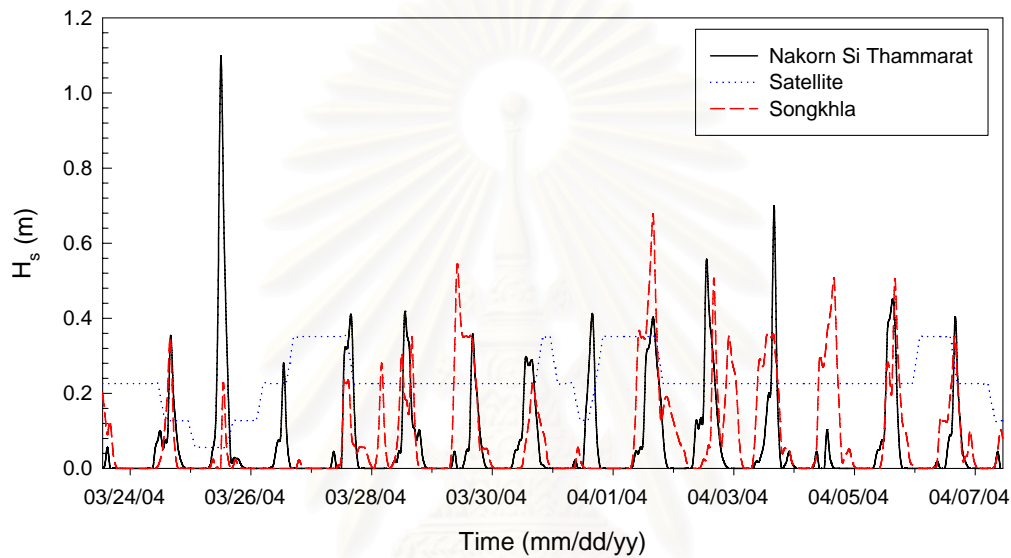
Figure 3.7 Significance wave heights at Nakorn Si Thammarat and SongKhla meteorological stations and from Satellite sensor (Sojisuporn et al., 2005)

From Figures 3.7 and 3.8 the significant wave heights and wave periods discontinued because the wind speed was equal to zero. Figure 3.8 shows the daily variation of wave period with wind speed as the wind speed was high during the day time and low during the night time.

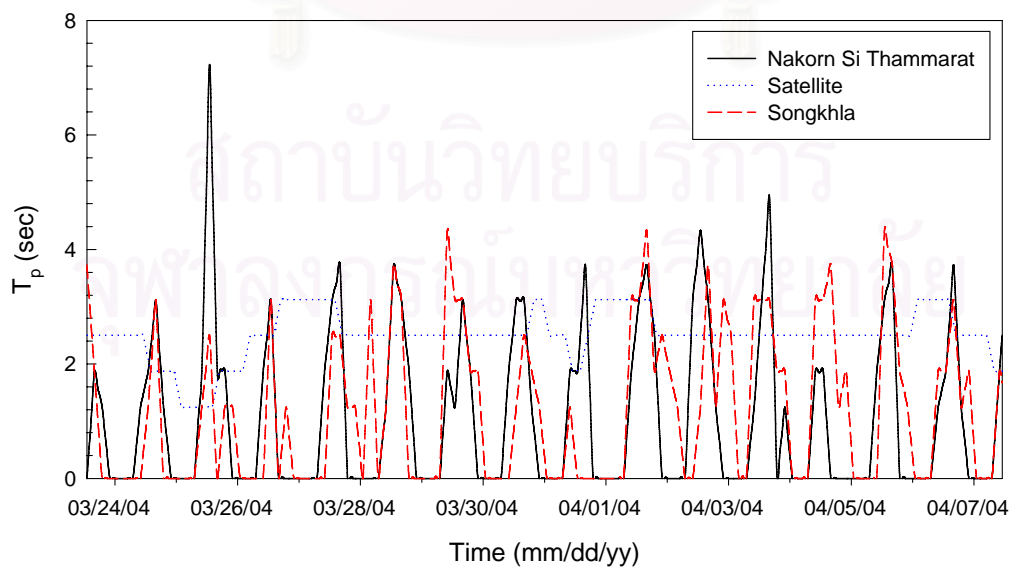
Figure 3.8 Wave periods from Nakorn Si Thammarat and SongKhla stations and from Satellite sensor (Sojisuporn et al., 2005)

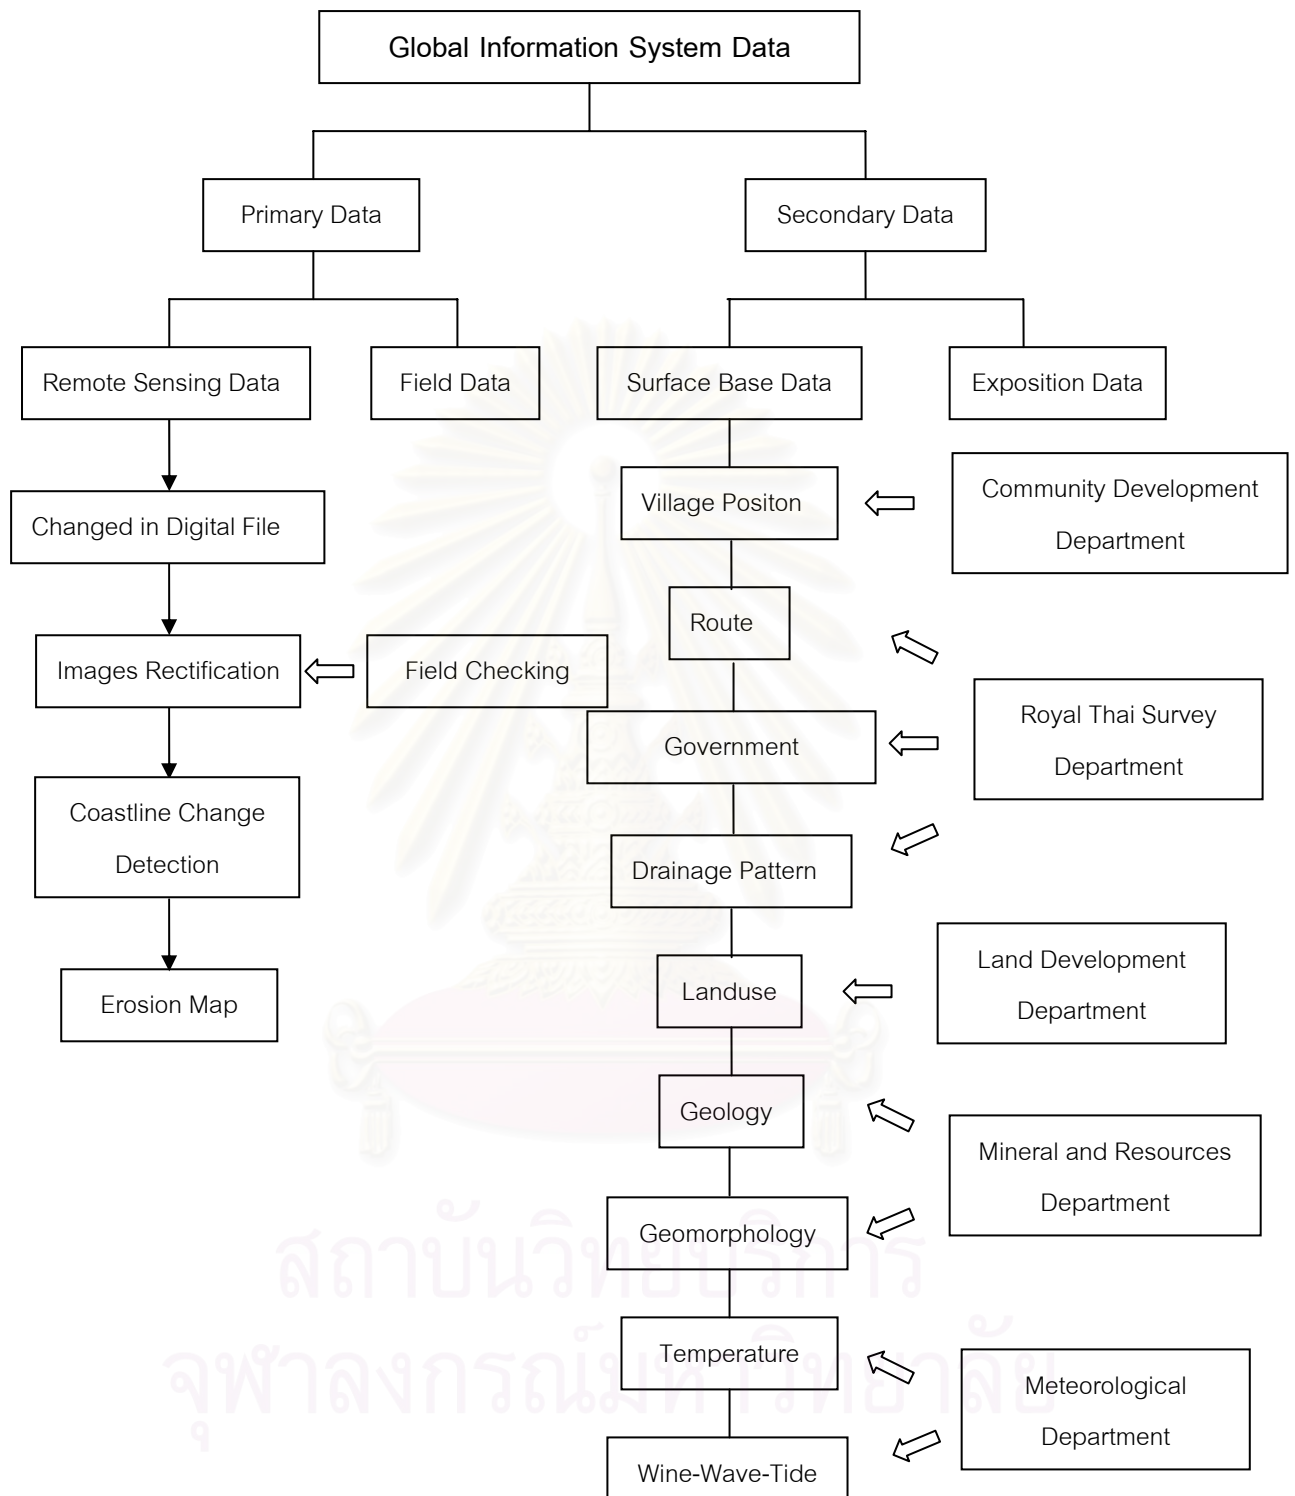
Figure 4.3 The steps taken in managing in the GIS system data.

Next, image reflection and detection of shoreline change, erosional and depositional area of the shoreline, were carried out twice. The processing step GIS data is shown in the Figure 4.3

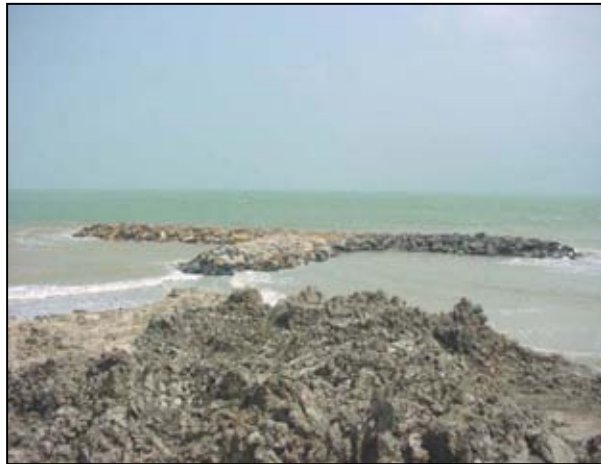
Figure 4.6 Groin T pattern at Ban Na Sarn, Na Saton sub-district, UTM 645698E/887542 N

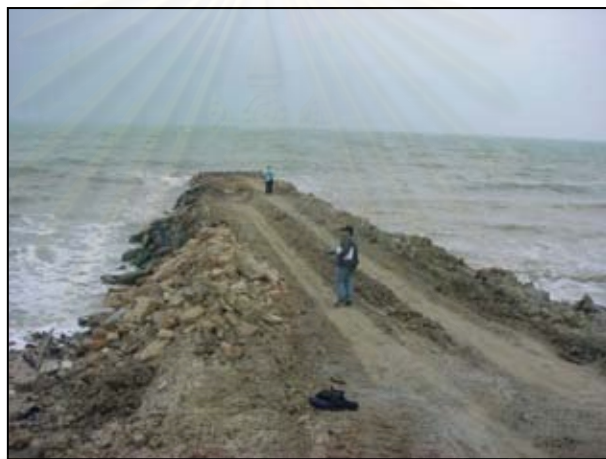
Figure 4.7 Groin I pattern at Ban Na Sarn, Na Saton sub-district, UTM 645635E/887795N

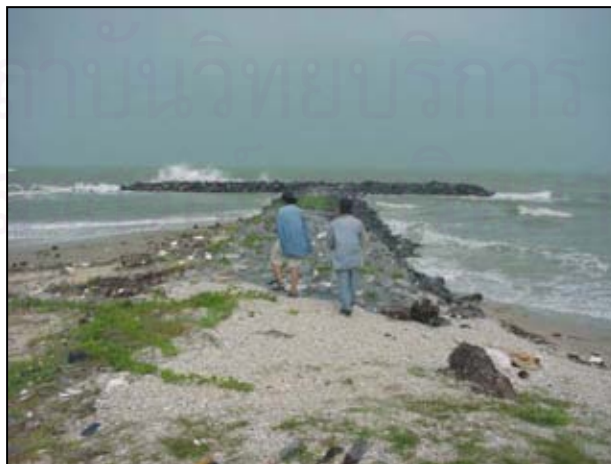
Figure 4.8 Groin T pattern at Ban Kho Phi, Kha Nap Nak sub-district, UTM 642216E/906809N

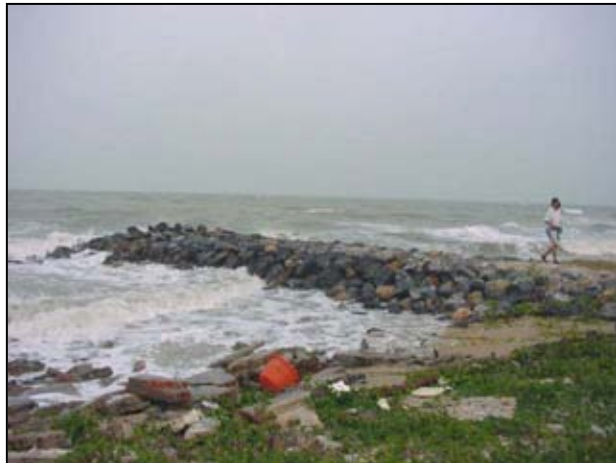
Figure 4.9 Groin I pattern at Ban Kho Phi, Kha Nap Nak sub-district, UTM 641910E/908326N

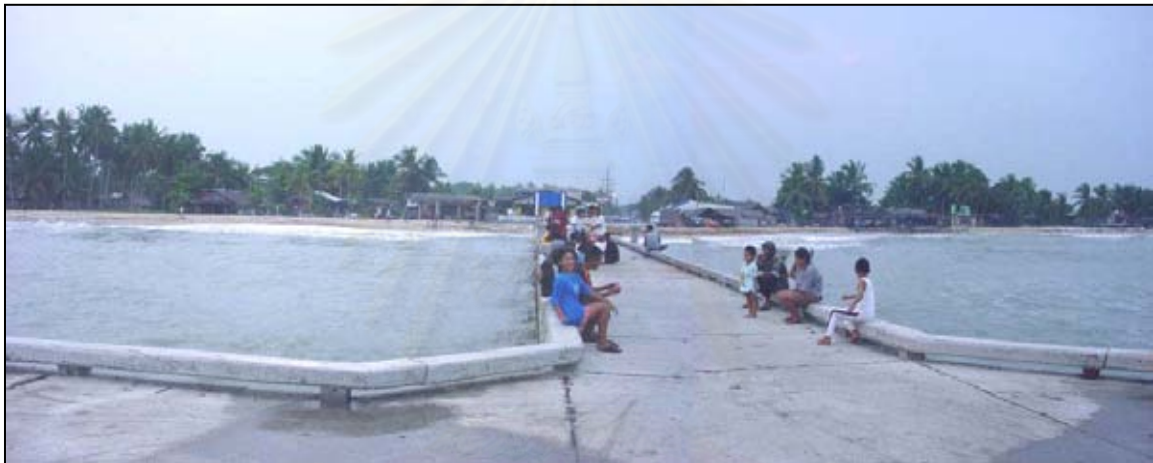
Figure 4.10 Pier at Ban Hua Tanon Chai Talay, East Pak Phanang sub-district, UTM 637090E/924939N

3. Pier is a platform extending from a shore over water and supported by piles or pillars. It is used for securing, protecting, and providing access to ships or boats and trapping sediments. Pier in this area is about 120 meters in length, 3 meters in width and is found in Ban Hua Tanon Chaitalay in East Pak Phanang sub-district and Ban Na

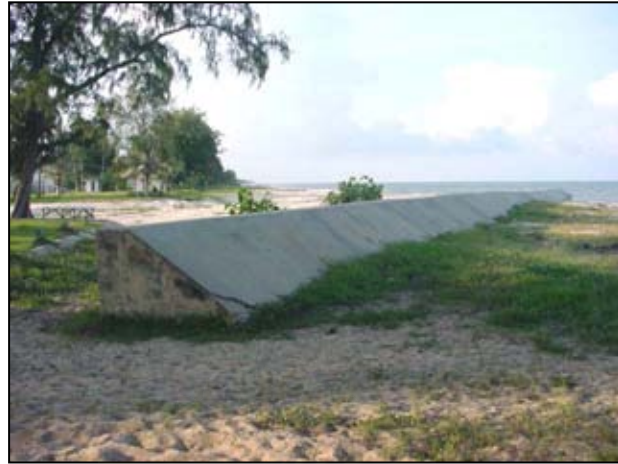
Figure 4.12 Jetty at Pak Ra Wa canal, Ban Na Thod, Na Saton sub-district, UTM  
647666E/876661N

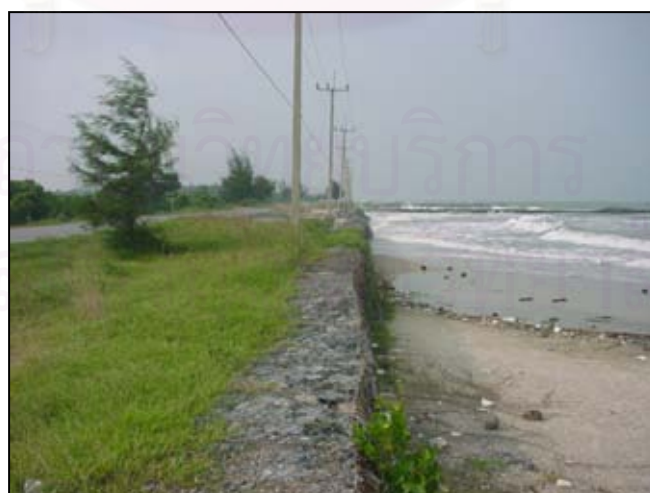
Figure 4.14 Rubble-mound Revetment at Ban Kho Fai, Ka Nap Nak sub-district, UTM  
642216E/906809N

4. Rubble-mound revetment (Figure 4.14) is a stone structure of about 1 meter wide and 1-1.2 meters high and about 450 meters in length. It is constructed in Ban Kho Fai, Kha Nab Nak sub-district, Pak Phanang District.

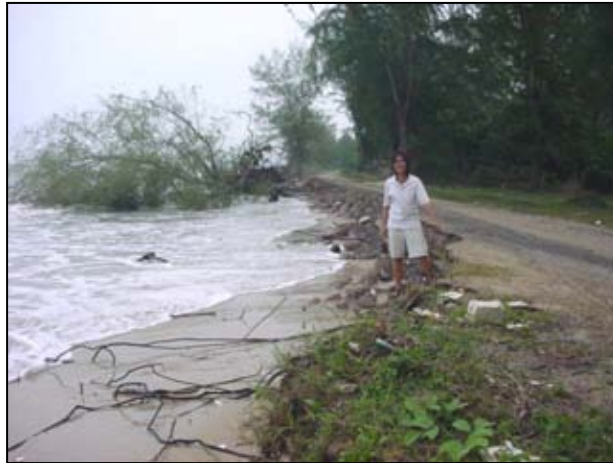
Figure 4.15 Eroded area at Laem Talum Puk UTM 627426 E/ 940764 N shows road in the area had eroded

The coast at Ban laem Talumpuk in Laem Talumpuk sub-district is 15.40 km in length (distance from the cape end on the outside sea to the area of East Pak Phanang sub-district). It was found that the coast at the end of Talumpuk cape was eroded up to the pine-trees line. Sandy beach was swept away 25-30 m from its previous location along the coastline and some pine trees died. In some locations, the coastline was eroded until the mangrove clay was visibly observed on the beach. Some parts from lateritic road to the viewpoint on Talumpuk cape were clearly eroded approximately 150 m in length (Figure 4.15).

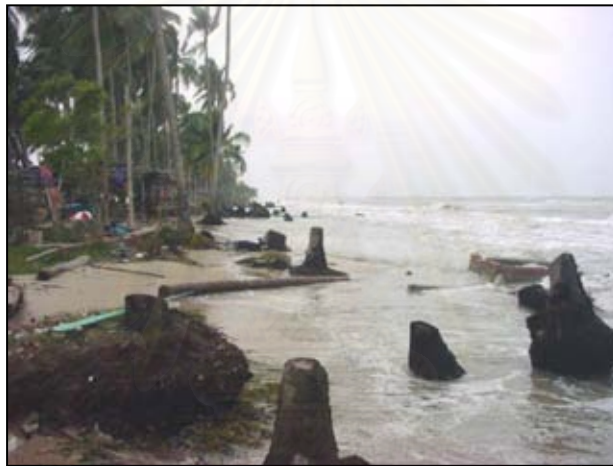
Figure 4.16 Eroded area at Ban Kong Kong, East, Pak Phanang sub-district UTM 636223E/ 927222 N shows coconut farm had destroyed

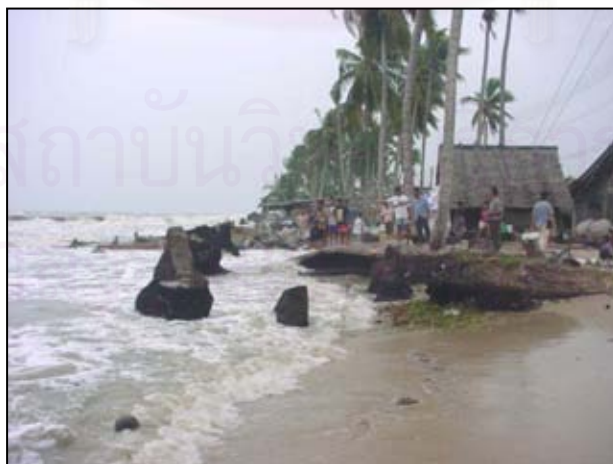
Figure 4.17 Eroded area at Ban Kong Kong, East, Pak Phanang sub-district UTM 636223E/927222N shows road, house and coconut tree had destroyed

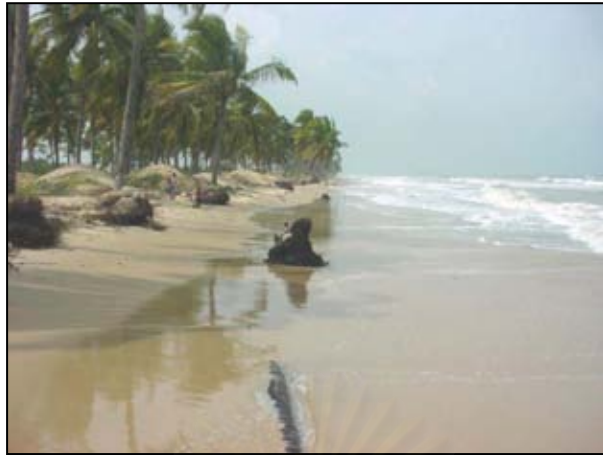
Figure 4.18 Eroded area at Ban Kho Tang, East, The Phaya sub-district UTM 640676E/913251 N show the heavy mineral in the beach sand

The coast at Ban Kho Tang was eroded by about 32 m. in length. Two lines of coconut trees had died since 2002. There are shrimp farms in the area next to the beach (Figure 4.18).

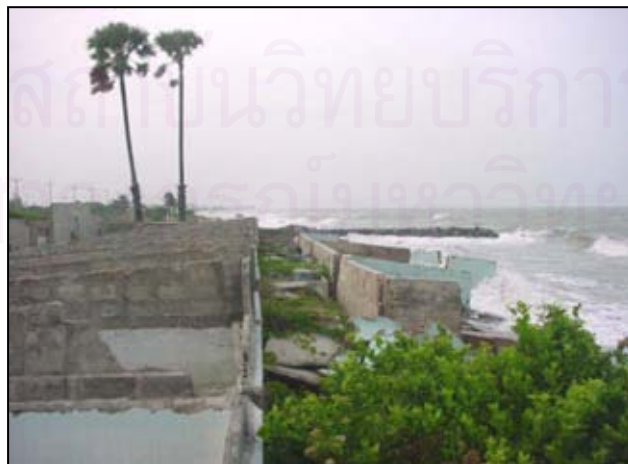
Figure 4.20 Eroded area at Ban Kho Fai, Kha Nab Nak sub-district UTM 641910E/908296N shows the shrimp farm had destroyed

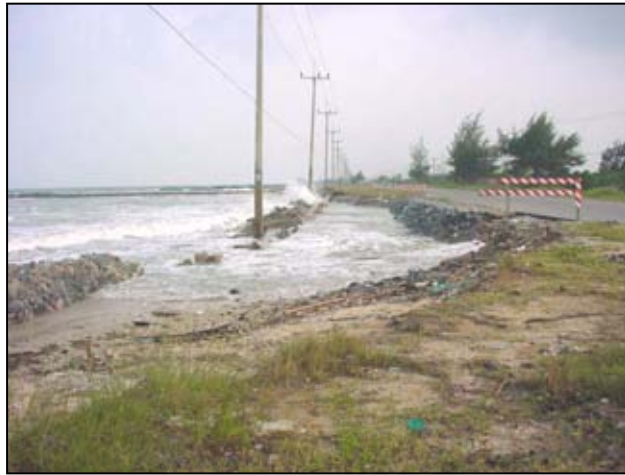
Figure 4.21 Pak Phanang-Song Khra road Km. 19-20 in Ban Kho Fai, Kha Nab Nak sub-district UTM 641826 E/ 908579 N shows the violence of wave that insist to the road

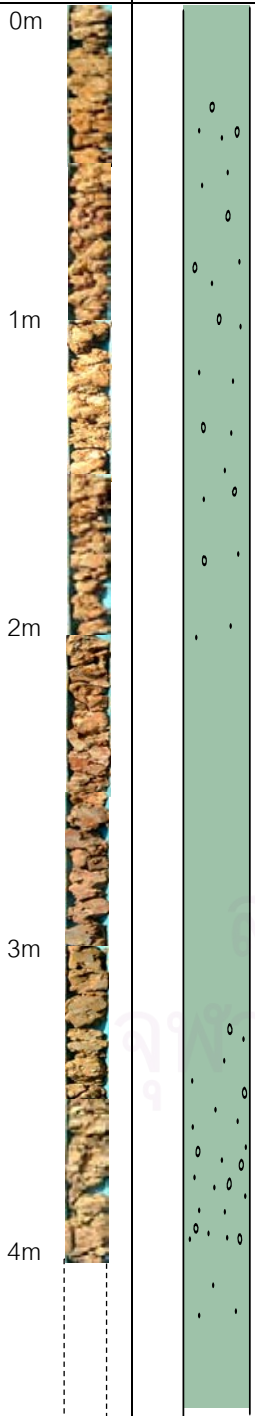
Geological Drill Chart				
Hole No: A2		Depth (meters): 4.5		
Location:				
Date of Drilling: 15/11/2004				
Map Sheet:		Grid Reference: 607664E 0879986N		
Sample	Type	Depth (m)	Description	Remark
0m

0.0 - 0.1	Clay: light brown with gray humid and root.	
		0.1 - 0.35	Clay: light gray yellowish brown, and Fe oxide.	
		0.35 - 0.55	Clay: yellowish brown orange and light gray with Fe oxide.	
1m		0.55 - 1.0	Clay: yellowish brown orange and light gray with Fe oxide interbedded coarse to medium sand sub angular to sub round.	
		1.0 - 1.3	Clay: yellowish brown orange with Fe oxide, coarse to fine sand and peat.	
		1.3 - 3.0	Clay: reddish brown and light gray, muddy sand and Fe oxide.	
		3.0 - 3.5	Clay: grayish red.	
3m		3.5 - 4.5	Clay: yellowish gray interbedded coarse to fine sand, sub round.	
4m
