CHAPTER IV

RESULTS AND ANALYSIS

4.1 Pranburi truncated barrier area

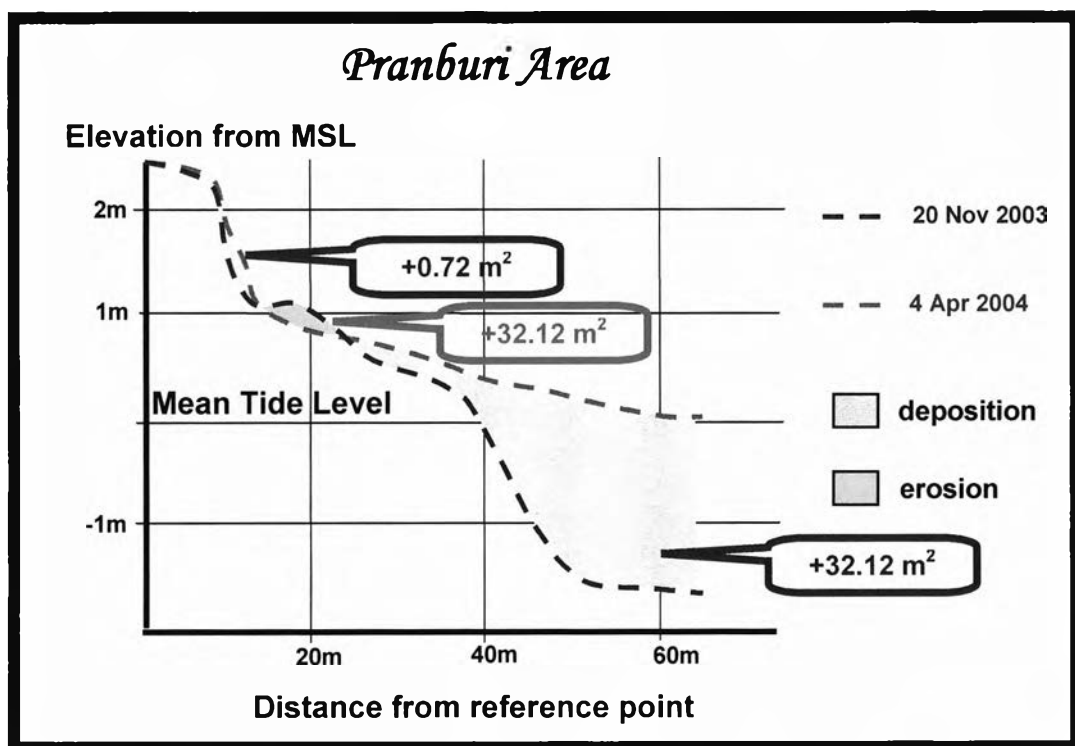
Figure 4.4 Plot of beach profiles from Pranburi area in between November 2003 to April 2004 showing deposition more than erosion during winter and summer season.

In analyzing shoreface changes through time, for instance, between the initial survey in November 2003 and the survey of April 2004, it seems likely that the toe of shoreface accreted more than eroded (Figure 4.4). However, the April 2004 to November 2004, the eroded of shoreface was markedly over steepened (Figure 4.5). The resulted since November 2003 to November 2004, further accretion of the shoreface was occurred, together with some retreats of shoreface (Figure 4.6). Therefore, it appears to be a trend for ongoing net shoreface accretion in this area.

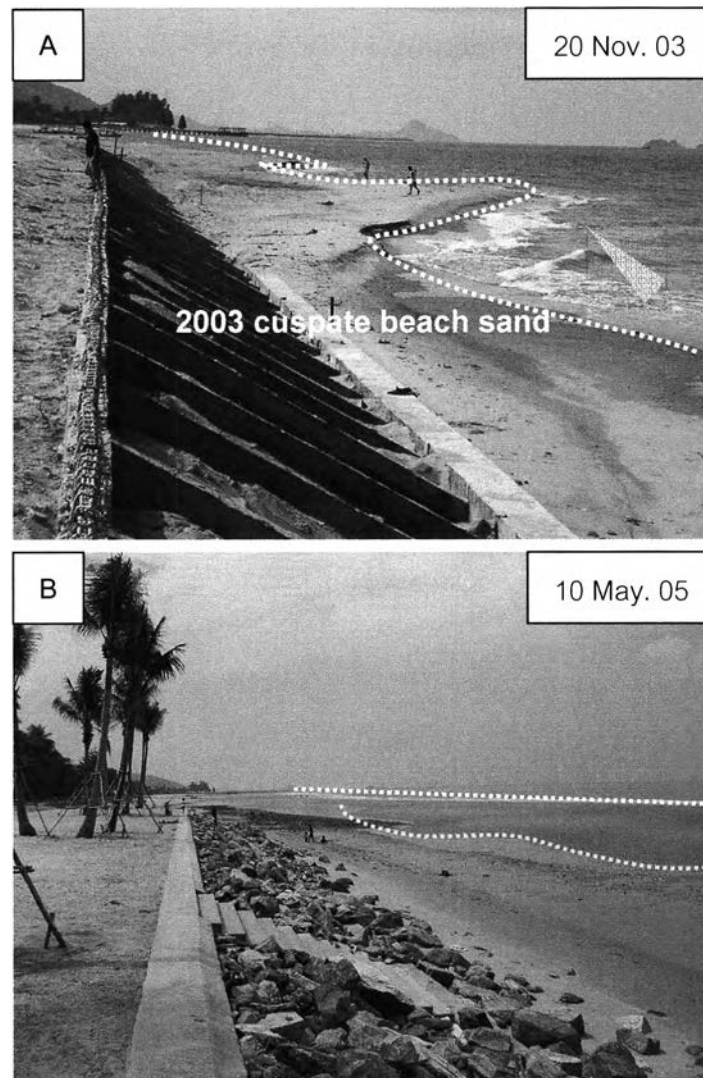
Figure 4.13 Photos showing the pattern of sediment accretion in the Pranburi area (UTM grid reference 609250N, 1367850N). Picture A is the pattern of cusped beach sand (white dot in picture A taken on 20 Nov 03 in low tide period). Sediments accrete along the beach barrier by the north longshore current. Picture B shows the developing of emerged sand bar, and developed into back barrier lagoon (picture was taken on 10 May 05). Pattern of sediment transportation and beach geomorphology, indicated that the deposition is more than erosion in this area. The erosion may be occurred in high monsoon season only.

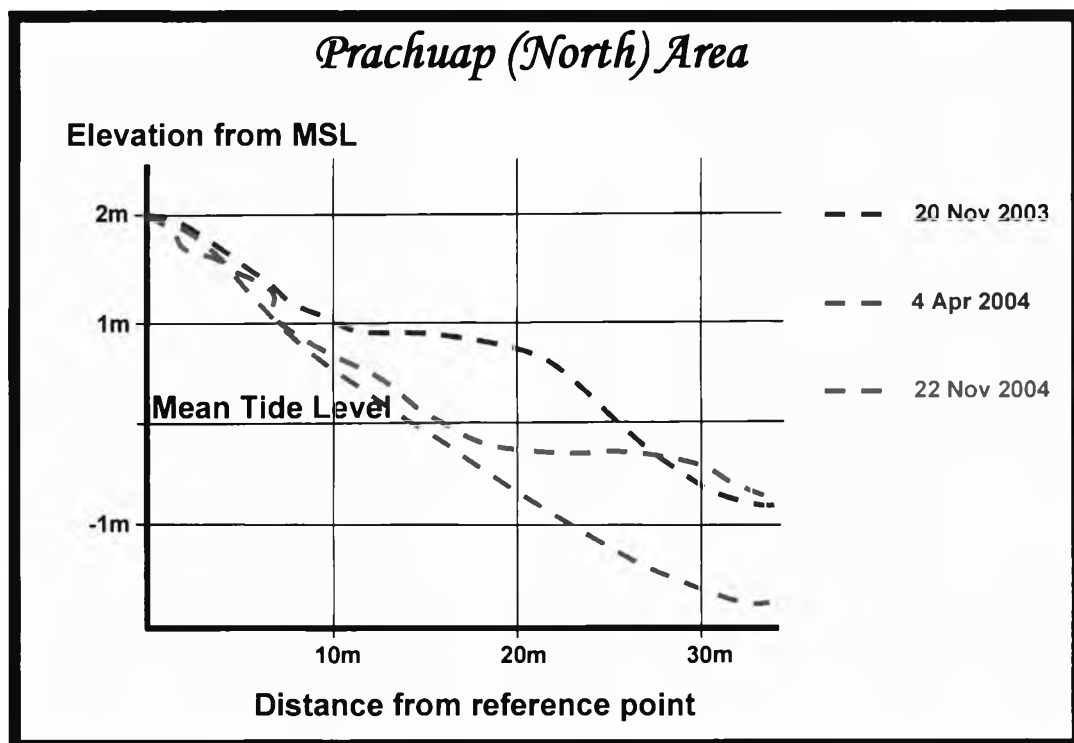
Figure 4.18 Beach profiles from Prachuap Khiri Khan (north) area.

This site has shown a clear and consistent trend for shoreface erosion over one year period since monitoring commenced (Figure 4.18). For example, in November 2003 to April 2004 the shoreface lay seaward (Figure 4.19). April 2004 to November 2004 survey, the accretion occurred in the area but not too much (Figure 4.20). As a result in one year period between the surveys of November 2003 until November 2004, the net of erosion dominant in this area (Figure 4.21).

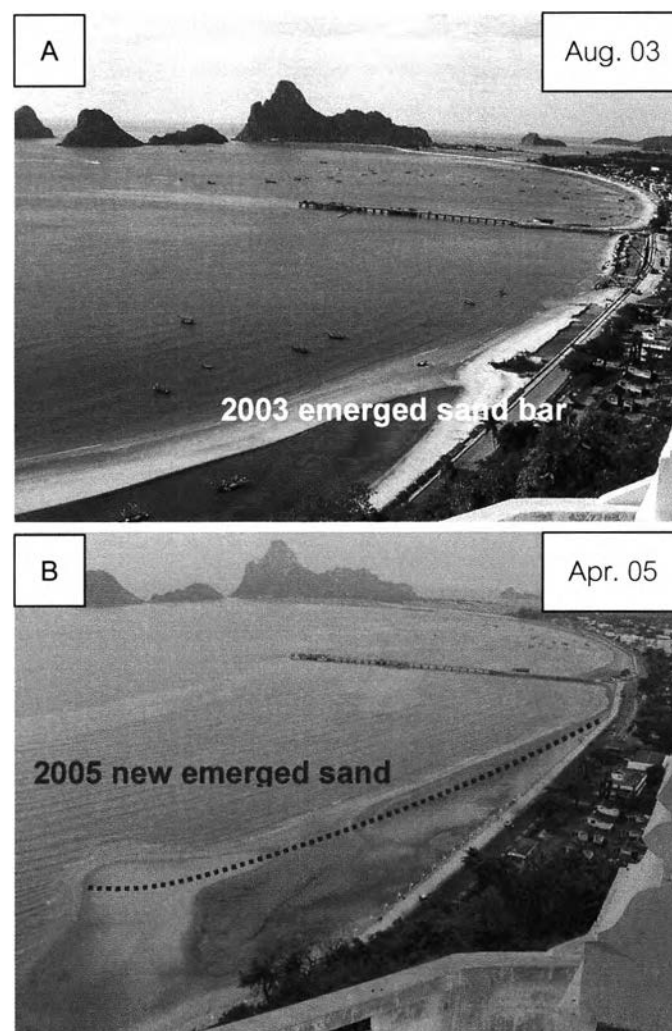
Figure 4.26 The photographs showing sediment movement in the area during low tide period. Both pictures were taken to the south of Prachuap Khiri Khan Bay. From picture A (taken on Aug 03), the sediments were moved by longshore current to the north (brown arrow), provided new sand bar.
