CHAPTER 5

EVIDENCES AND PARAMETERS AFFECTING DEBRIS FLOW-FLOOD PROCESSES IN NAM KO YAI SUB-CATCHMENT

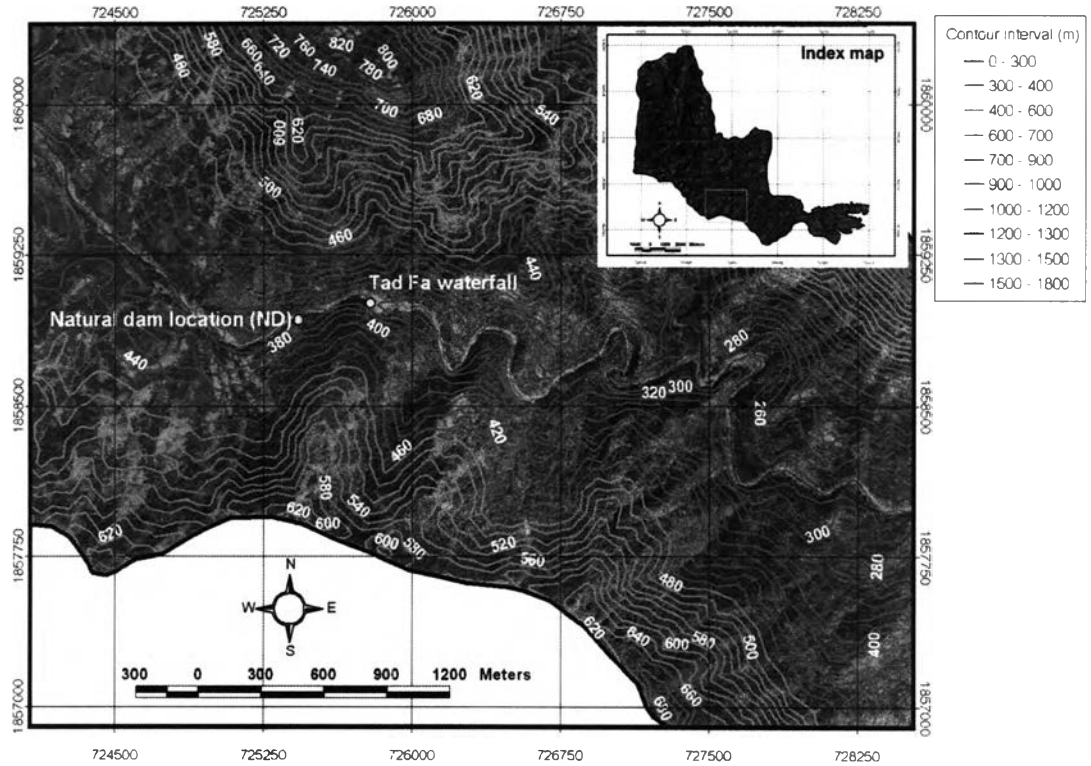
From the field investigations and orthophotograph interpretation, there was a specific location along the course of Nam Ko Yai stream in the central part of the study area that was looked suspiciously. Here the stream issues from a flat open land behind (upstream) to a very narrow V-shape channel with a sudden change of elevation at Tad Fa waterfall (Figure 5-2). It could be hypothesized that this specific location is suitable for an accumulation of sediments composed of plant debris, soils, and rock boulders to form a natural landslide dam of at least 10 m high (Figures 5-3, 5-4 and 5-5). A field check revealed fallen trees and vegetation traces. This probably indicated that the temporary natural dam was broken, sending the debris and water to flood further downstream, eroding the channel along the way, and finally dropping its loads on the alluvial fan at the canyon mouth.

Figure 5-2 Orthophotograph (1:25,000 scale, 9th January 2002 after the 8/11 event) illustrating the specific configuration of Nam Ko Yai stream in the central part of the study area.

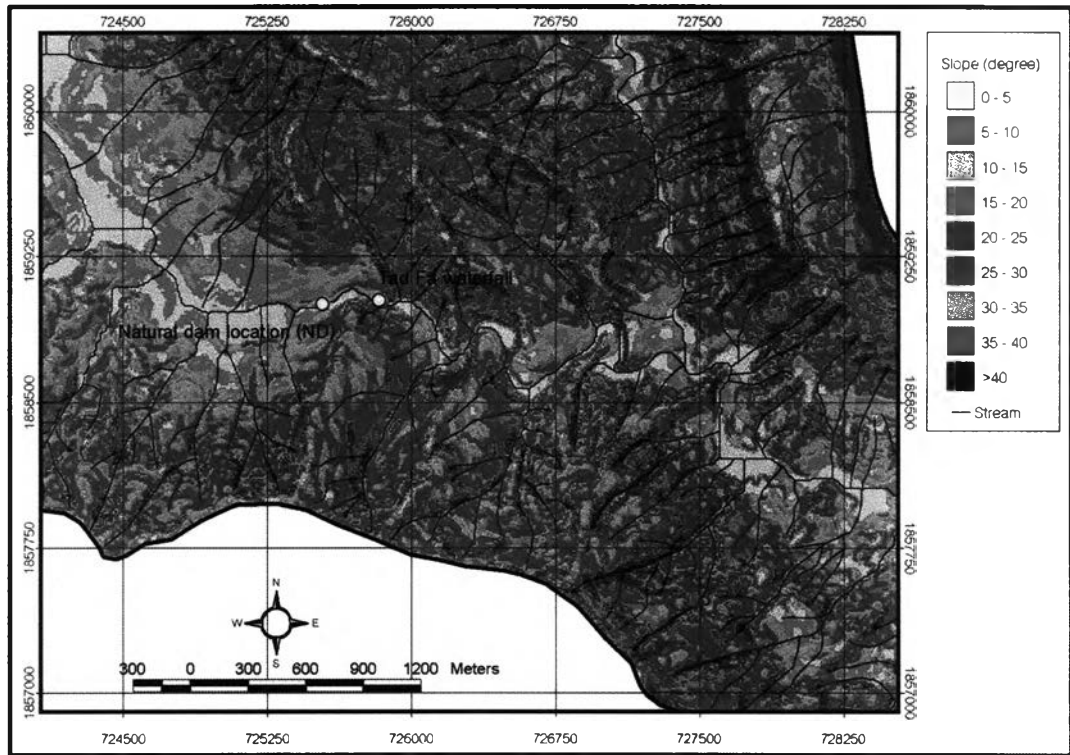
Figure 5-6 Slope map of the upstream and downstream area above and below the suspected natural landslide dam location (ND) in Nam Ko Yai stream channel.

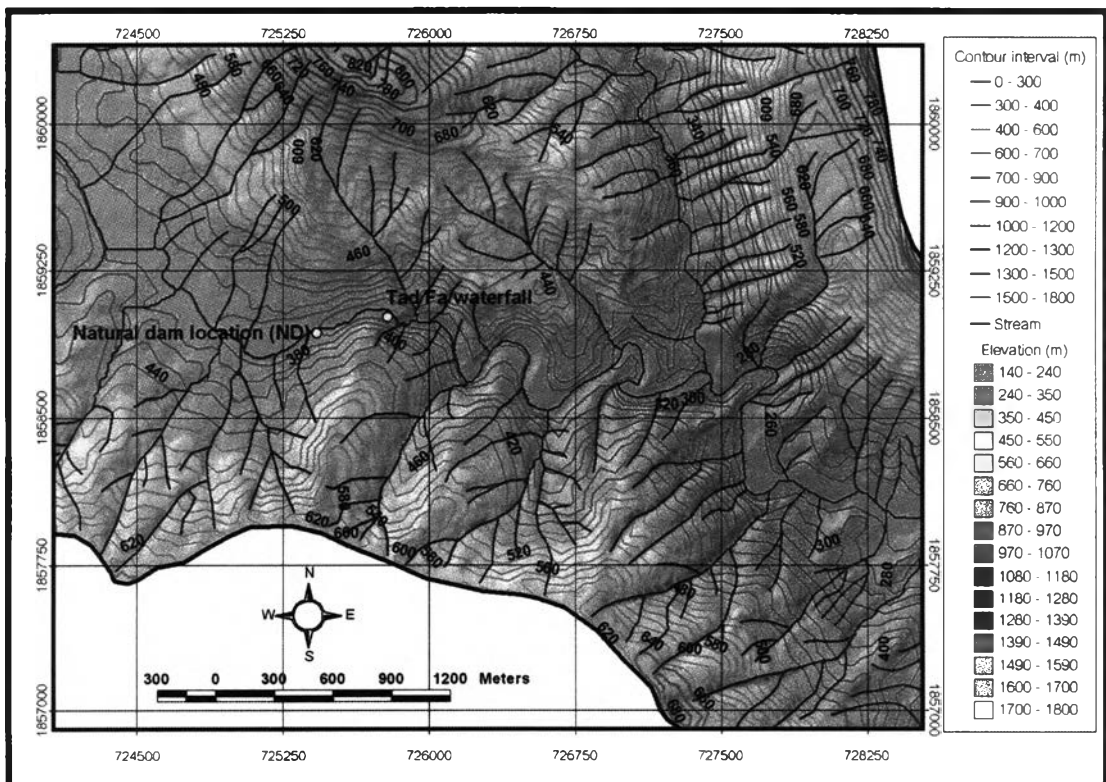
Figure 5-7 Elevation map of the upstream and downstream area above and below the suspected natural landslide dam location (ND) in Nam Ko Yai stream channel.

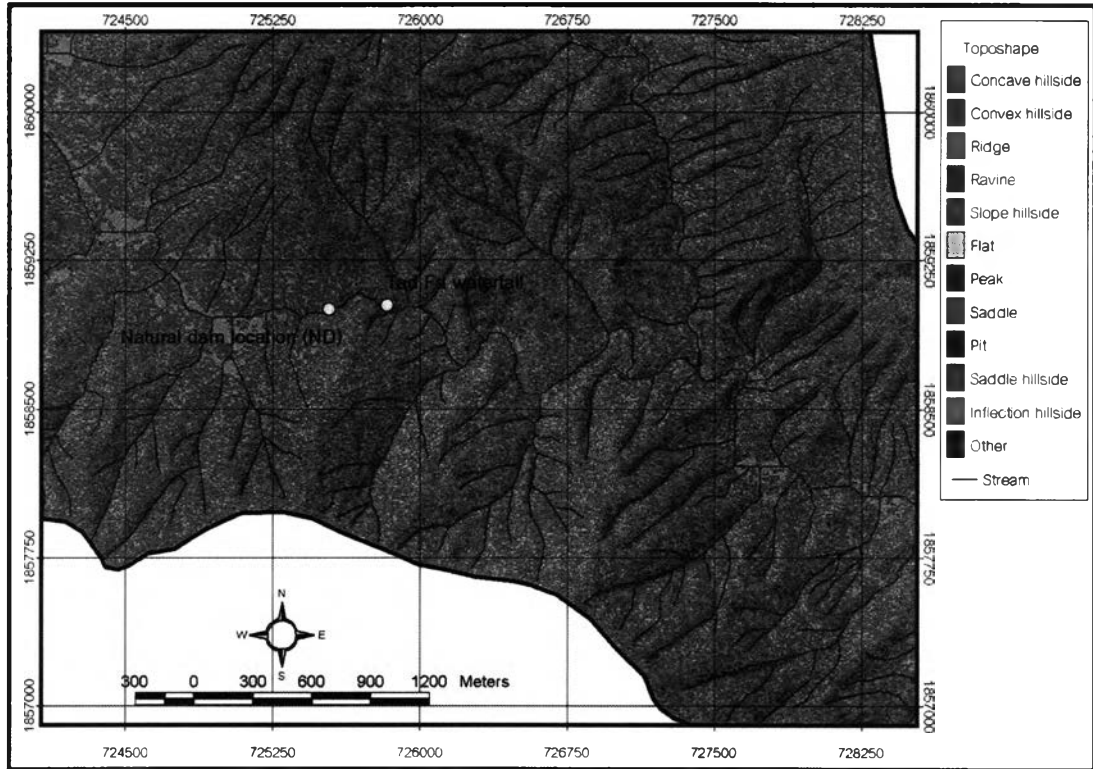
Figure 5-8 Topographic shape of upstream and downstream area away from the suspected natural landslide dam location (ND) in Nam Ko Yai stream channel.

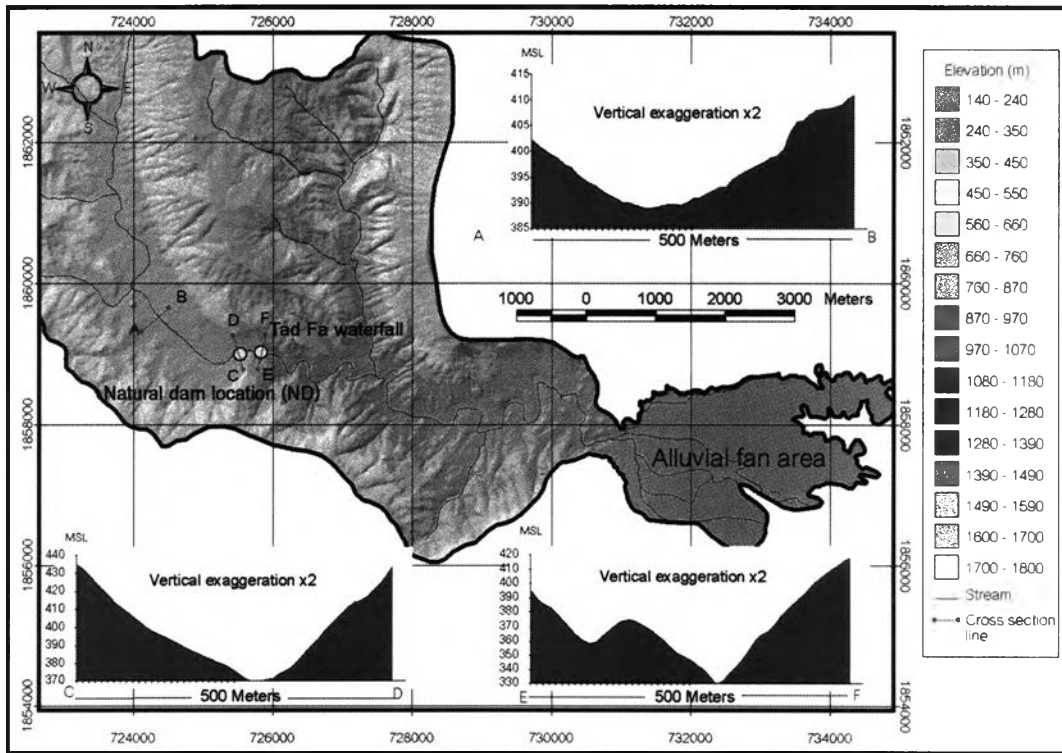
From the channel configuration of Nam Ko Yai stream up- and downstream from the suspected natural dam location (Figure 5-10), the 8/11 flow-flood should follow the pre-existing drainage way. Downstream from the dam, the stream has a V-shape or nearly rectangular cross-section as shown in the cross-section lines of G-H and I-J (Figure 5-11). This narrow V-shape and strong sinuosity channel configuration of Nam Ko Yai stream here also indicates as one of the most influent parameters that allow increasing energy for the torrent stream caused from the broken natural dam to be formed as a severe flow-flood. This destructive form of mass movement strongly eroded and transported sediments (plant debris, soils and rock boulders) along the downstream

Figure 5-10 Three cross-sections (line A-B, C-D and E-F) across Nam Ko Yai stream channel and its valley at the upstream area, the suspected natural landslide dam location, and Tad Fa waterfall, respectively.

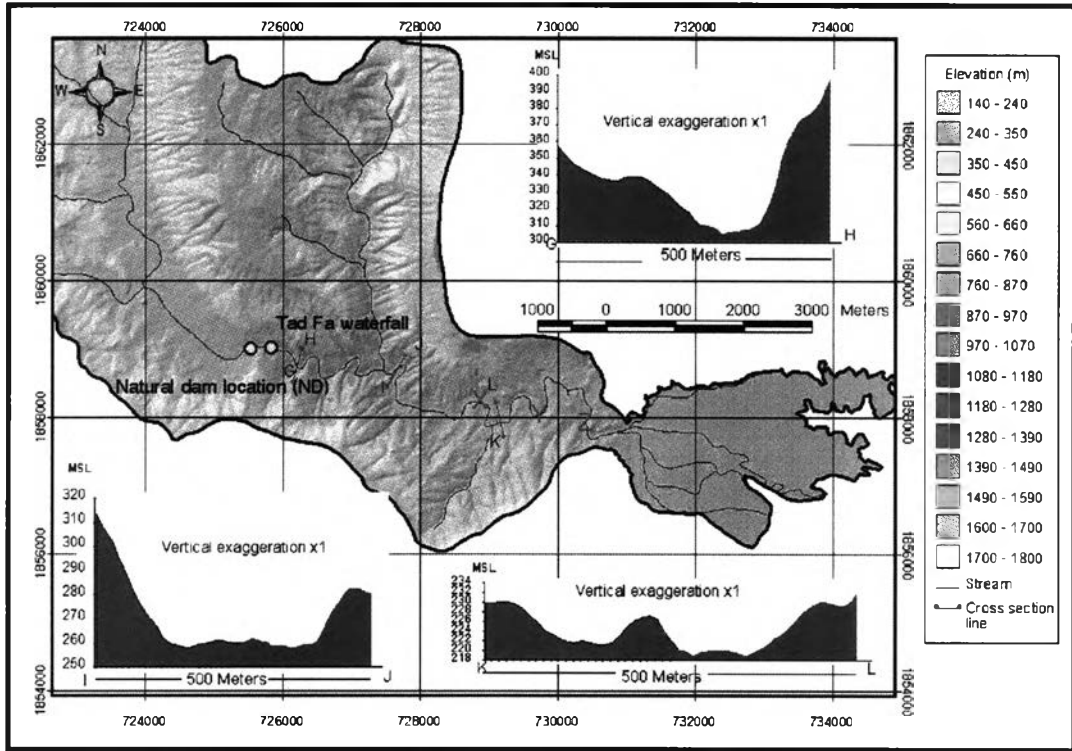
channel, especially in the outer-curvature bank of steep slope and incorporated them into the flow-flood. The evidences of 8/11 event could be observed in the field visit where Nam Ko Yai stream had a steep V-shape cross-section downstream. The traces of the erosional feature in the outer curving-bank were common. Some huge logs or intertwined bamboo clumps were left in the channel or up high on the tree splices as they were not all transported by the torrent stream flows (Figure 5-12).

Figure 5-11 Three cross-sections (line G-H, I-J and K-L) across Nam Ko Yai stream channel and its valley at the downstream areas from the suspected natural landslide dam location (ND).
