APPENDIX B

RESULTS OF EXPERT SYSTEM

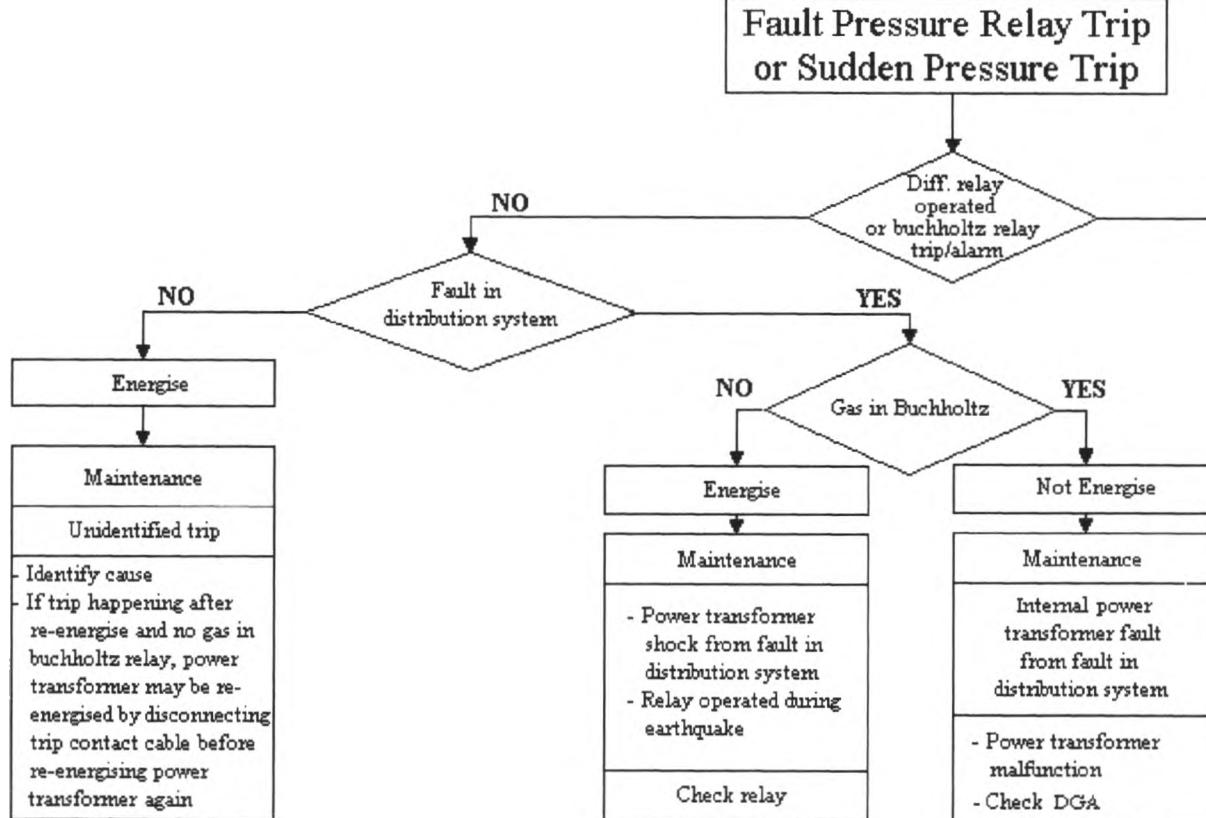
Fault Pressure Relay Trip or Sudden Pressure Trip

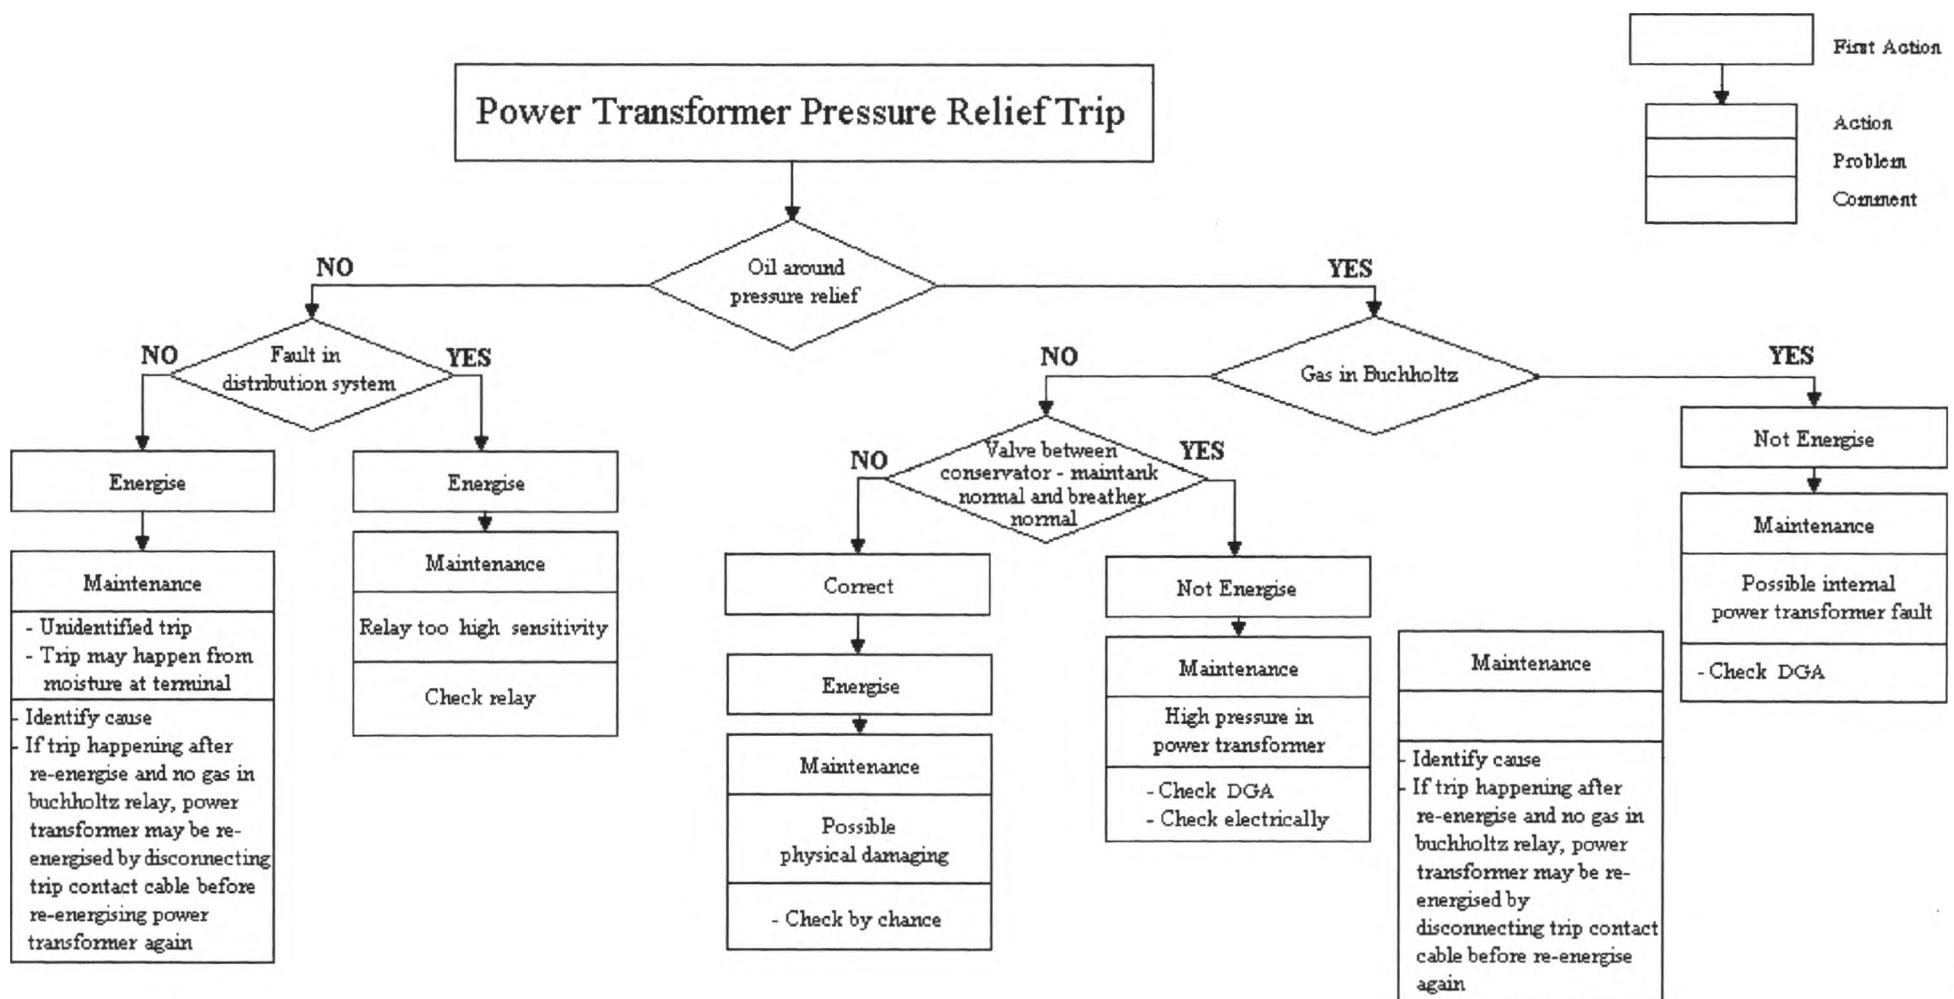
Power Transformer Pressure Relief Trip

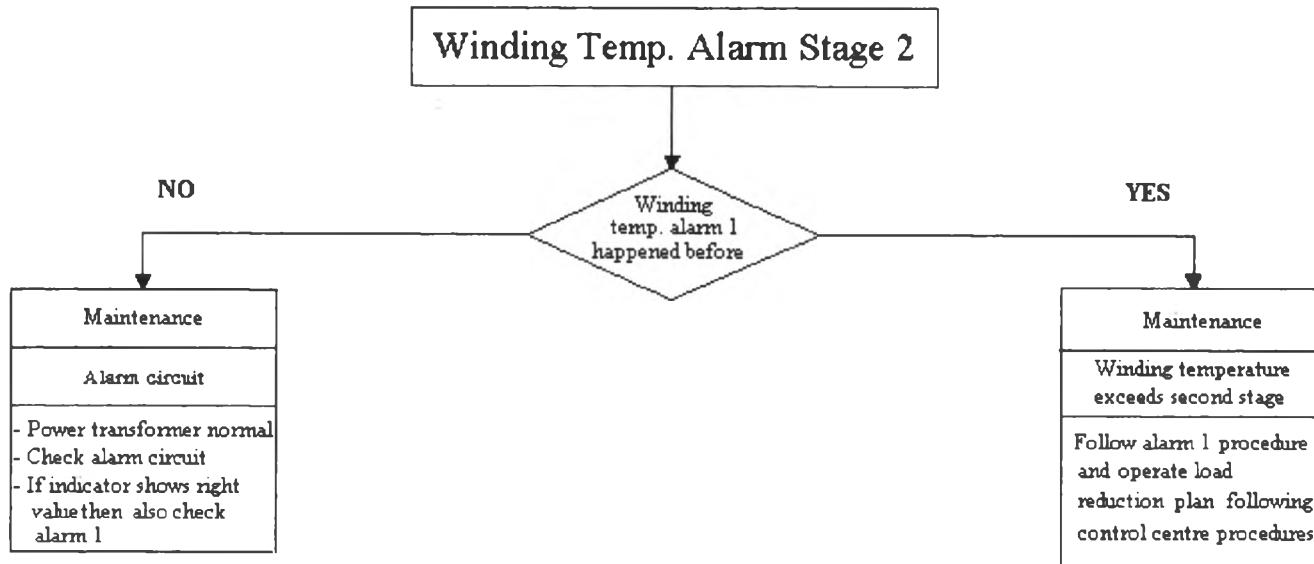
Winding Temperature Alarm Stage 2

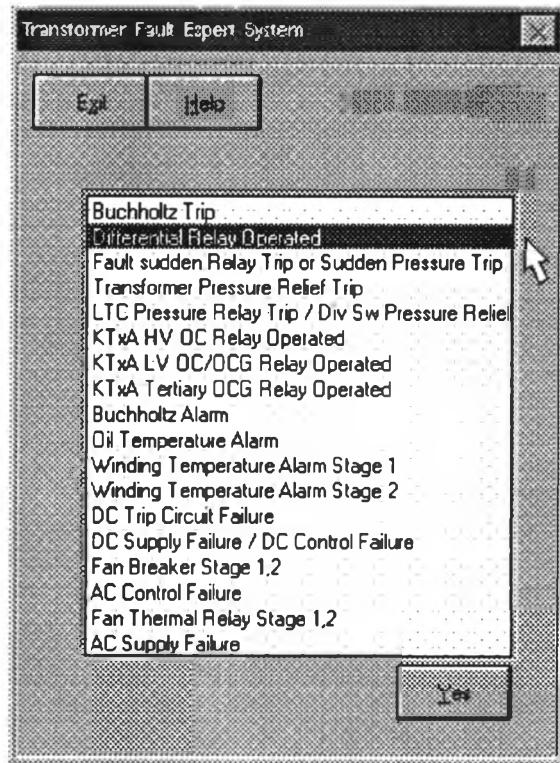
When the differential relay operated, the related case will be selected from the list on main screen.

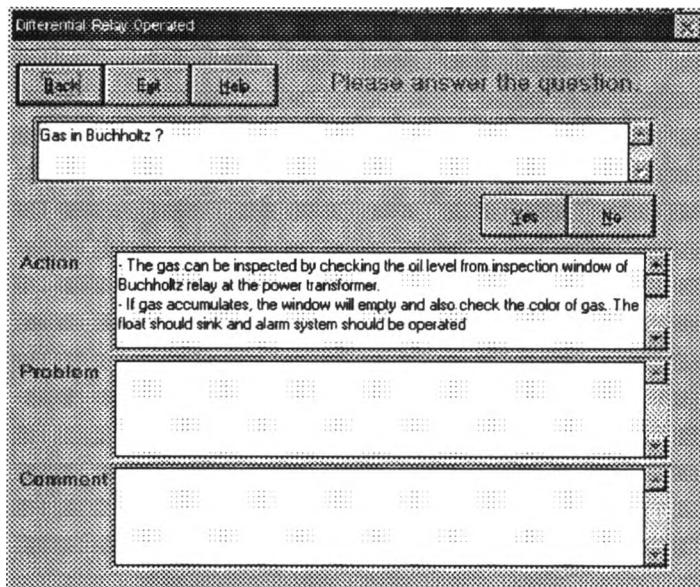
After selecting differential relay operated, the expert system needs to know about gas in inspection window of Buchholz relay.

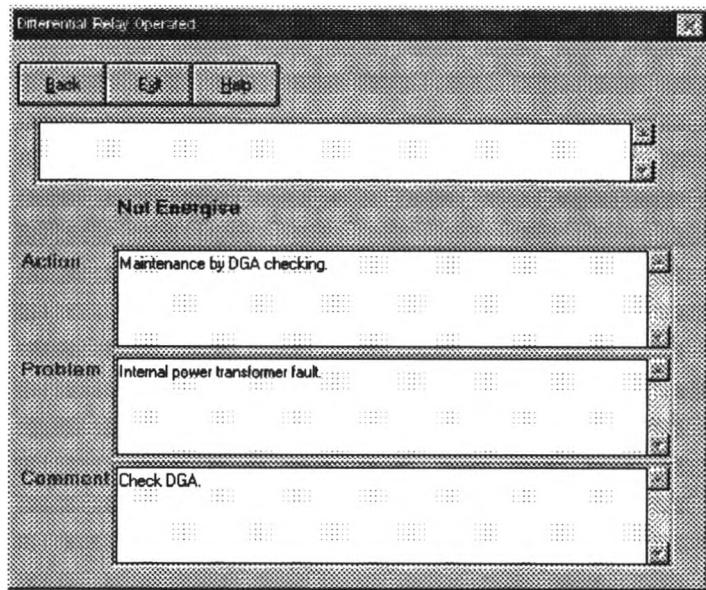
If there is any gas accumulated in Buchholtz relay, the recommendation screen will appear respectively after answering by clicking 'yes' button.

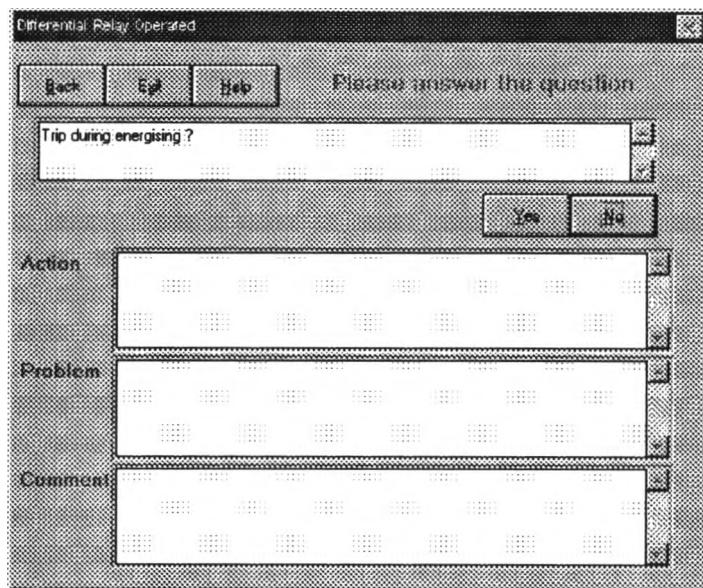
But if there is no gas accumulated in Buchholtz relay, the next question about trip during power transformer energising from the expert system will be launched.

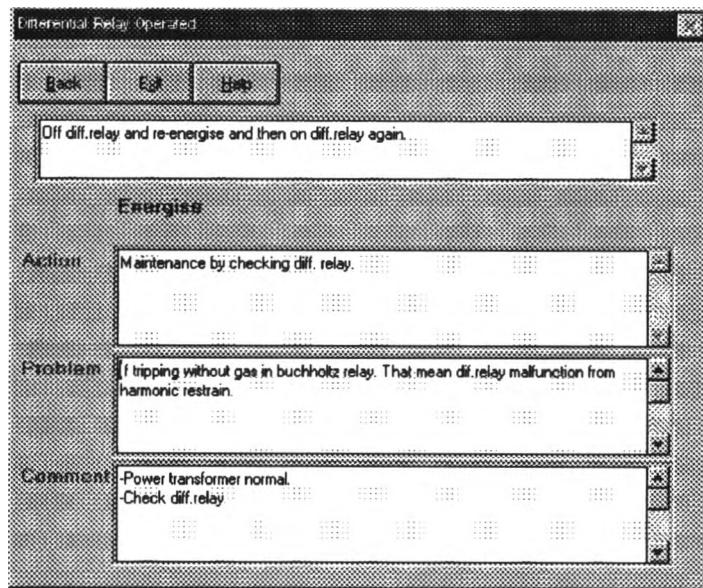
If trip during energising, the summary screen will appear respectively after answering by clicking 'yes' button.

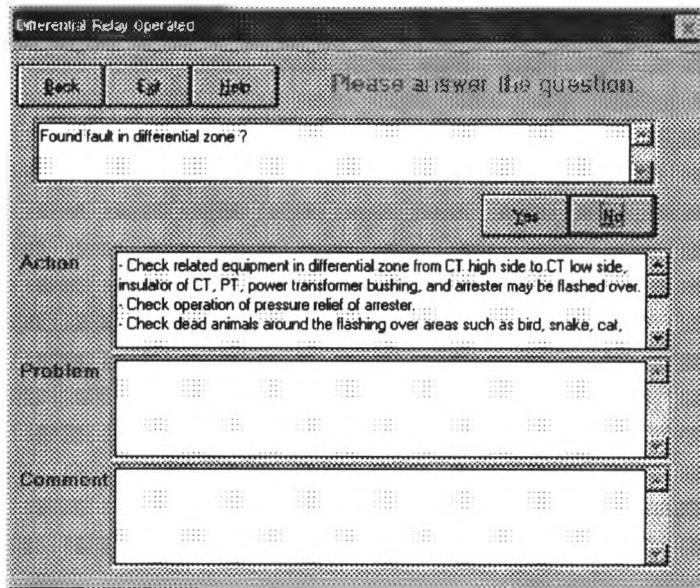
But if there is no trip during energising, the next question from expert system will be appeared for additional information.

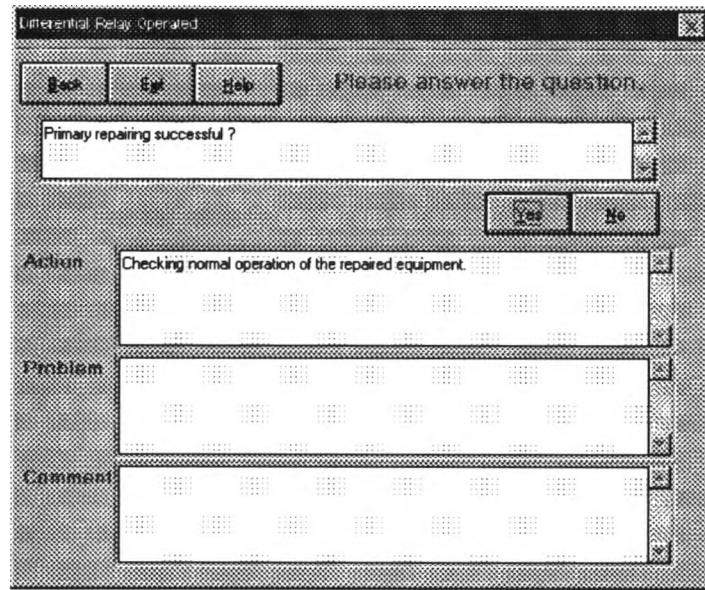
If there was any fault happened in differential zone before differential relay operated, the next question from the expert system will be shown for gathering additional information about the repairing of damaged equipment from fault.

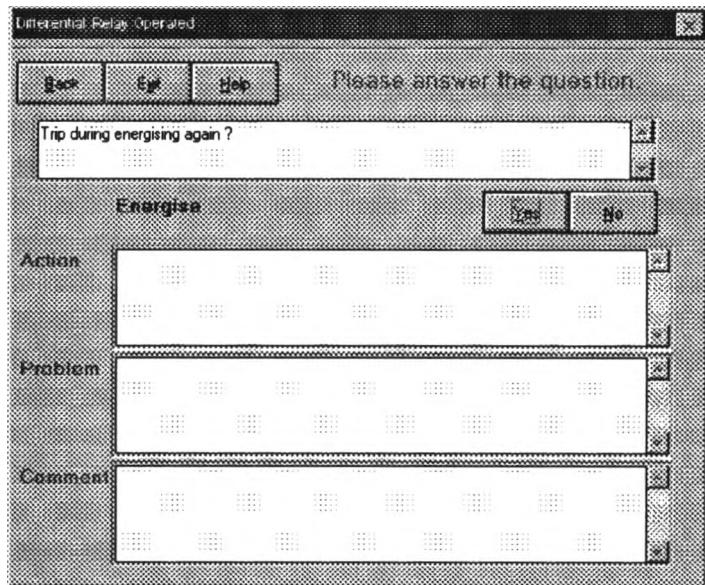
If primary repairing on damaged equipment was successful, the system will be recommended from the expert system to be re-energised and followed the result of energising.

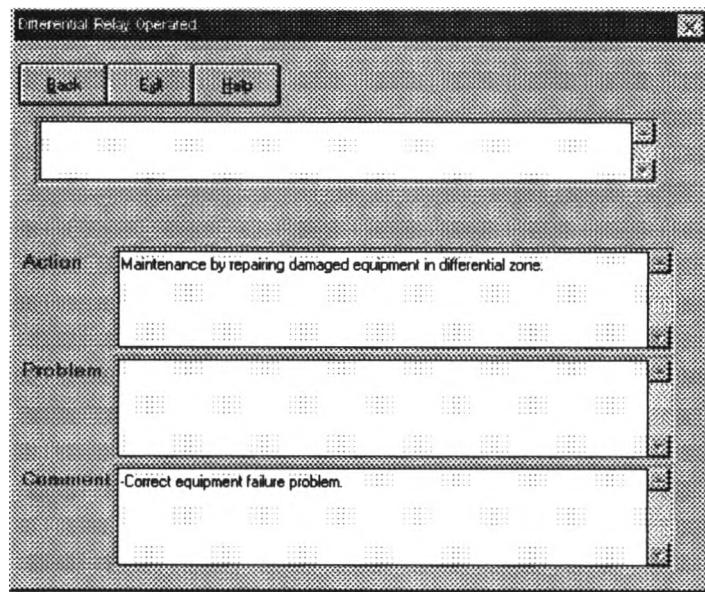
If power transformer condition is normal after re-energising, the equipment damaged from fault in differential zone is needed to be repaired permanently.

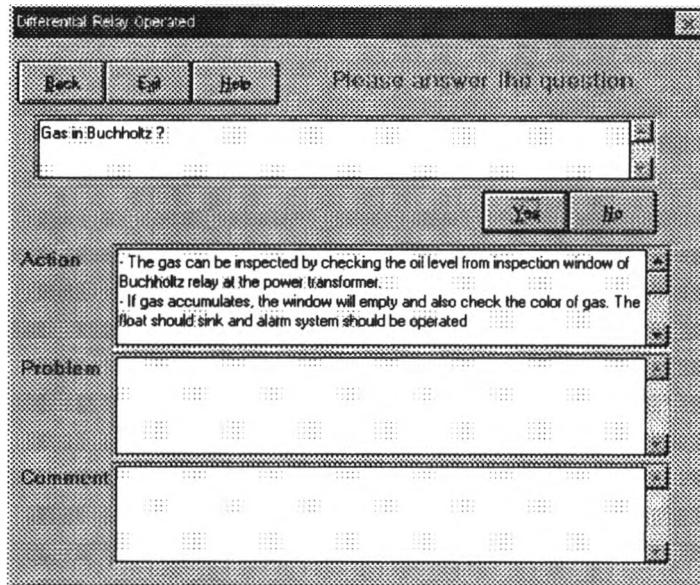
But if the power transformer was still tripped again, the gas in Buchholtz relay is needed to be checked.

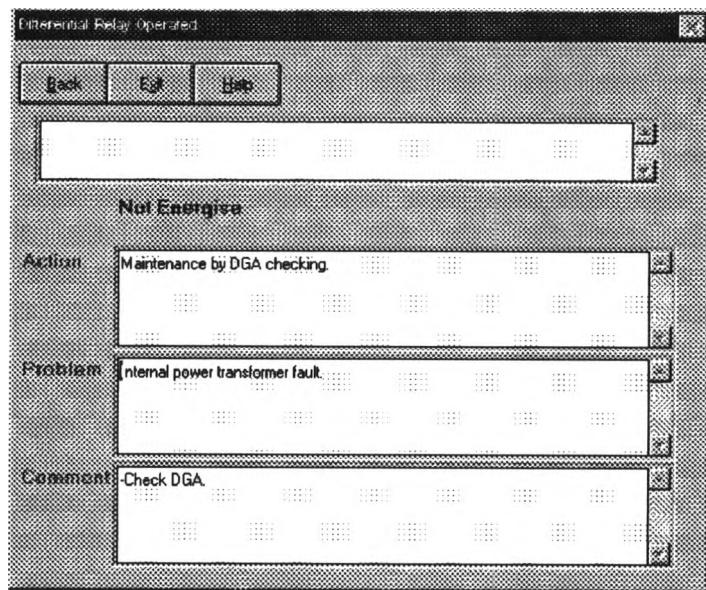
If there is any gas accumulated in Buchholtz relay, the summary screen will appear respectively after answering by clicking 'yes' button.

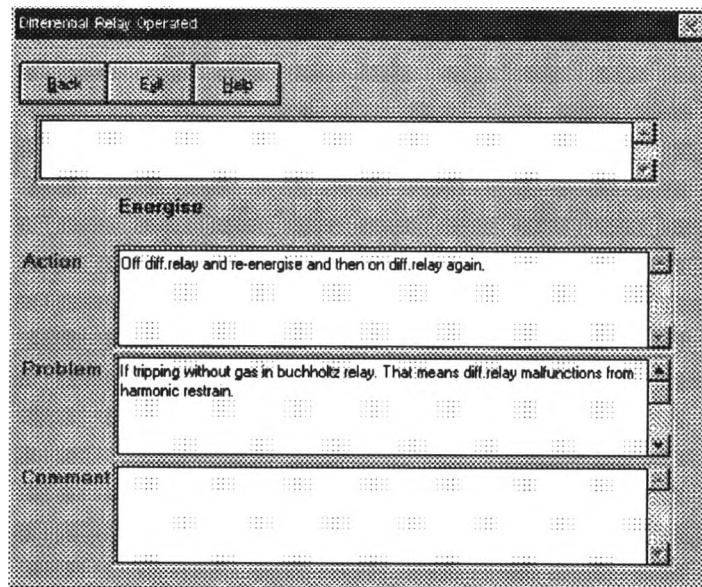
But if there is no gas accumulated in Buchholtz relay, the summary screen will appear respectively after answering by clicking 'no' button.

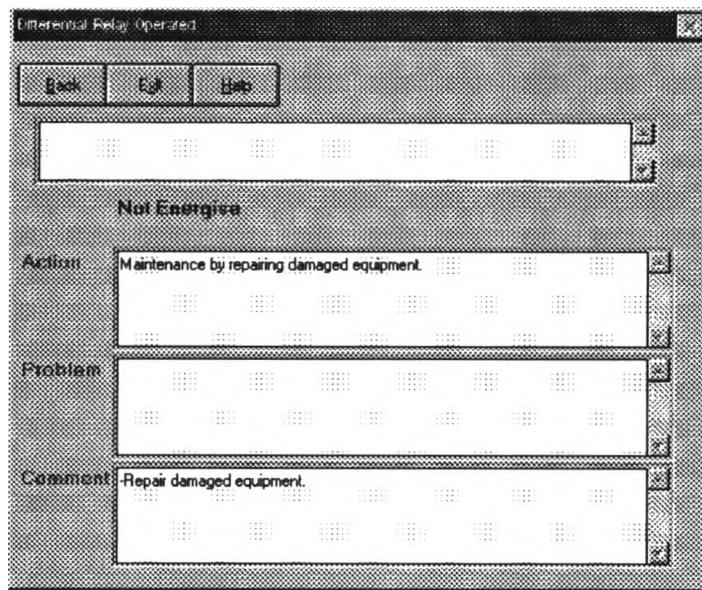
But if primary repairing on damaged equipment was still unfinished, the power transformer needed to be disconnected manually from the system until the primary repairing will be successful.

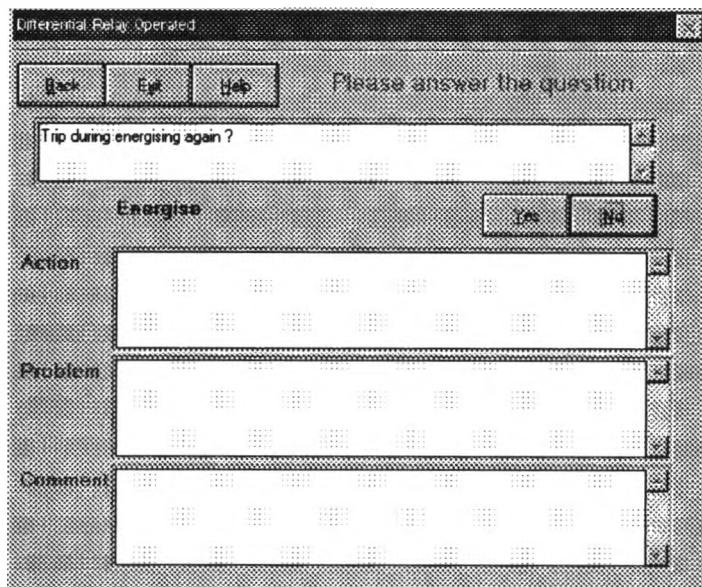
After there is no fault found in differential zone, the power transformer will be recommended from the expert system to be re-energised and followed the result of energising.

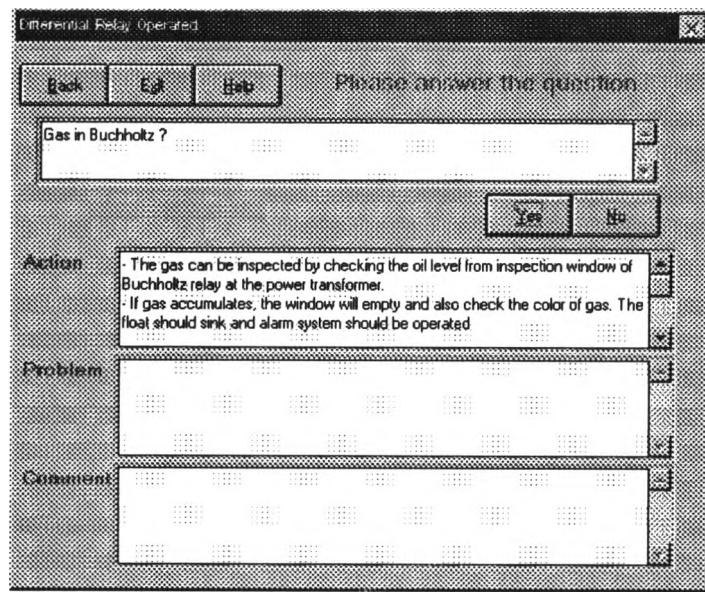
If the power transformer was still tripped again, the gas in Buchholtz relay is needed to be checked.

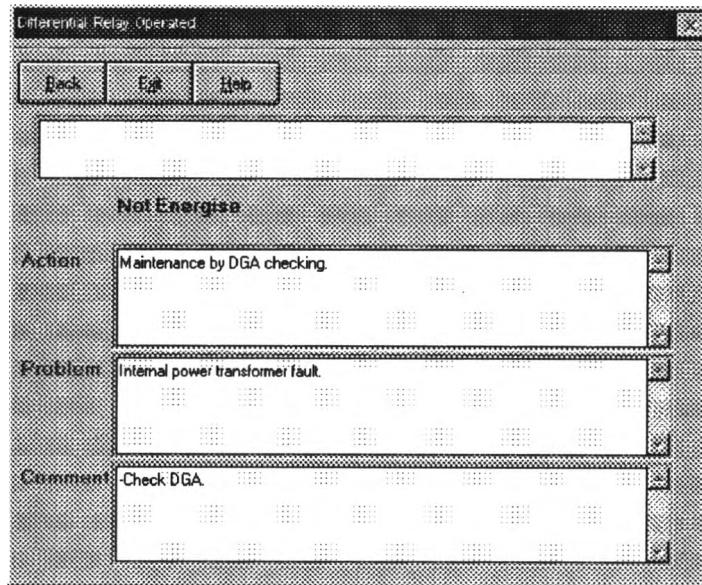
If there is any gas accumulated in Buchholtz relay, the summary screen will appear respectively after answering by clicking 'yes' button.

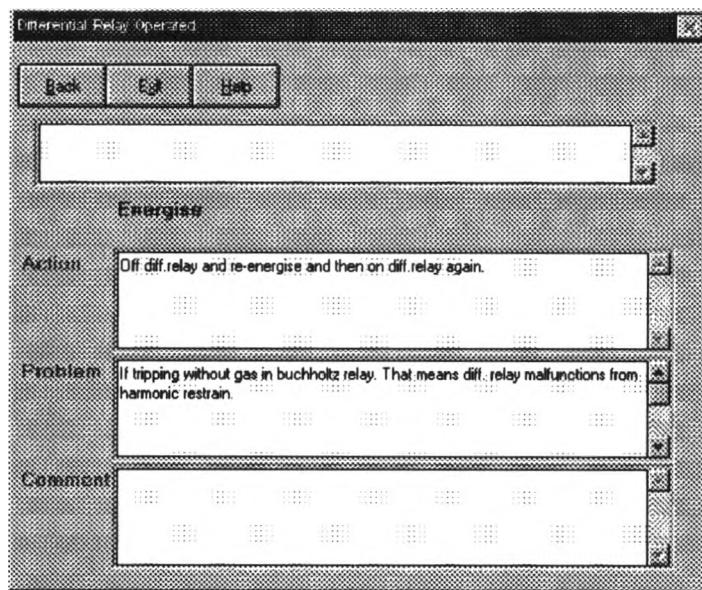
But if there is no gas accumulated in Buchholtz relay, the summary screen will appear respectively after answering by clicking 'no' button.

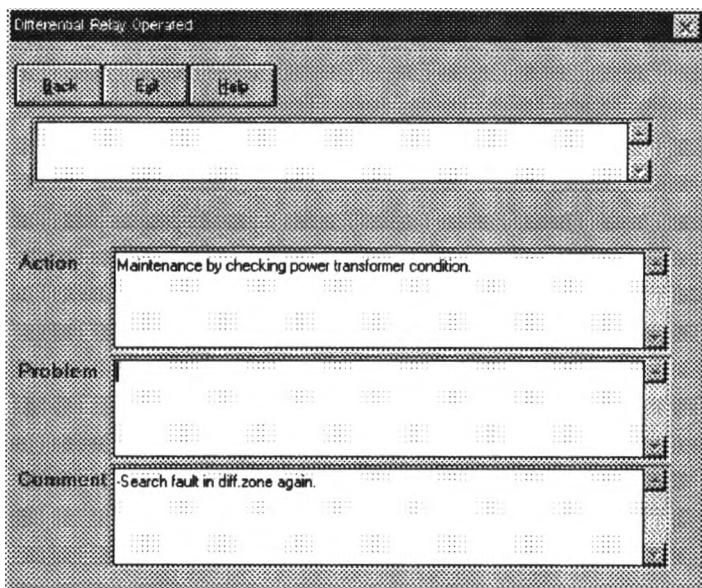
But if power transformer condition is normal after re-energising, the fault in differential zone is needed to be searched again.
