CHAPTER 7

DISCUSSION

7.3 FLO-2D simulation results for validation of the suspected temporary landslide dam occurrence

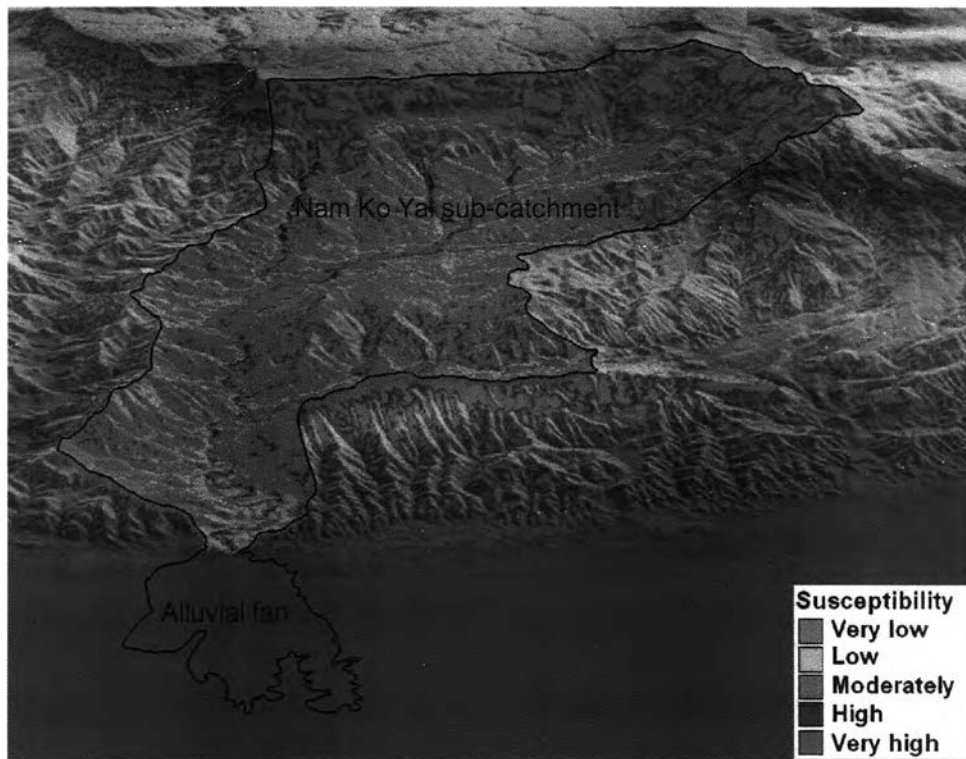
Figure 7-2 Three-dimensional drupe of five classes susceptibility of very high, high, moderate, low, and very low, through a 1:20,000 base-scale DEM in Nam Ko Yai sub-catchment. Very high to very low susceptibility was noted here.

Using the parameters above, probability method was applied to analyze the flow-flood hazard. The analyzed results were used to reconstruct the GIS database, then to maps. The flow-flood susceptibility map and relevant maps as previously proposed in Chapter 4 might be of great help to planners and engineers for choosing suitable locations to implement developments in Nam Ko Yai sub-catchment. Besides, three-dimensional drape of five classes of susceptibility as very high, high, moderate, low, and very low through 1:20,000 base-scale DEM was also illustrated in Figure 7-2 as the flow-flood susceptibility model in the sub-catchment. It was noted that the very high to very low susceptibility was occurred here. In general, the middle part of Nam Ko Yai stream channel and its adjacent banks had a very high to high flow-flood susceptibility whereas the lower downstream part of the stream had a high flow-flood susceptibility. Whereas the western and northern steep-cliff areas had a low to moderate flow-flood susceptibility whereas the main other parts else of the sub-catchment have in general very low flow-flood susceptibility.

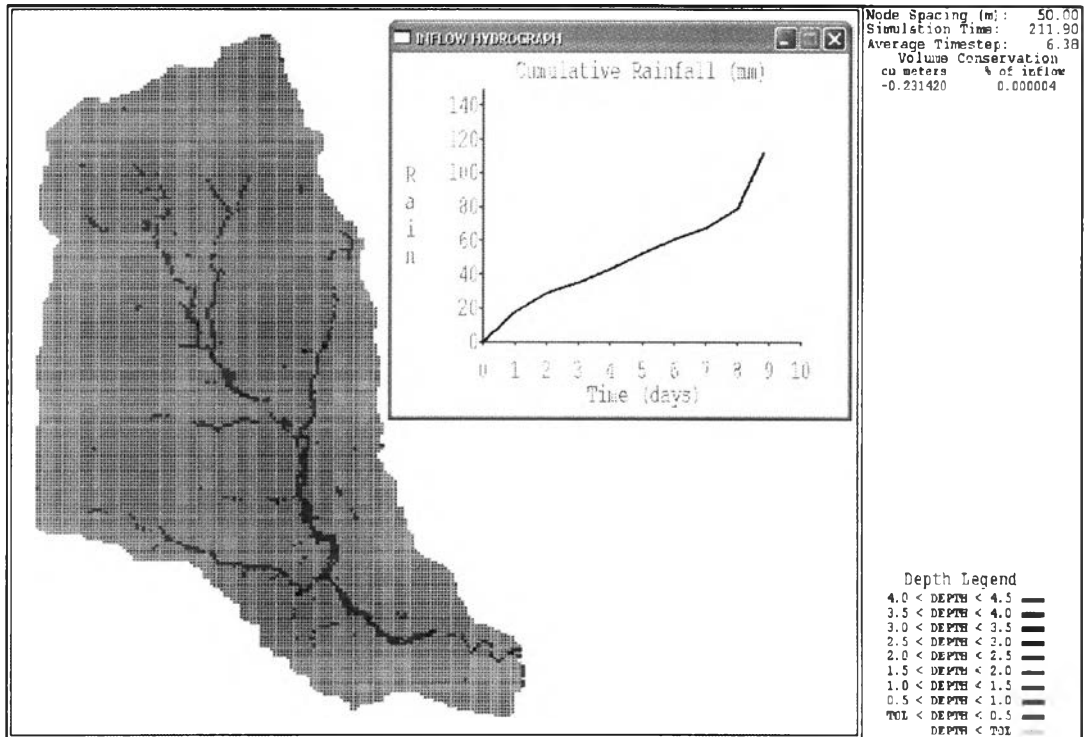
Figure 7-6 FLO-2D simulation results of the channel flow conditions of water height from the condition without dam while the rainfall accumulation was 120 mm at 3 a.m. on 10th August 2001 (about 24 hours before the 8/11 event).

August 2001 (about 24 hours before the 8/11 event), the water height in the condition without dam was generally increased up to 0.5 - 2.0 m along the stream channels further down in the middle part of sub-catchment while the rainfall accumulation was approximately 120 mm as modeled in Fig 7-6. It is noted that the water height in the further down of middle part along the channels was locally increased to 3.0 – 4.5 m. At 3 a.m. on 11th August 2001 (0.5 hour before the 8/11 event) the water height in the condition without dam was generally increased up to 1.0 - 3.0 m along the stream channels in the upper and middle parts, and significantly increased up to 1.0 - 10.0 m in the further down of lower part of sub-catchment while the rainfall accumulation was more than 140 mm as modeled in Figure 7-7.
